**Consumers
Power
Company**

Re: Docket No 50-255
License No DPR-20

This letter is written to apprise you of a recent incident involving the primary coolant system at this facility.

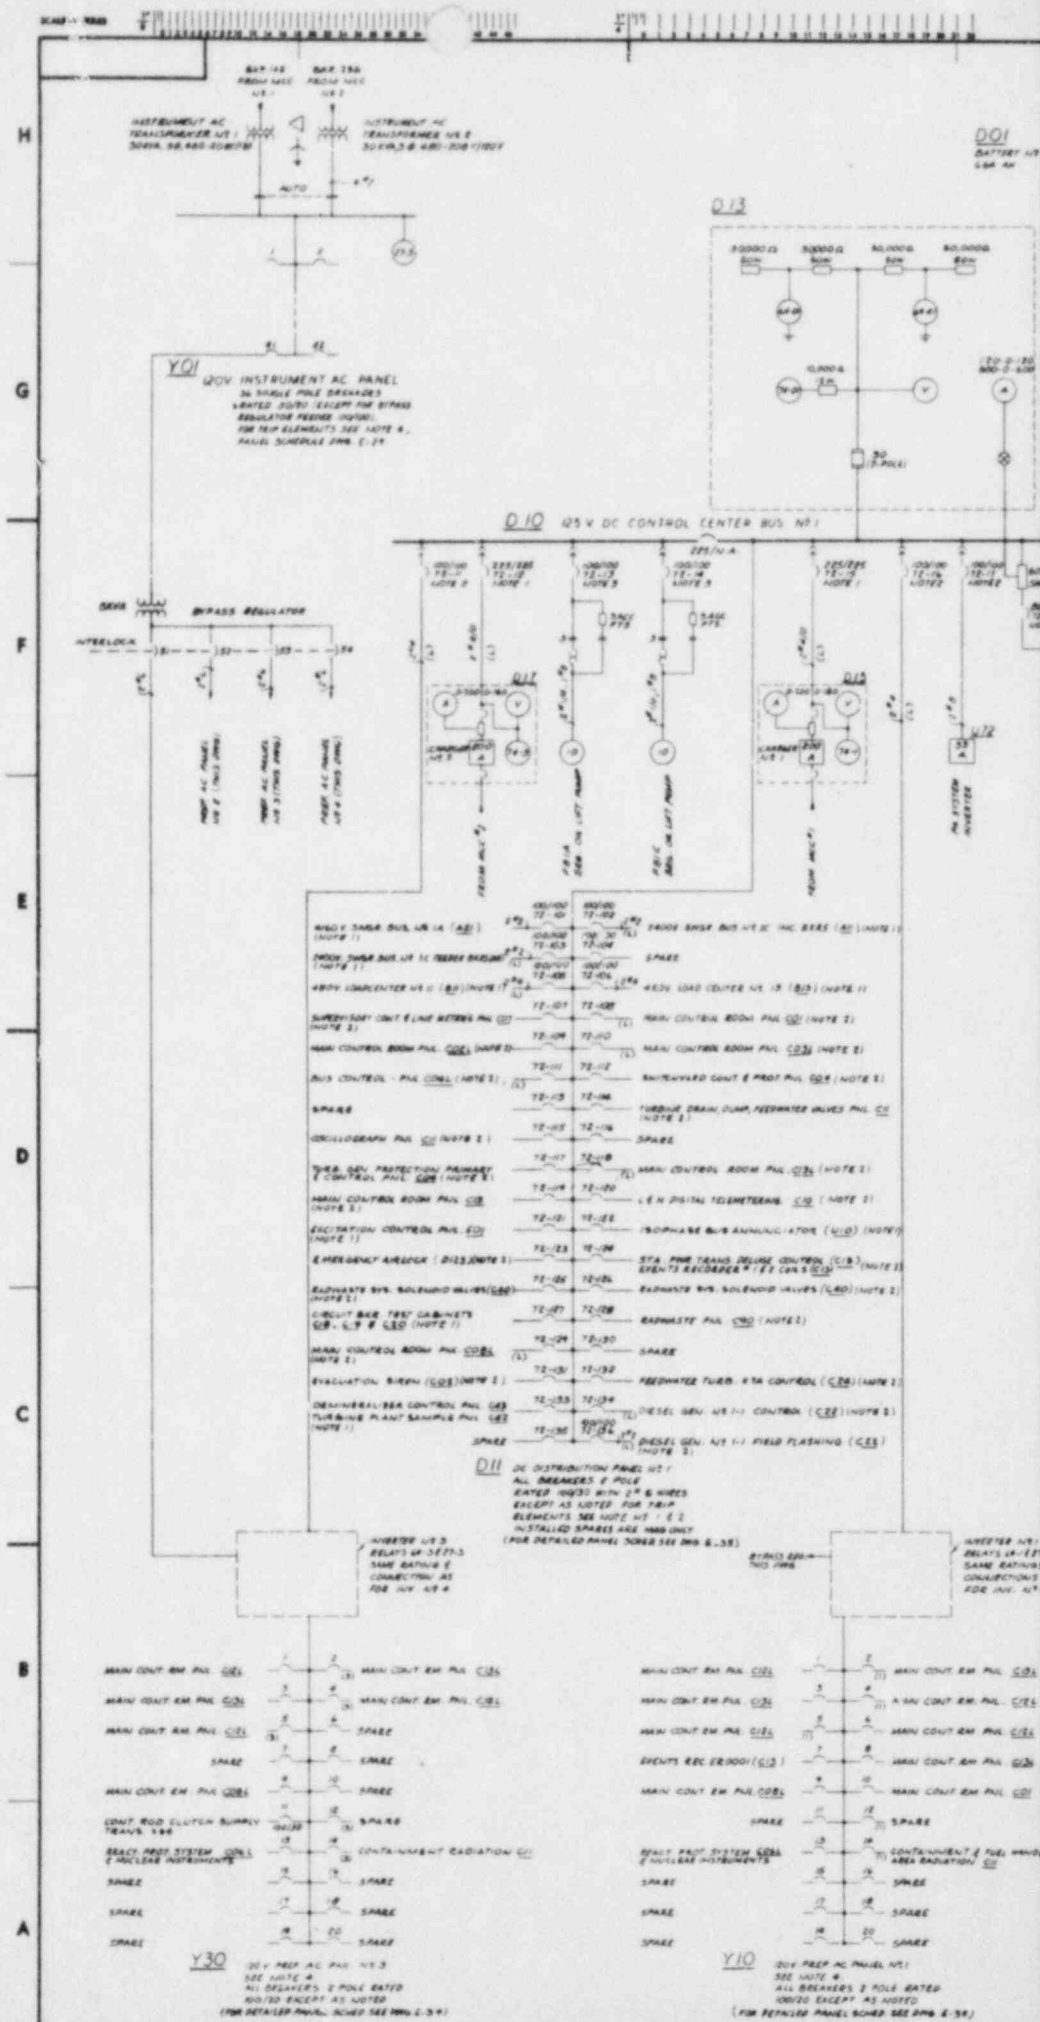
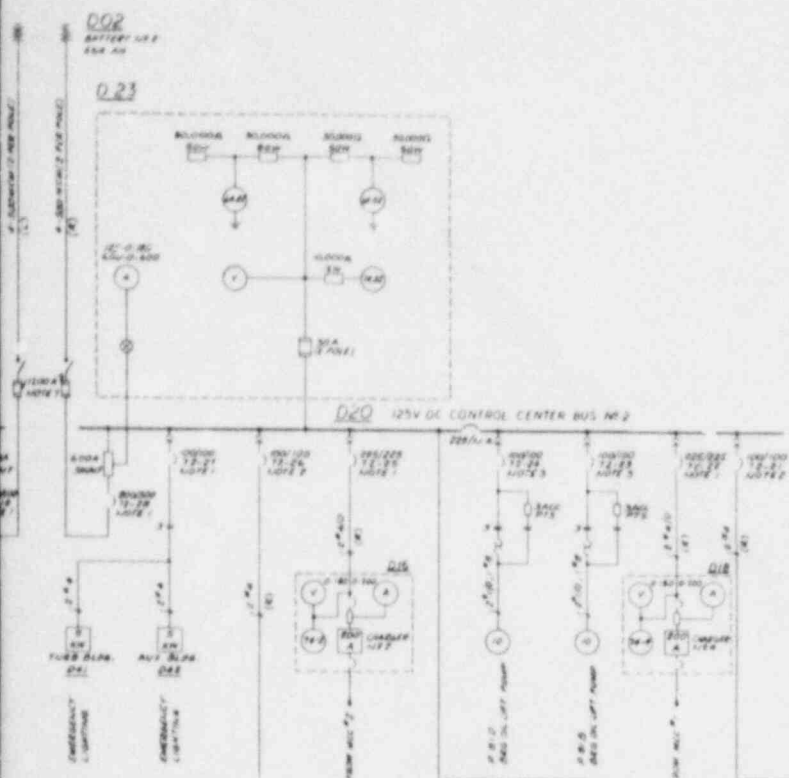
- 1335 Breaker #13 on panels Y10 and Y30 de-energized to allow for a minor modification to the reactor protective system. Refer to attached drawing E-8.
Relays K1 and K3 which feed the electrically operated pressurizer relief valve bi-stables (RV1042B and RV1043B) de-energized.

The basic cause of this incident was the non-standard designation of contacts (as used by the architect engineer on the drawing) in the control circuit to the power operated relief valves. The technician was misled by the 'a' contact designation as shown on the drawing when in fact the circuit is wired using 'b' contact(s). This led him to believe the relief valves would not open when the power was removed by opening breaker #13 on the panels Y10 and Y30.

The drawing(s) will be corrected to indicate the "as built" condition using standard notations.

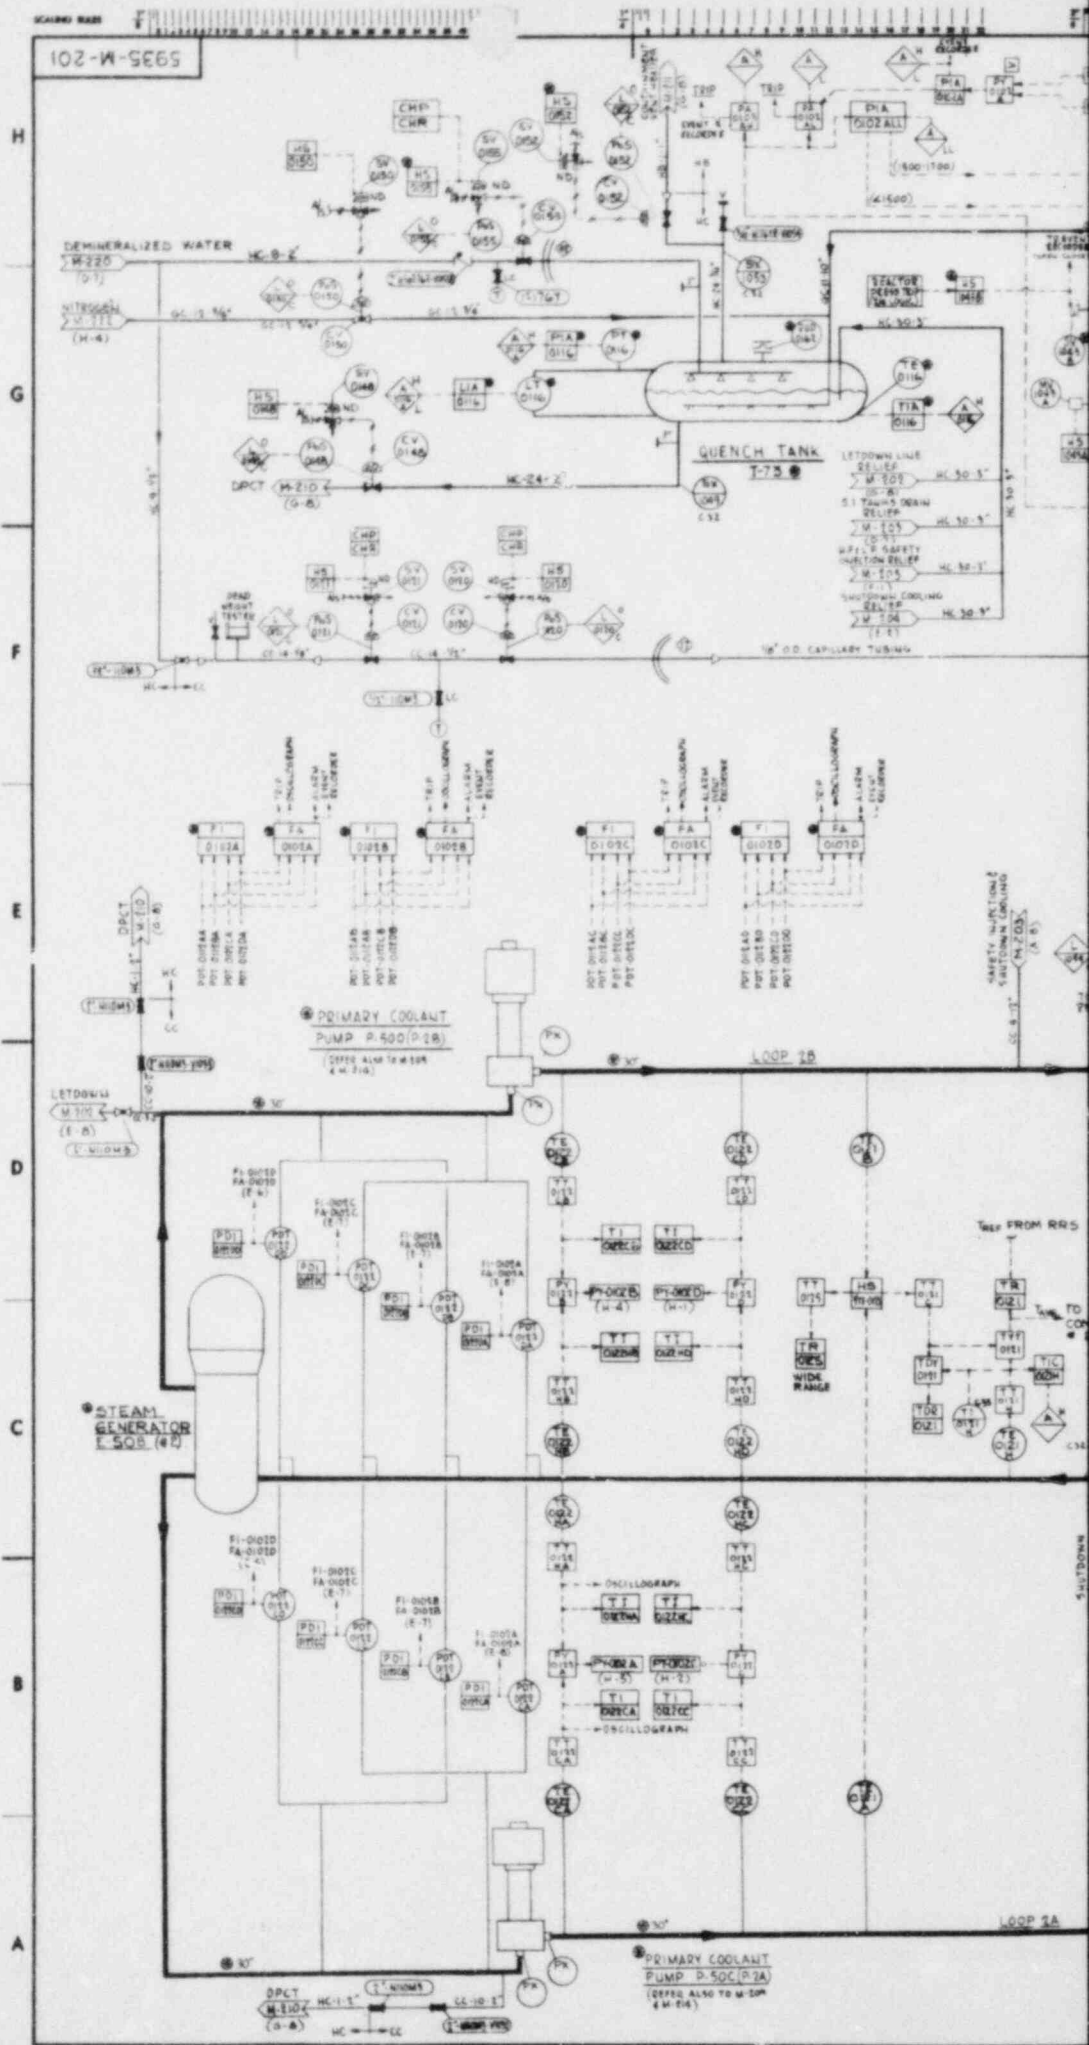
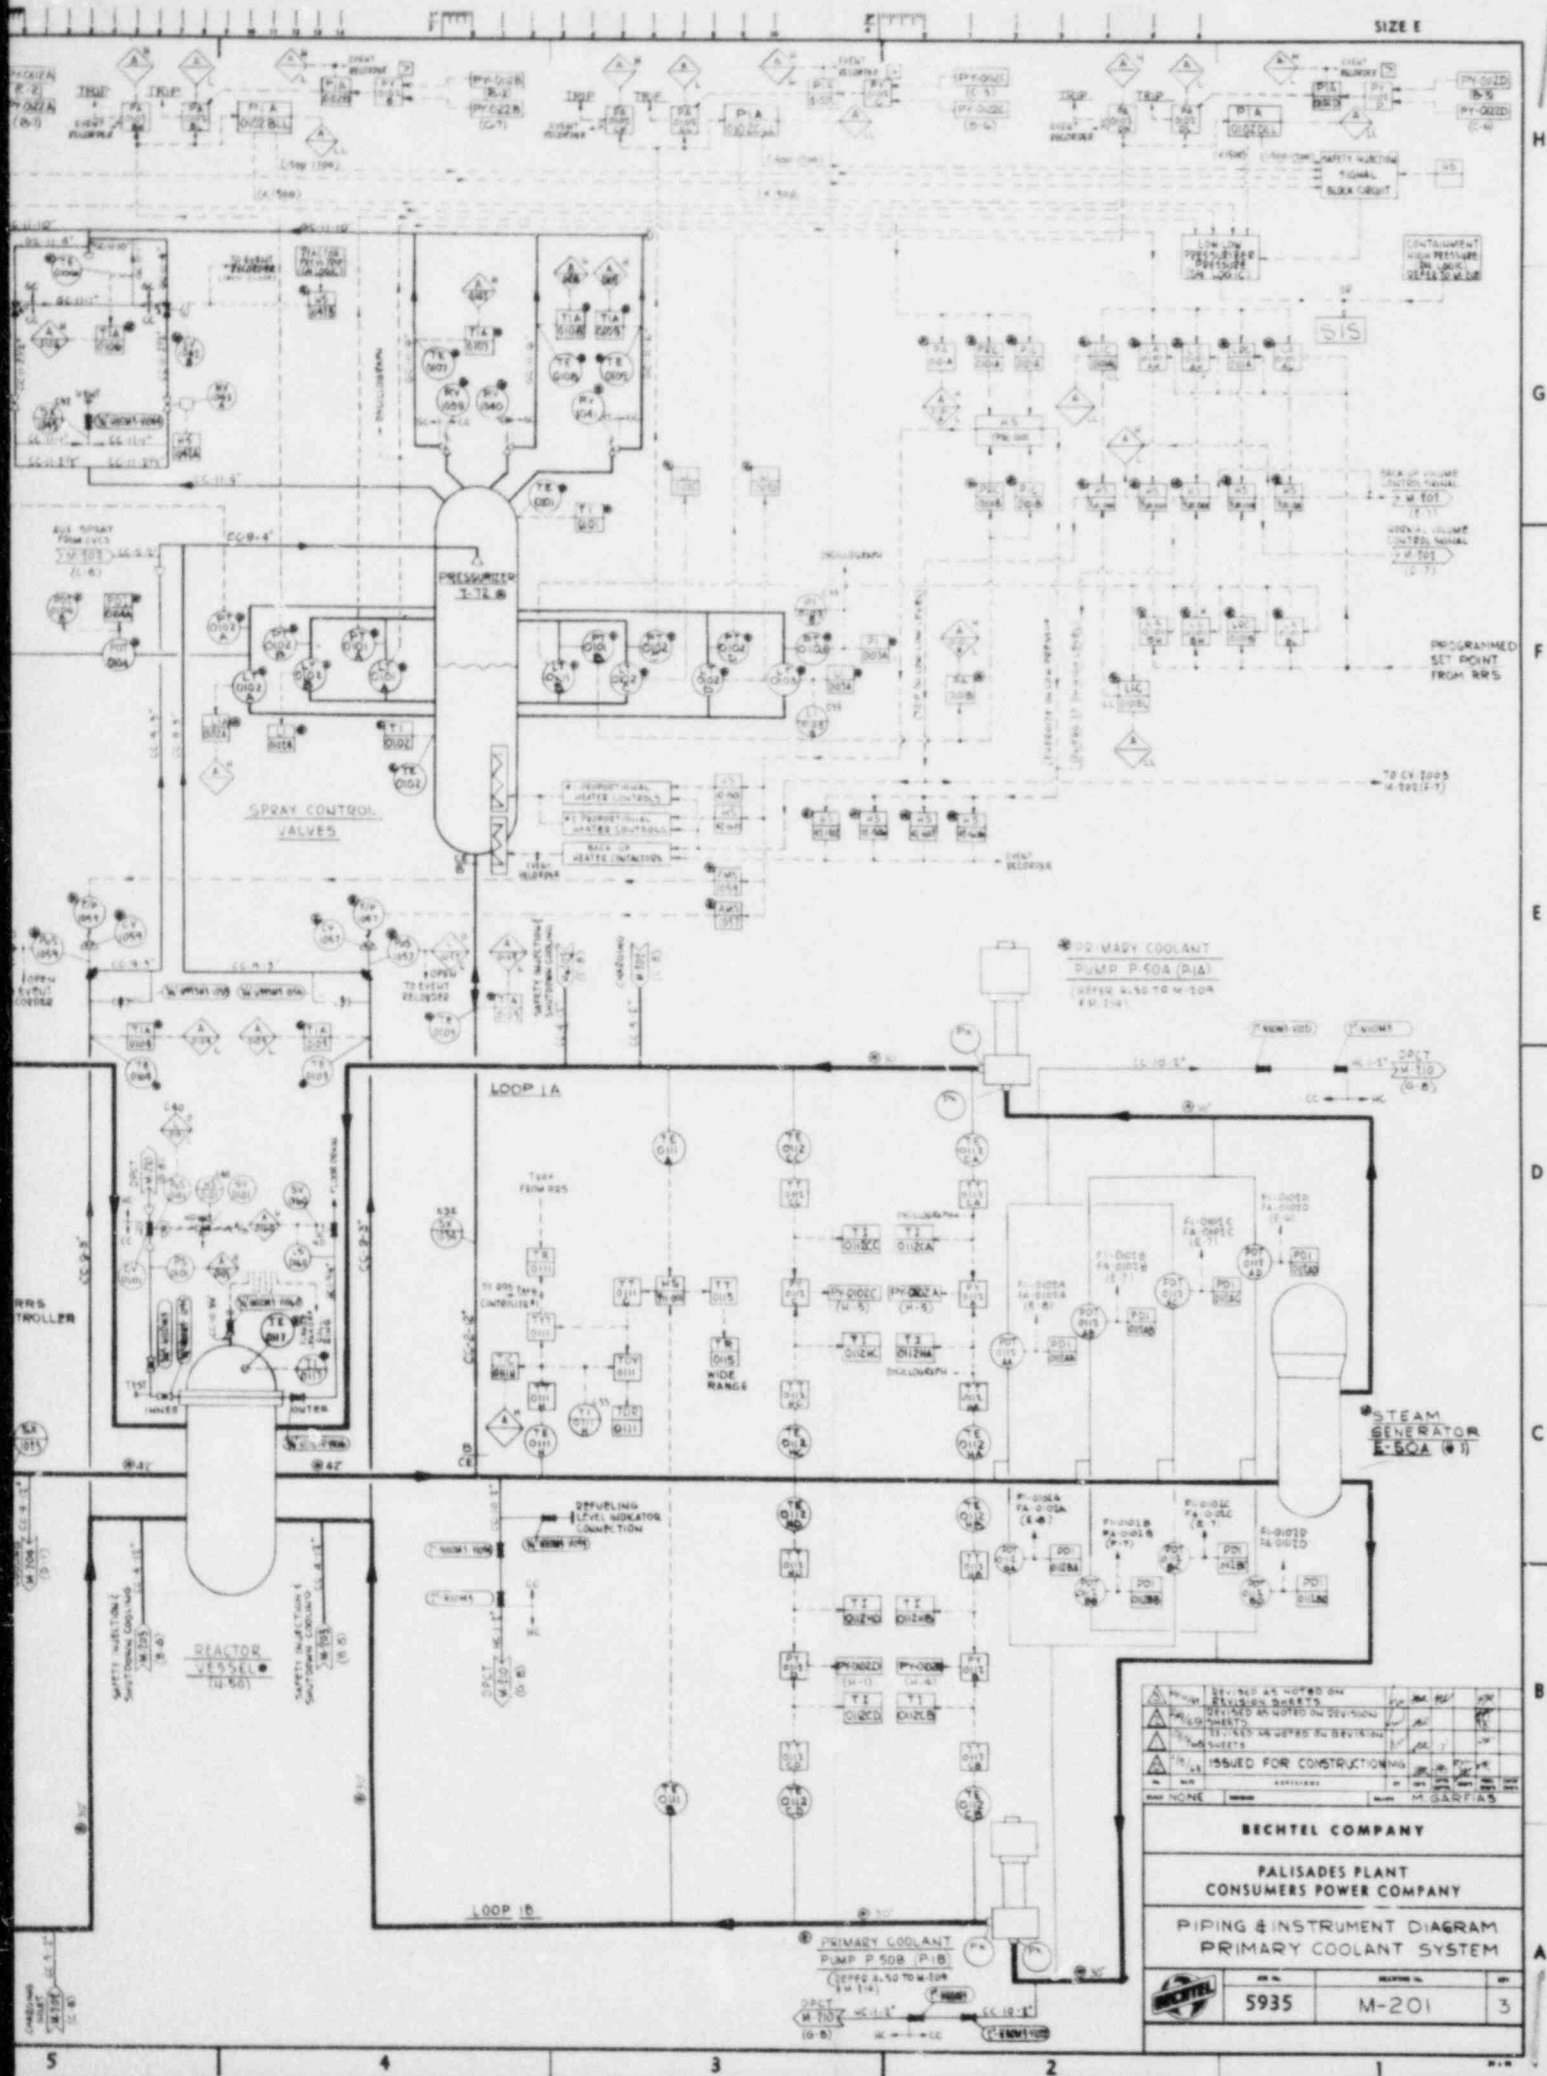
- 1335 RV1043B opened and released steam to the quench tank starting a decrease of primary system pressure. RV1042B had previously been isolated by means of the motor operated isolation valve and did not pass steam during the incident. Refer to attached drawing M-201.
