Consumers
Power
Company

May 18, 1971

Re: Docket 50-255
License No DPR-20

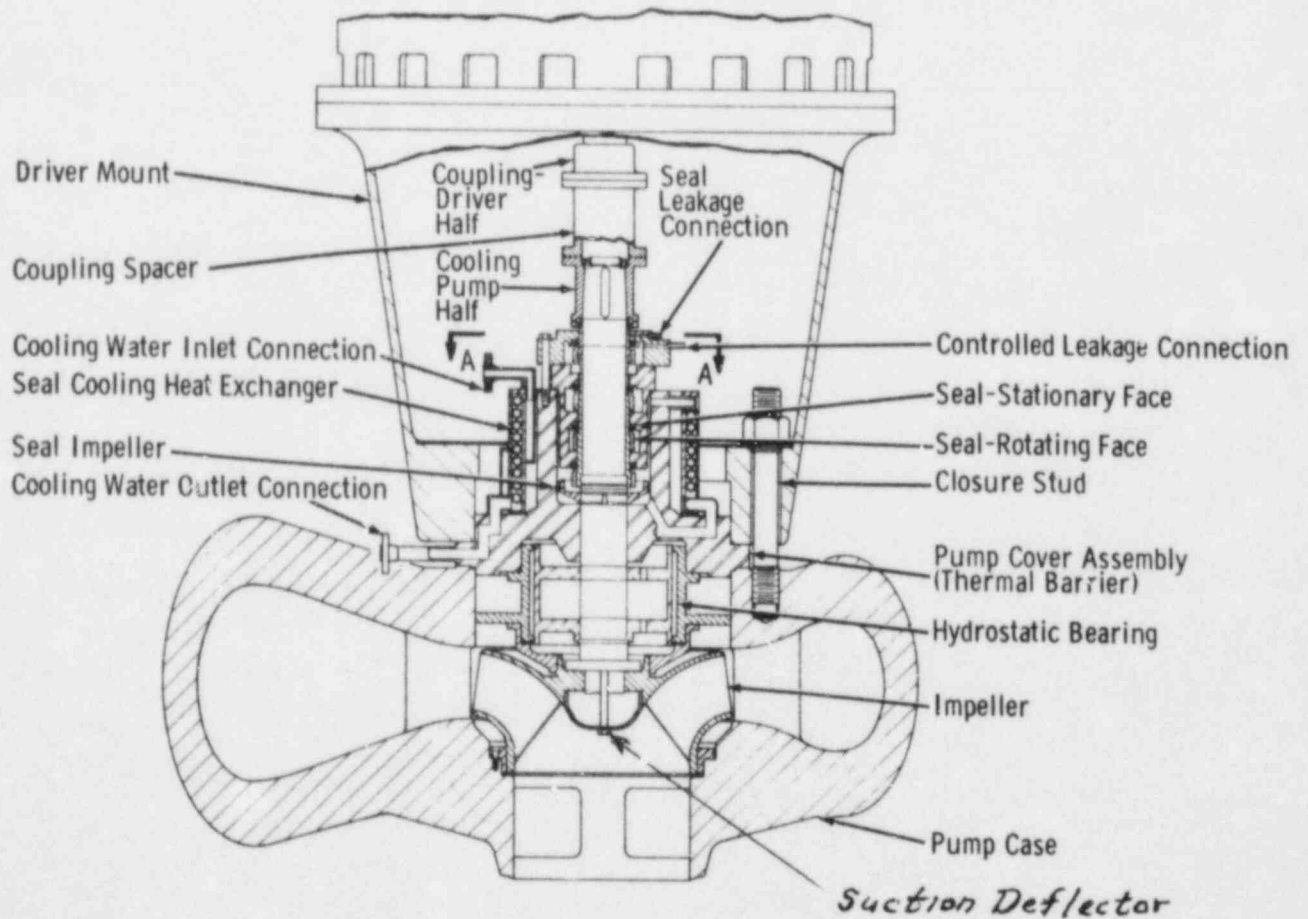
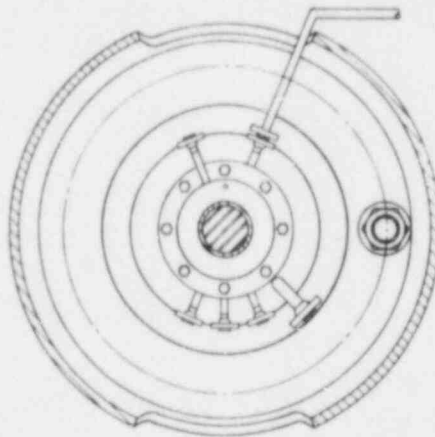
Figure
4-4A

A noise in the suction piping of the "A" primary coolant pump was detected at 8:00 PM on May 8, 1971 and the plant was cooled down. Subsequent inspection revealed that the noise was caused by the hexagonal head cap screw from the suction deflector on the "B" primary coolant pump (see attached figure from the FSAR). In addition, the suction deflector was found in the plenum of the steam generator common to the suction piping for the "A" and "B" primary coolant pumps. Damage to the impellers of both pumps indicated that one or both of the loose parts had impacted against the impellers during a period of pump operation.

The suction deflector cap screw and the suction deflector dropped off the lower end of the "B" primary coolant pump shaft. An investigation as to the cause is currently under way; however, the results are inconclusive at this time. The cap screw had been welded to the deflector to prevent the cap screw from backing out. Inspection of the "A" and "B" pump disclosed the following:

"B" Primary Coolant Pump - The suction deflector and cap screw were found missing from the impeller hub. Wear marks about 1-1/2" by 1/2" were found on one edge of each of two impeller-to-shaft hexagonal head cap screws protruding from the bottom of the impeller. Matching marks were noted on two of the suction deflector ribs. A 304 SS locating pin (1/2" diameter, 7/8" long) is presumed to have been installed and has not been located as yet. Impact marks were found on several of the impeller vanes, the most significant one being about 3" by 1-1/2" with about a 1/2" deflection at the leading edge of the impeller vane.

"A" Primary Coolant Pump - Cap-screw-to-suction-deflector welds were found cracked through on five of the six sides of the hexagonal head cap screw. Impact marks were noted on all of the impeller vanes and one vane has a tear approximately three inches into the leading edge. One flap of the tear is bent back about 60°. Several gouges were also noted in the pump casing. However, none of these are more than 1/32" deep or greater than two square inches in area. The suction line elbow from the steam generator has numerous impact marks caused by the bouncing of the cap screw. Preliminary inspection disclosed no cracks or deep penetrations in the clad surface.

A possible mode of failure is stresses set up in the welds due to differences in heating rate of cap screw and deflector, or from the welding operation. These welds had been reinforced prior to the last installation of pump intervals.

PRIMARY COOLANT CIRCULATING PUMP

The "C" and "D" primary coolant pump suction deflectors will be replaced by 2" flat plates (13-1/4" diameter) milled to recess the eight impeller-to-shaft hexagonal head cap screws. A hole will be machined through the center of each plate to allow free flow and assist in reducing thermal stress in the plate-to-impeller cap screws. The plate will be attached with two 3/4" socket head cap screws anchored in the jacking bolt holes. The cap screws will be staked to the plate. The stake pins will be anchored in the plate.

The "B" primary coolant pump will be repaired in a similar manner. The shaft seal cartridge on the "B" pump has been replaced. The "A" primary coolant pump suction deflector cap screw welds will be removed and the cap screw tack welded on two faces 180° apart.
