DRESDEN NUCLEAR POWER STATION

UNIT 3

SPECIAL REPORT

INCIDENT OF MAY 4, 1972

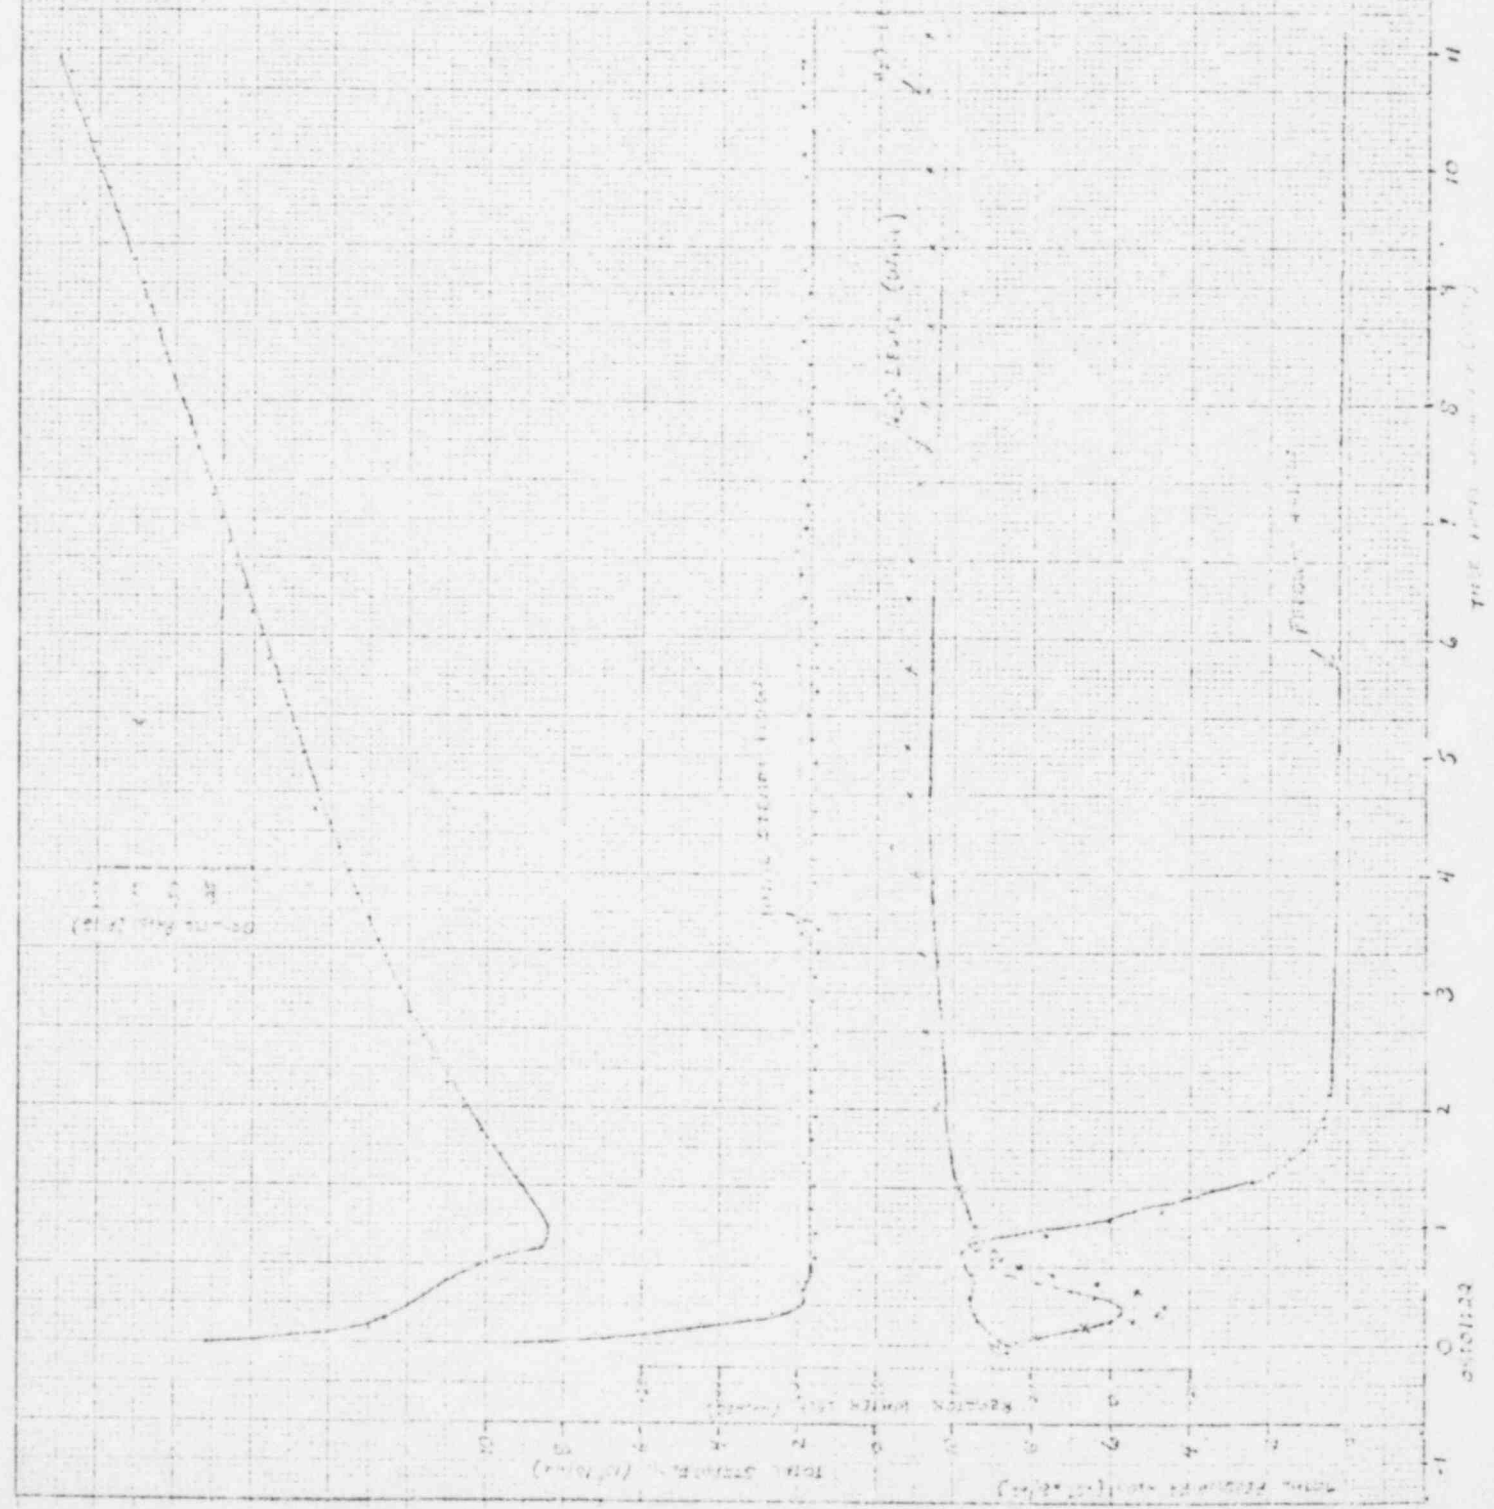
FIG. 1

A complete description of the events is presented below in chronological order with discussion where pertinent. Response of significant parameters following the scram is presented in Figure 1.

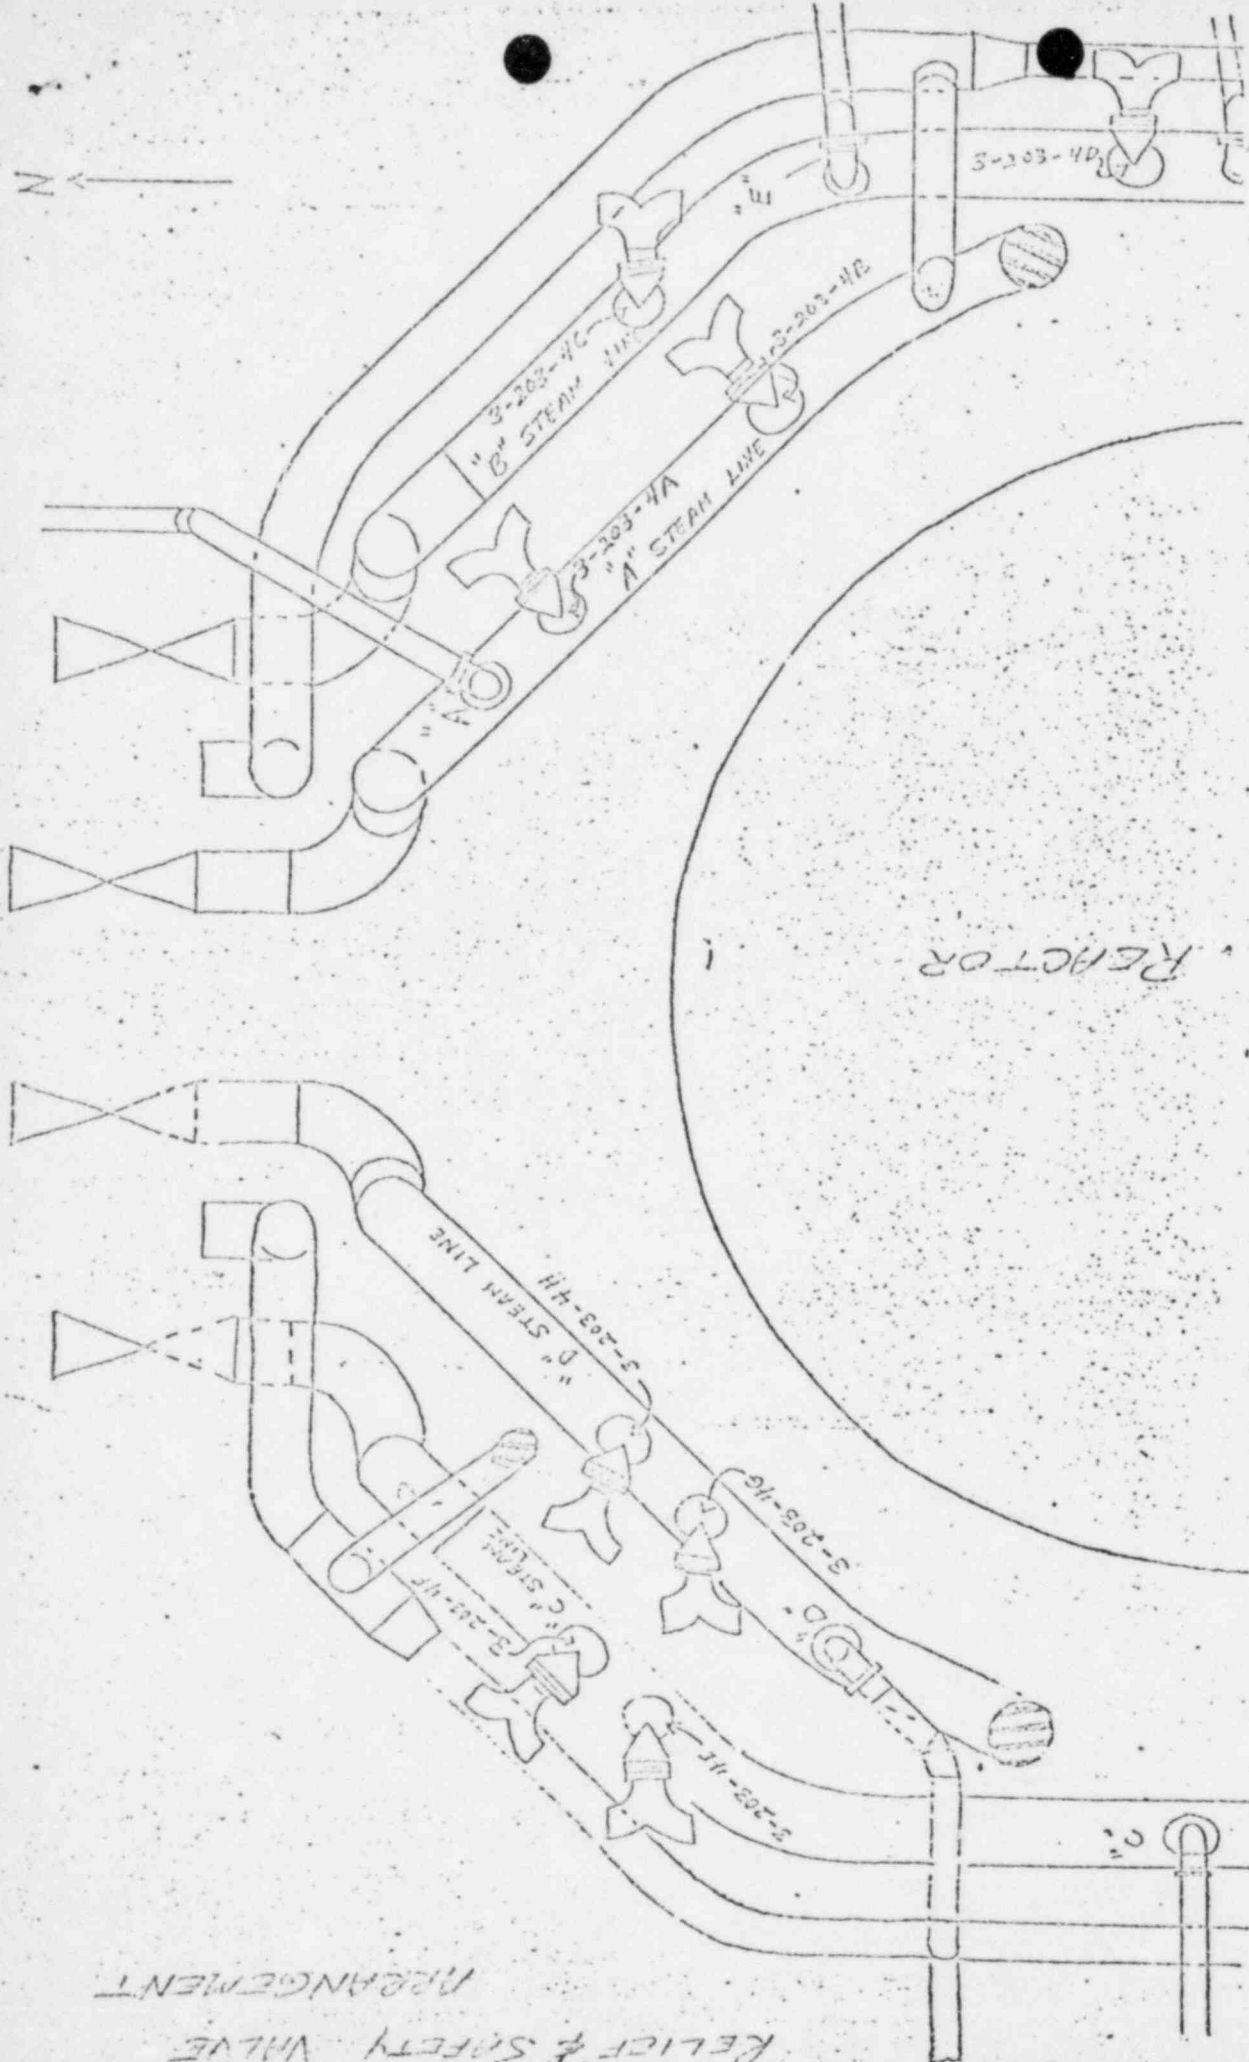
RELIEF & SAFETY VALVE

When safety valve 3-203-4A lifted, steam was ejected into the drywell. This steam struck the line from electromatic relief valve 3A to the torus, line number 3-3019-A-8" and also the base of electromatic relief valve 3E. Upon striking the base of the relief valve, a piece of insulation was torn loose. The insulation was replaced and line 3-3019-A-8" was visually inspected and found to be undamaged. A sketch of the safety and relief valve arrangement is presented in Figure 2.

2. Safety valve 3-203-4A which lifted was serial number BK7155. The valve had originally been set at a steam pressure lift point of 1210 psig. After the incident, a nitrogen test was conducted on the valve and it lifted approximately 75 psig lower than previously set. The valve was replaced with valve BK7163 which had been set with steam and nitrogen at the manufacturer's plant located in Alexandria, Louisiana and was verified with nitrogen at 1140 psig prior to installation.

3. The 3A electromatic relief valve was tested and found to have a lifting pressure of 1108 psig and a reset of 1035 psig, indicating that the set point had drifted from its last setting of 1133 psig trip and 1052 reset made 6/28/71. All electromatic relief valves were checked and recalibrated to proper relieving pressures.
