Commonwealth Edison
Quad-Cities Generating Station
Post Office Box 216
Cordova, Illinois 61242
Telephone 309/654-2241

REPORT NUMBER: AC-50-265/75-8

IDENTIFICATION OF OCCURRENCE:

Jet pump components were discovered missing during a jet pump inspection.

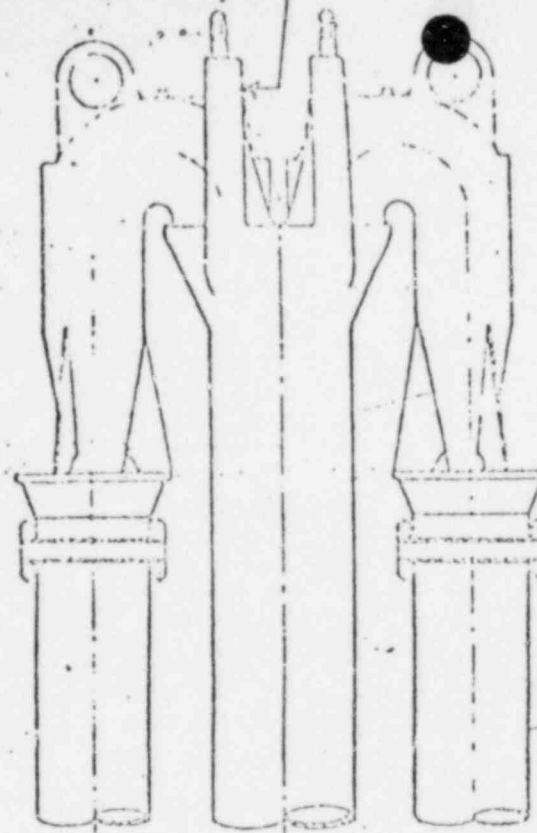
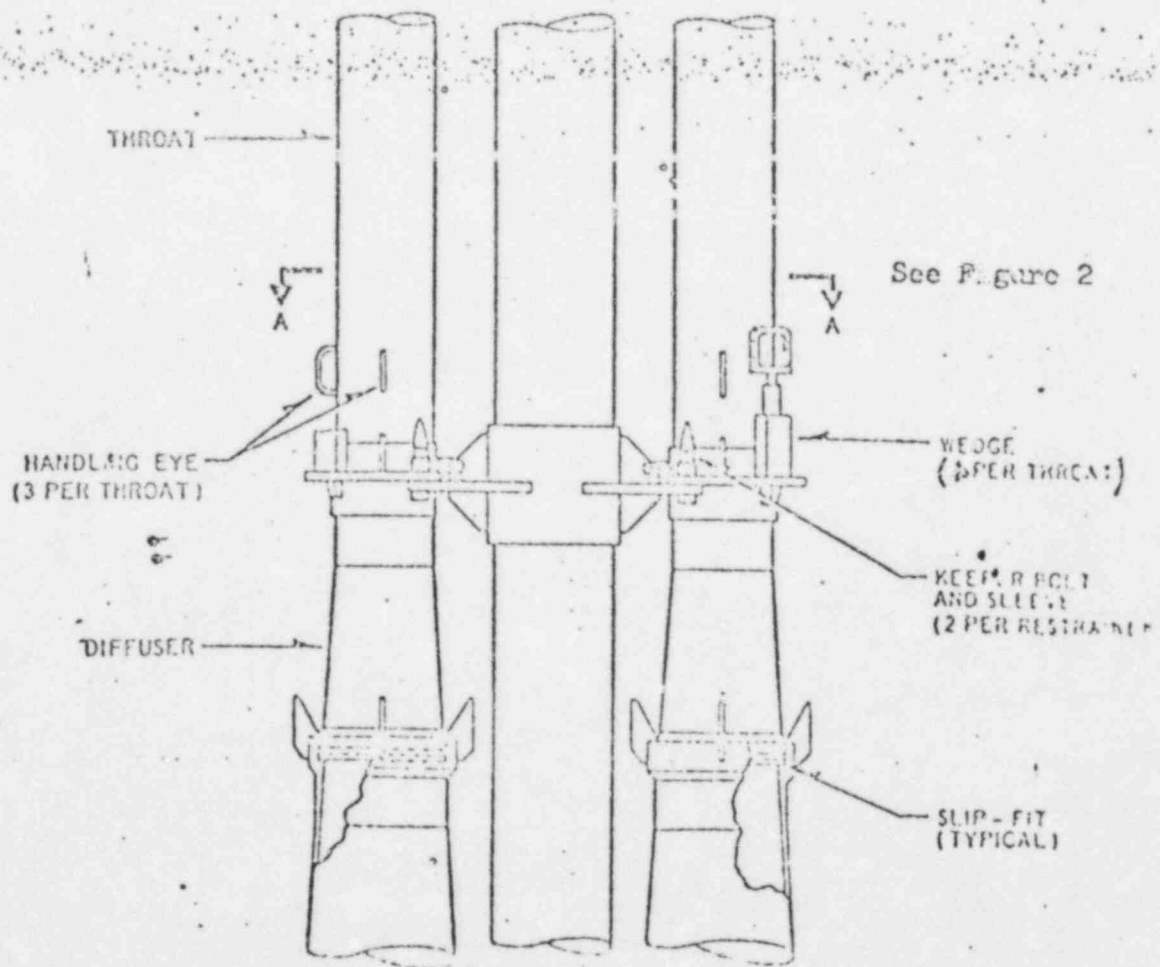
Jet Pump Figure 1

- (1) The beam bolt retainer clips and 1/2" cap screws were found to be missing on jet pumps 7 and 8.
- (2) The restrainer adjusting screw on the shroud side of jet pump 18 was found to be missing.
- (3) Restrainer gate keepers on jet pumps 1, 8, 12, 15, and 18 were found to have their welds in place, but not fused to the restrainer gate.

The apparent cause of the missing retainer clips, the 1/2" cap screws, and the adjusting screw is attributed to equipment failures caused by installation deficiencies. Based on the parts being inadequately installed, the vibrational forces present during normal operation could cause these components to become dislodged from their normal positions.

The missing beam bolt retainer clips and 1/2" cap screws of jet pumps 7 and 8 will not be replaced. These pieces are important only during the initial construction of the jet pump beam assembly or during their removal. After installation of the beam bolt, the function of these pieces is completed.
