Northeast
Nuclear Energy

LICENSEE EVENT REPORT (LER)

FACILITY NAME (1) Millstone Nuclear Power Station Unit 3 DOCKET NUMBER (2) 05000423 PAGE (3) 1 OF 8

TITLE (4) Containment Leakage in Excess of Technical Specification Limits Due to Valve Leakage

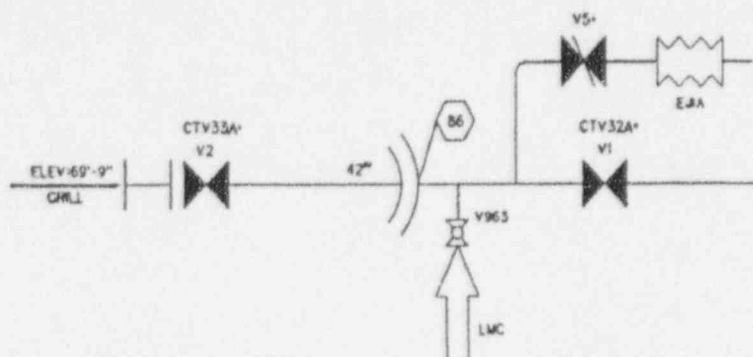
Figure 1, Containment Purge Supply Penetration, #86

- The containment purge supply line (42-inch) penetration (#86) has three isolation valves, one inboard (3HVU*CTV33A), one outboard (3HVU*CTV32A), and an additional outboard valve on a 30-inch branch line (3HVU*V5). The combined "as found" LLRT leakage through these three valves was 7,300 SCCM. The large isolation valves cannot be tested independently. However, the branch valve has been determined to have insignificant leakage. See Figure 1.

The apparent cause of the excessive leakage through the 42-inch butterfly isolation valves on the purge supply and exhaust lines, was deterioration of the resilient valve seats. The cause of the deterioration is being investigated. It is believed that the cause is isolated to the current event, as this deterioration has not been observed in the past. The cause of the excessive leakage through the 8-inch outboard vacuum line valve was inadequate design. The valve is a hard-seated gate valve which historically had similar leakage, and, therefore, was replaced during the current refueling outage.

- The combined leakage through all of the isolation valves on the 42--inch containment purge supply and exhaust lines was 15,120 SCCM. This total is below the current Technical Specification allowable bypass leakage, L_a of 20,633.9 SCCM. The purge valve leakage had low safety significance. The actual leakage through the penetrations, even assuming a single failure, would be even lower than 15,120 SCCM. This is because the penetration leakage is conservatively assumed to be equal to the sum of the redundant valve leakages, since they cannot be individually tested.

The valve seats for the containment purge supply and exhaust line valves were inspected and two of the four valve seats were found to be somewhat worn. New seats were installed on all four 42-inch valves and they were tested satisfactorily. The valves are large diameter butterfly valves which require precision seating to maintain low leakage rates. These valve seats will continue to be replaced every other refueling or each refueling as needed, to maintain acceptable low leakage.

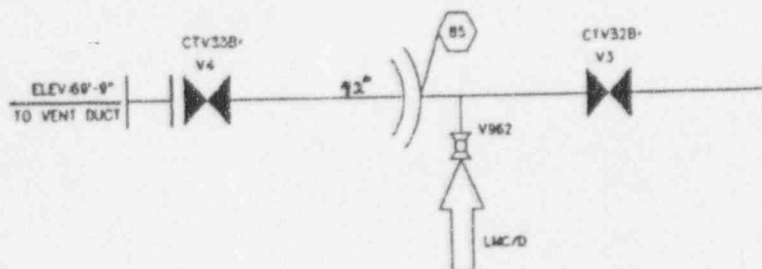
Figure 2, Containment Purge Exhaust Penetration, #85

- The containment purge exhaust line (42-inch) penetration (#85) has one inboard valve (3HVU*CTV33B) and one outboard valve (3HVU*CTV32B). The combined "as found" LLRT leakage through these two valves was 7,820 SCCM. The valves cannot be tested independently. See Figure 2.

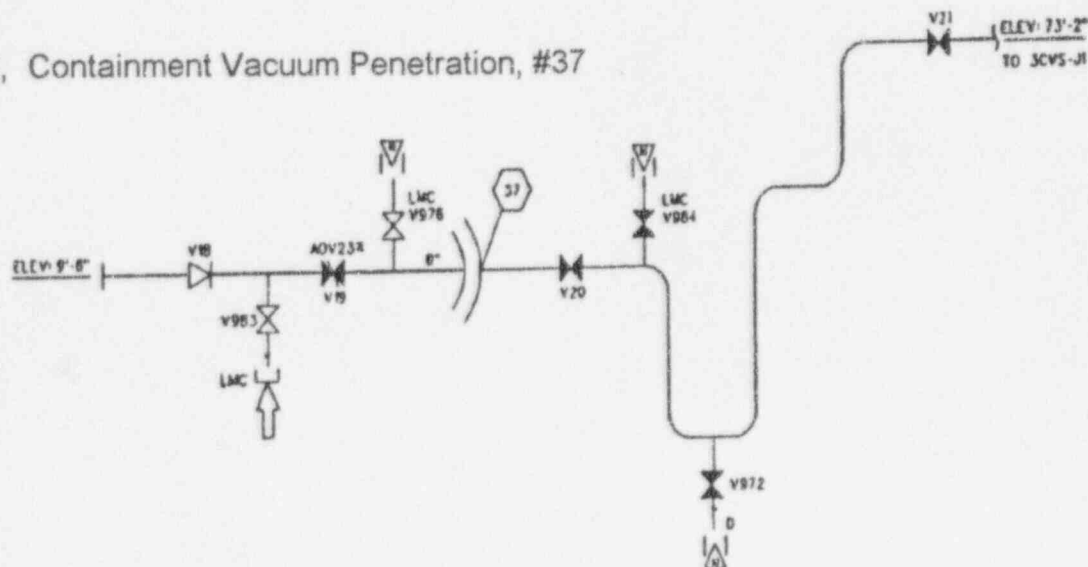
Figure 3, Containment Vacuum Penetration, #37

- The containment vacuum line (8-inch) penetration (#37) has one inboard valve (3CVS*AOV23) and one outboard valve (3CVS*V20). The "as found" LLRT leakage through the inboard valve was 27 SCCM, which maintained penetration integrity, while the outboard valve was found to have 11,970 SCCM leakage. See Figure 3.

- The "as found" bypass leakage through the outboard containment vacuum isolation valve was 11,970 SCCM. This would have been limited by the operable inboard valve which was isolated to only 46.5 SCCM. A single failure of the inboard valve would have resulted in the combined total of these bypass leakages, slightly exceeding the Technical Specification Limit.

The containment vacuum line outboard isolation valve was replaced during the current refueling outage. The 8-inch hard seated gate valve was replaced with a soft seated butterfly valve, which is a better design for this application.

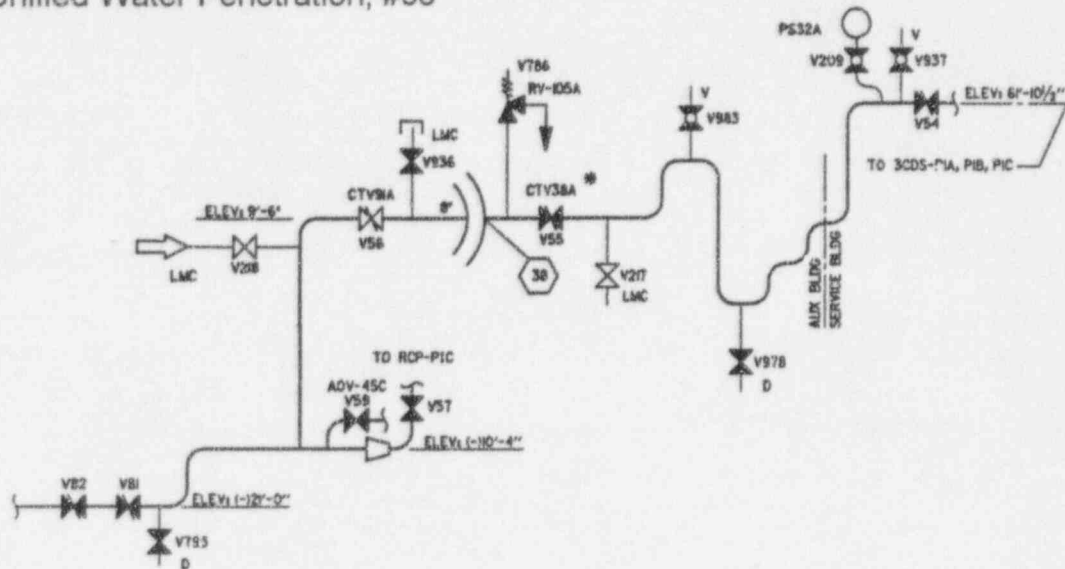
Figure 4, Chilled Water Penetration, #38

On May 2, 1995, the bypass leakage through containment isolation valves on the Reactor Plant Chilled Water (CDS) system (10-inch line) penetration (#38) exceeded the Technical Specification limit during the LLRTs. The inboard valve (3CDS*CTV91A) had 52,900 SCCM leakage. The outboard valve (3CDS*CTV38A) combined with relief valve (3CDS*RV105A) had 52,800 SCCM leakage. See Figure 4.

The cause of excessive leakage through the CDS 10--inch butterfly isolation valves appears to be inadequate setting of the valve actuators' stop--travel limiter. There was no significant leakage through the relief valve. Although the butterfly valves had passed their previous LLRT, it is now believed that they were probably not in their optimum seating position, and that with time and wear, their full closure capability became degraded.

Both the inner (3CDS*CTV91A) and outer (3CDS*CTV38A) containment isolation valves had leakage in excess of Technical Specification bypass leakage limits. This event had moderate safety significance. The penetration is normally filled with water as part of a non--safety related closed loop chilled water system. Although the CDS system is a closed loop system inside containment, a passive failure of the system pipe inside containment during a LOCA, could have resulted in a containment bypass leakage of 52,900 SCCM, exceeding the Technical Specification bypass limit of 20,633.9 SCCM. The CDS valves passed their previous LLRT during the previous refueling outage, which was completed in the Fall 1993. It is not known at what point in the operating cycle the valve condition changed. This type of LLRT failure had not been previously experienced. However, it is possible that the excess leakage condition may have existed prior to discovery in May 1995.

The corrective action for the CDS valves was to carefully reset the valve actuators' travel limiters while actively monitoring leakage to obtain the optimum seating position. The overhaul procedure for the actuators of these type of valves will be changed to improve the travel limiter adjustment methodology, based on this experience.

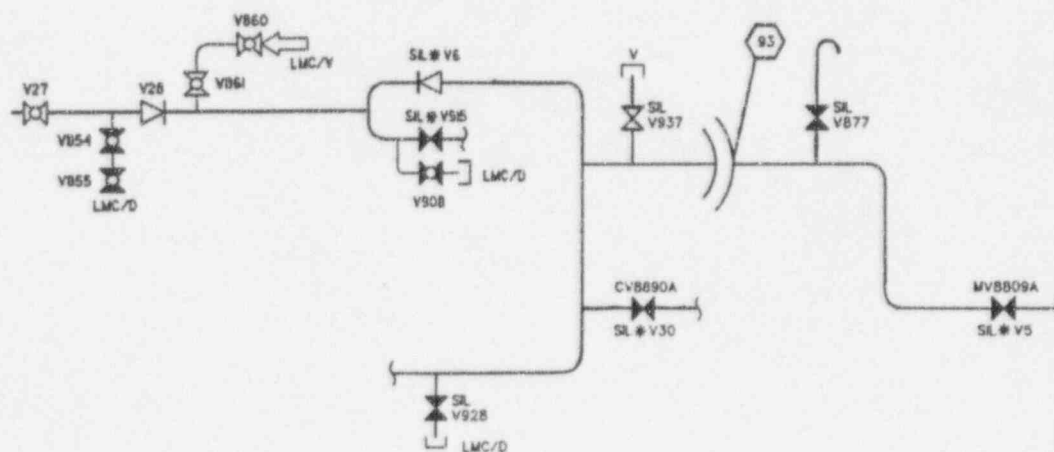
Figure 5, Low Pressure Safety Injection, #93

On May 10, 1995, the containment leakage through inboard isolation check valve (3SIL*V6) on the low pressure Safety Injection System (6-inch) line penetration (#93) had excessive leakage which prevented the desired test pressure from being reached. This "as found" undetermined leak rate exceeded the Technical Specification limit of 0.6L_a. The "as found" LLRT leakage through the outboard isolation valve (3SIL*MV8809A) was 2,060 SCCM, which maintained containment integrity. No immediate action was required since the plant was shutdown. See Figure 5.

The root cause of the 3SIL*V6 leakage appears to be a failed body to bonnet gasket.

The inboard (3SIL*V6) isolation valve leakage could not be determined. The actual leakage would have been limited by the outboard (3SIL*MV8809A) isolation valve which successfully passed an LLRT, with a leakage rate of 2,060 SCCM. A single failure of the outboard valve would have resulted in the combined total leakage exceeding the Technical Specification Limit. However, the line would be pressurized by the residual heat removal pumps, during an accident, whenever the RCS pressure drops below approximately 200 psig. The SIL valves passed their LLRT during the previous refueling outage. It is not known at what point in the operating cycle the valve condition changed.

The SIL check valve was disassembled and inspected. The body to bonnet gasket was replaced. The freedom of movement of the valve disk was verified after the inspection. The valve was reassembled and subsequently retested satisfactorily prior to startup.
