Reference: Facility Operating License No. NPF-49
Docket No. 50-423
Licensee Event Report 95-009-01

LICENSEE EVENT REPORT (LER)

FACILITY NAME (1) Millstone Nuclear Power Station Unit 3										DOCKET NUMBER (2) 05000423		PAGE (3) 1 OF 7		
TITLE (4) Containment Leakage in Excess of Technical Specification Limits Due to Valve Leakage														
EVENT DATE (5)			LER NUMBER (6)			REPORT DATE (7)			OTHER FACILITIES INVOLVED (8)					
MONTH	DAY	YEAR	YEAR	SEQUENTIAL NUMBER	REVISION NUMBER	MONTH	DAY	YEAR	FACILITY NAME		DOCKET NUMBER			
04	26	95	95	009	01	06	01	95			05000			
										FACILITY NAME		DOCKET NUMBER		
												05000		
OPERATING MODE (9)		6		THIS REPORT IS BEING SUBMITTED PURSUANT TO THE REQUIREMENTS OF 10 CFR §: (Check one or more) (11)										
POWER LEVEL (10)		000		20.402(b)		20.405(c)		50.73(a)(2)(iv)		73.71(b)

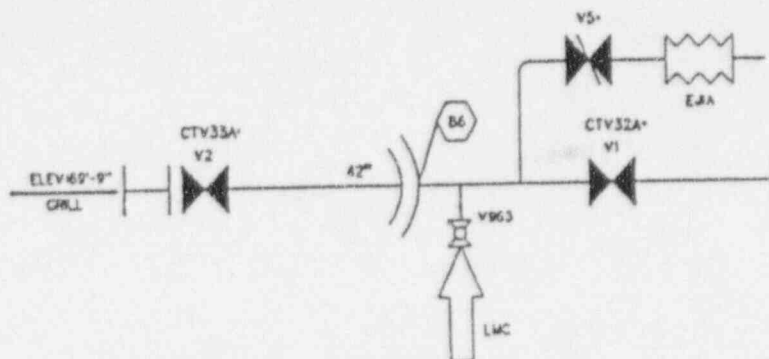
Figure 1, Containment Purge Supply Penetration, #86

- The containment purge supply line (42-inch) penetration (#86) has three isolation valves, one inboard (3HVU*CTV33A), one outboard (3HVU*CTV32A), and an additional outboard valve on a 30-inch branch line (3HVU*V5). The combined "as found" LLRT leakage through these three valves was 7,300 SCCM. The large isolation valves cannot be tested independently. However, the branch valve has been determined to have insignificant leakage. See Figure 1.

The apparent cause of the excessive leakage through the 42-inch butterfly isolation valves on the purge supply and exhaust lines, was deterioration of the resilient valve seats. The cause of the deterioration is being investigated. It is believed that the cause is isolated to the current event, as this deterioration has not been observed in the past. The cause of the excessive leakage through the 8-inch outboard vacuum line valve was inadequate design. The valve is a hard-seated gate valve which historically had similar leakage, and, therefore, was replaced during the current refueling outage.

- The combined leakage through all of the isolation valves on the 42-inch containment purge supply and exhaust lines was 15,120 SCCM. This total is below the current Technical Specification allowable bypass leakage, L_a of 20,633.9 SCCM. The purge valve leakage had low safety significance. The actual leakage through the penetrations, even assuming a single failure, would be even lower than 15,120 SCCM. This is because the penetration leakage is conservatively assumed to be equal to the sum of the redundant valve leakages, since they cannot be individually tested.

The valve seats for the containment purge supply and exhaust line valves were inspected and two of the four valve seats were found to be somewhat worn. New seats were installed on all four 42-inch valves and they were tested satisfactorily. The valves are large diameter butterfly valves which require precision seating to maintain low leakage rates. These valve seats will continue to be replaced every other refueling or each refueling as needed, to maintain acceptable low leakage.

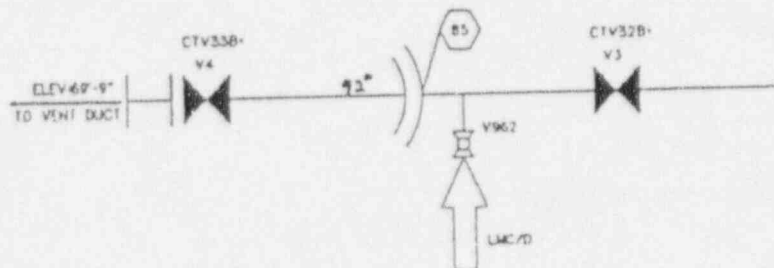
Figure 2, Containment Purge Exhaust Penetration, #85

- The containment purge exhaust line (42-inch) penetration (#85) has one inboard valve (3HVU*CTV33B) and one outboard valve (3HVU*CTV32B). The combined "as found" LLRT leakage through these two valves was 7,820 SCCM. The valves cannot be tested independently. See Figure 2.

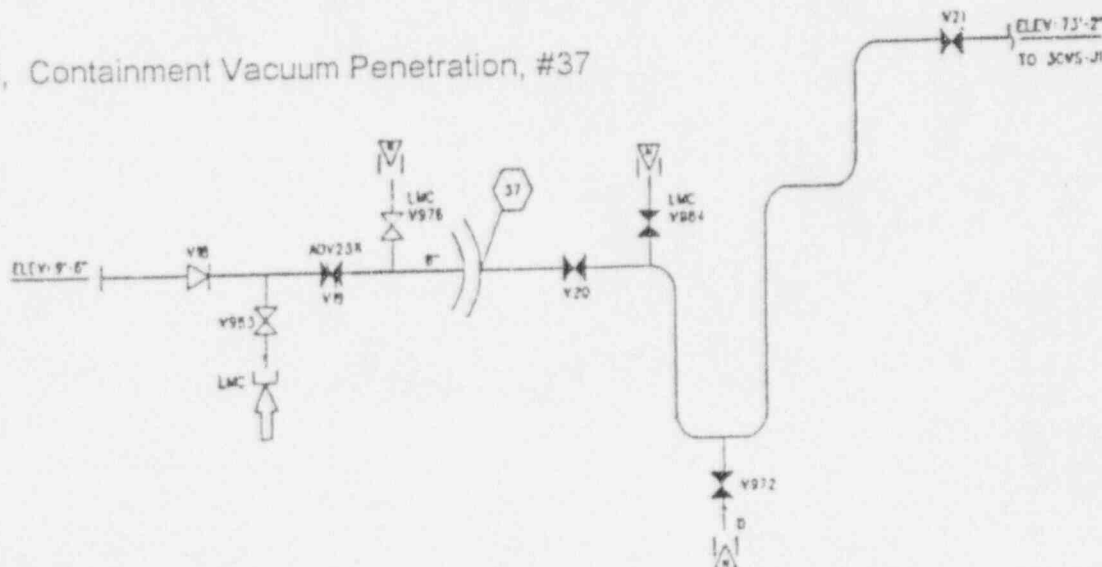
Figure 3, Containment Vacuum Penetration, #37

- The containment vacuum line (8-inch) penetration (#37) has one inboard valve (3CVS*AOV23) and one outboard valve (3CVS*V20). The "as found" LLRT leakage through the inboard valve was 27 SCCM, which maintained penetration integrity, while the outboard valve was found to have 11,970 SCCM leakage. See Figure 3.

- The "as found" bypass leakage through the outboard containment vacuum isolation valve was 11,970 SCCM. This would have been limited by the operable inboard valve which was isolated to only 46.5 SCCM. A single failure of the inboard valve would have resulted in the combined total of these bypass leakages, slightly exceeding the Technical Specification Limit.

The containment vacuum line outboard isolation valve was replaced during the current refueling outage. The 8-inch hard seated gate valve was replaced with a soft seated butterfly valve, which is a better design for this application.
