**Beaver Valley Power Station, Unit No. 2
BV-2 Docket No. 50-412, License No. NPF-73
Potential 10 CFR 21 Condition, Suction Valves for the
Recirculation Spray Pumps
Special Report - Supplement No. 1**

10 CFR Part 21, Supplement No. 1
BVPS Unit No. 2 - Suction Valves for the Recirculation Spray Pumps

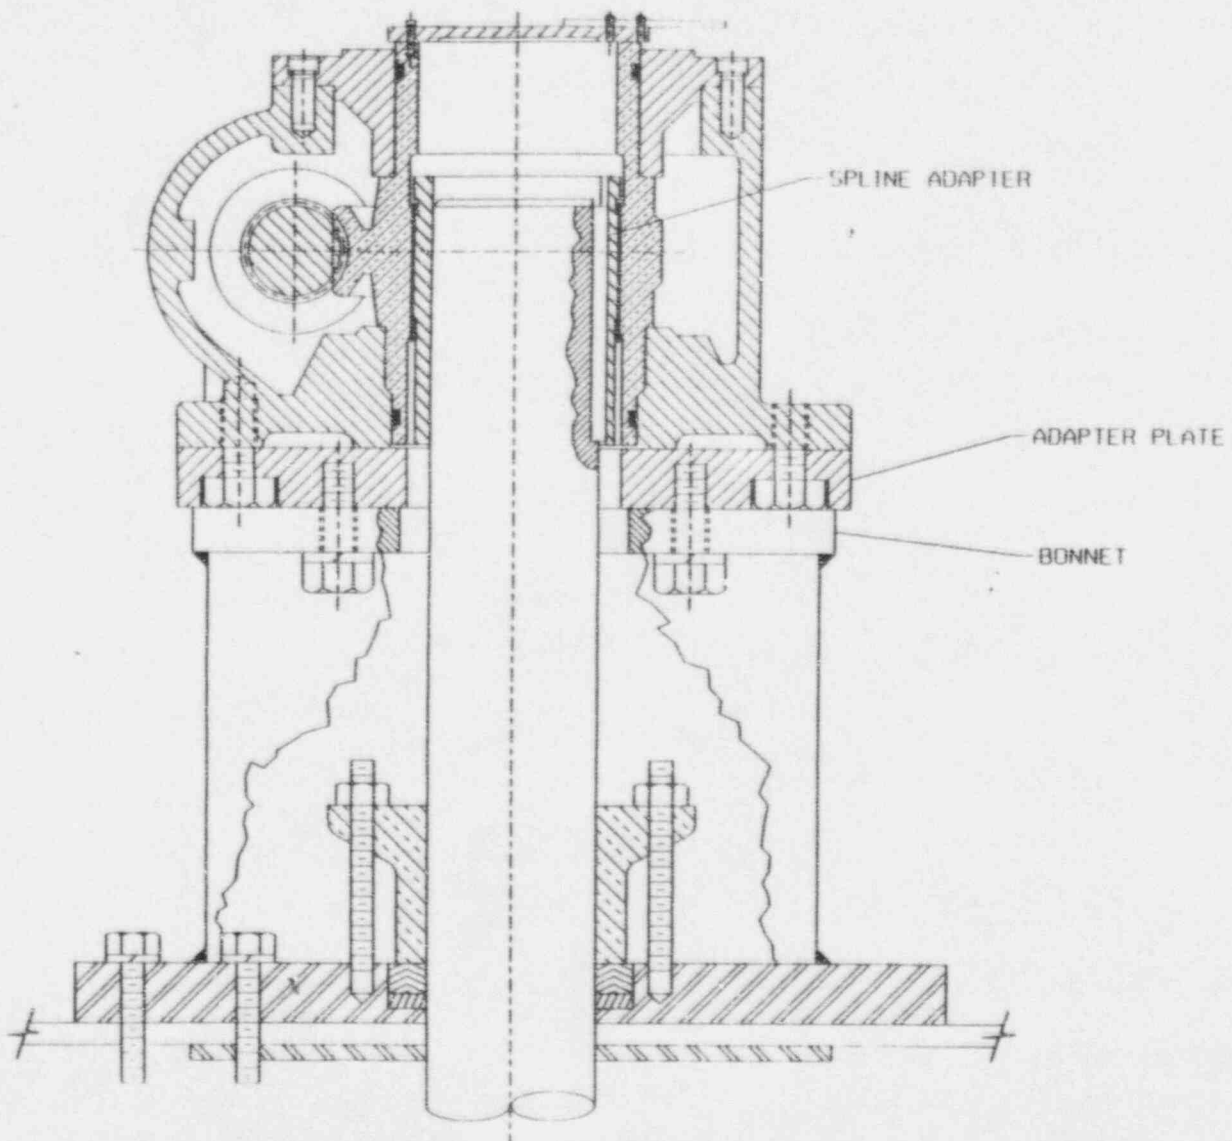
Duquesne Light Company NUCLEAR GROUP		BEAVER VALLEY POWER STATION	
2RSS-MOV155A THRU D PART 21 SKETCH			
DATE: 11-23-93	CHKD:	SKETCH NO.	REV
DWN: KMK	APP:	2CMK00078	1

The spline adapter is retained in the motor operator by an adapter plate which is in turn supported by a valve bonnet piece. The retention is accomplished by limiting the through-hole diameters of the adapter plate and bonnet piece to a value that would not allow the spline adapter to move out of position. Both diameters were intended to be the same for the above valve. If the adapter plate diameter is larger than the diameter of the bonnet piece, the spline adapter could be retained by the bonnet piece.

However, this arrangement may not provide sufficient spline engagement depending on specific valve dimensions (see attached sketch). For the Beaver Valley Power Station Unit Number 2, the adapter plate and bonnet piece-plate were provided by the valve manufacturer. The valve is a 12" Pratt Butterfly valve (Model 1400) with a Limitorque HBC Operator.

In conclusion, stem friction clamps have been permanently installed to retain the HBC spline adapter from slipping down the stem and thus prevent the possibility of the motor operator becoming disengaged from the drive sleeve for the four recirculation spray pump suction valves [2RSS-MOV155A, B, C and D] and the two service water valves [2SWS-MOV120A, B].
