Commonwealth Edison Company

Dresden Nuclear Power Station
R. R. #1
Morris, Illinois 60450
March 17, 1972

SUBJECT: LICENSE DPR-25, DRESDEN NUCLEAR POWER STATION UNIT #3,
SECTION 6.6.B.2 OF THE TECHNICAL SPECIFICATIONS

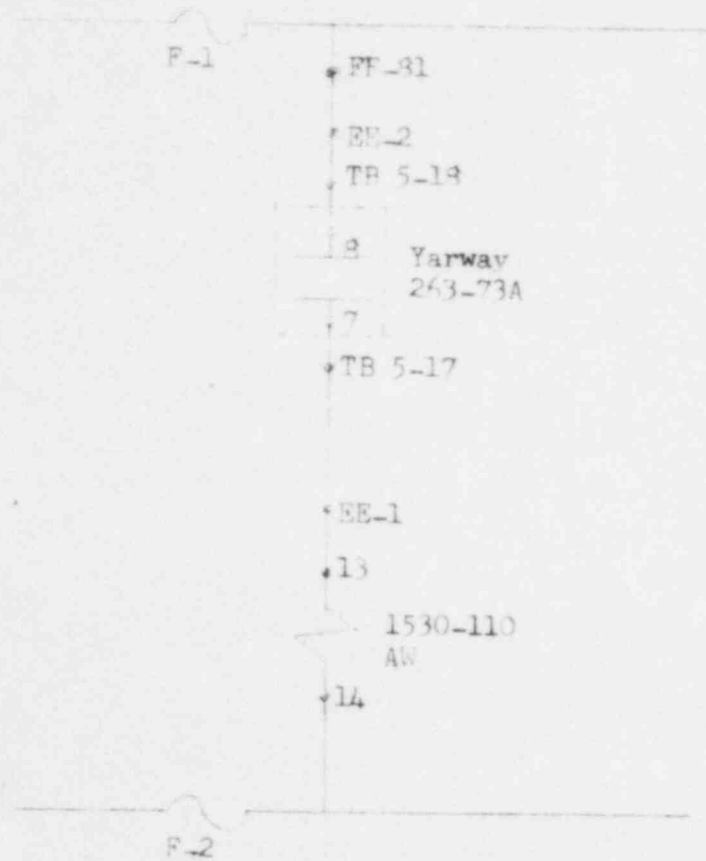
Correct Wiring
as shown on
print 12E3437

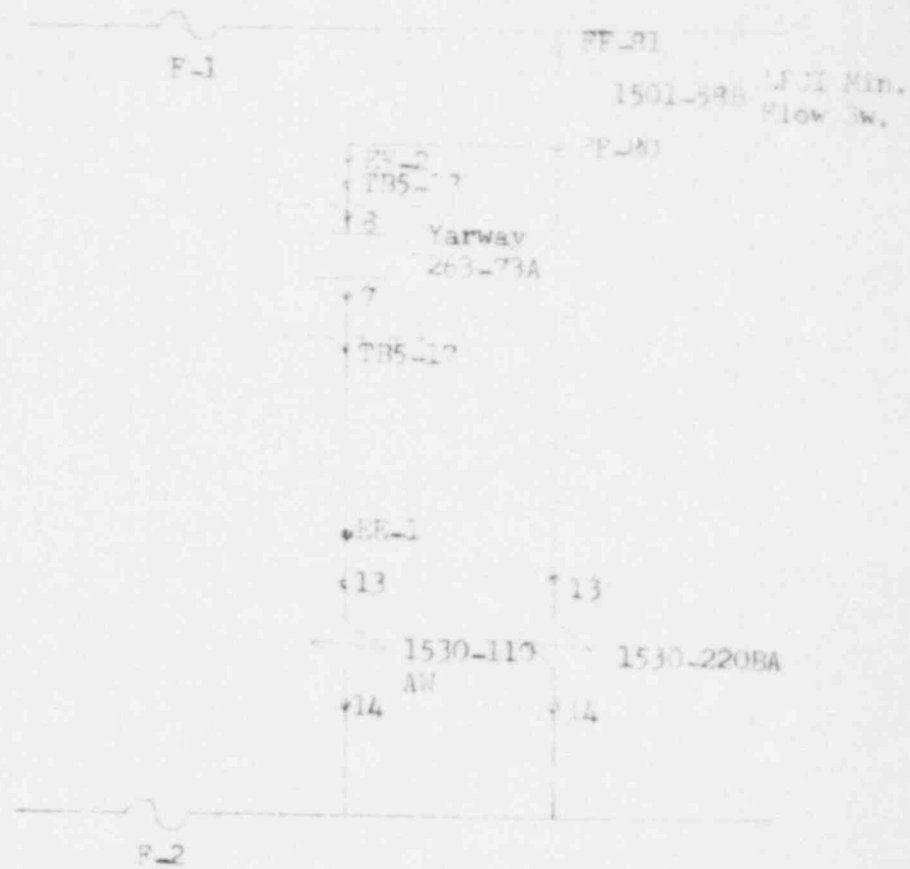
On March 7, 1972, at 1500 hours, while conducting monthly surveillance tests on the Low Pressure Coolant Injection System (LPCI), a containment spray interlock relay (1530-110AW) would not energize. This relay provides permissive to utilize containment spray if reactor water level is greater than 2/3 core height. Investigation revealed that one side of the relay was wired such that the "LPCI System low flow" switch, (3-1501-58B) was included in the relay circuit, contrary to the wiring diagram. (Refer to attached schematic.)

The "LPCI System low flow" switch contact is normally closed when the surveillance test is conducted. During this particular surveillance testing, however, the "low flow" switch calibration had drifted and the contact on this switch was open. This resulted in the de-energization of relay 1530-110AW. The drift in the calibration of the "low flow" switch was thus responsible for the events which led to the discovery of the wiring error. This also explains the fact that this wiring error was not detected during previous surveillance testing. *no preps*

Wiring as found. Wire from EE-2
to FF-31 should be from EE-2 to FF-31

The wiring circuit for relay 1530-110AW was changed to correspond with that on the wiring diagram and the "LPCI System low flow" switch was recalibrated. The required surveillance test was repeated satisfactorily following the wiring change.
