SAN ONOFRE NUCLEAR GENERATING STATION

Subject: Docket No. 50-361
30-Day Report
Licensee Event Report No. 91-008
San Onofre Nuclear Generating Station, Unit 2

LICENSEE EVENT REPORT (LER)														
Facility Name (1) SAN ONOFRE NUCLEAR GENERATING STATION, UNIT 2										Docket Number (2) 0 5 0 0 0 3 6 1 1			Page (3) 1 of 6 6	
Title (4) Units 2/3 Spurious Toxic Gas Isolation System (TGIS) Actuation due to Train "A" Ammonia Analyzer Failure														
EVENT DATE (5)			LER NUMBER (6)			REPORT DATE (7)			OTHER FACILITIES INVOLVED (8)					
Month	Day	Year	Year	Sequential Number	Revision Number	Month	Day	Year	Facility Names			Docket Number(s)		
0 6	2 2	9 1	9 1	0 0 8	0 0	0 7	2 2	9 1	NONE			0 5 0 0 0 3 6 2		
OPERATING MODE (9)			THIS REPORT IS SUBMITTED PURSUANT TO THE REQUIREMENTS OF 10CFR (Check one or more of the following) (11)											
POWER LEVEL (10) 1 0 0			<div style="display: flex; justify-content: space-between;"> <div> 20.402(b) 20.405(a)(1)(i) 20.405(a)(1)(ii) 20.405(a)(1)(iii) 20.405(a)(1)(iv) 20.405(a)(1)(v) </div> <div> 20.405(c) 50.36(c)(1) 50.36(c)(2) 50.73(a)(2)(i) 50.73(a)(2)(ii) 50.73(a)(2)(iii) </div> <div> X 50.73(a)(2)(iv) 50.73(a)(2)(v) 50.73(a)(2)(vi) 50.7

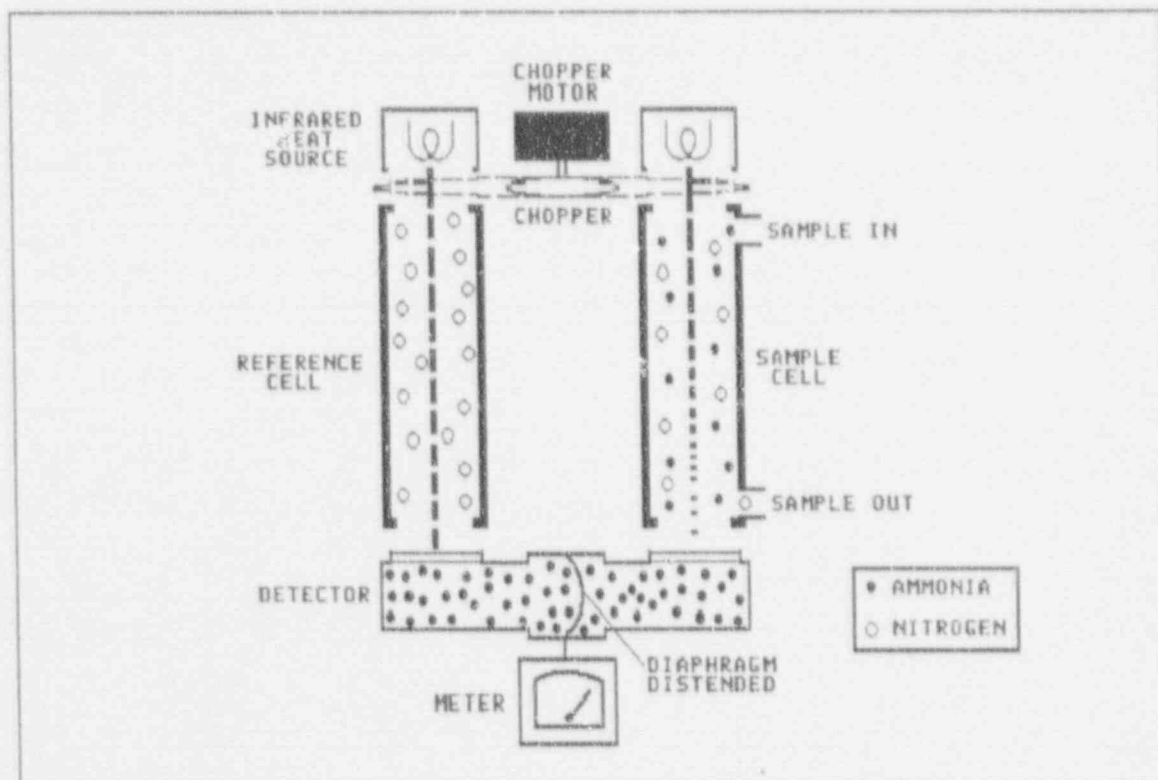
Figure 1 : Functional Diagram of Ammonia Detector

The ammonia analyzers (Figure 1), Beckman Model 865 Infrared Analyzers, operate by producing infrared radiation (heat) from two separate energy sources. The heat radiated from these sources is beamed separately through a chopper which interrupts it at a specified frequency. The beams then pass through two cells; one a sealed reference cell containing air, the other a sample cell containing a continuous flowing air sample. A portion of the infrared radiation is absorbed by the ammonia, with the percent of infrared radiation absorbed being proportional to the ammonia concentration. The two beams cause differential heating of the two sides of the ammonia-filled detector. The resulting pressure difference causes a change in the diaphragm position which results in a capacitance change. This capacitance change, which is proportional to ammonia concentration, is amplified and indicated on a meter.

The spiking resulted from erratic rotation of the ammonia analyzer chopper motor [MTR] due to corrosion of the motor internals. This erratic rotation occurred only intermittently, as the motor operated normally following the actuation. During bench and surveillance testing prior to installation there was no evidence of spiking or erratic motor operation, despite the apparent existence of the corrosion.

The cause of the corrosion of the chopper motor internals has been attributed to either: 1) moisture introduced during storage for the five year period since SCE received the motor, or 2) moisture introduced during manufacture of the chopper motor resulting in the observed corrosion. SCE examined three chopper motors that had been stored under similar conditions and found no evidence of corrosion. In addition, SCE has not experienced any similar problems with chopper motors. It has therefore been concluded that receipt of the chopper motor with moisture introduced is the more likely cause of the observed corrosion. The supplier of the analyzer has been contacted, but has been unable to identify problems of a similar nature.

- a. The ammonia analyzer chopper motor was replaced and the analyzer re-calibrated.
- b. As noted above, the failed ammonia analyzer chopper motor was sent to an offsite laboratory for failure analysis, which established that the corrosion of the motor internals occurred prior to installation of the chopper motor.

TGIS analyzer chopper motors will be inspected for evidence of corrosion prior to installation until compelling evidence exists that the observed corrosion was an isolated occurrence.
