SAN ONOFRE NUCLEAR GENERATING STATION

Subject: Docket No. 50-361  
Voluntary Report  
Licensee Event Report No. 91-014  
San Onofre Nuclear Generating Station, Unit 2

# LICENSEE EVENT REPORT (LER) TEXT CONTINUATION

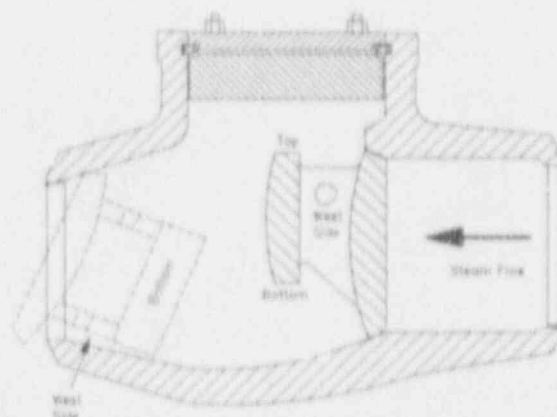
Figure 2: Check Valve MU-005

On 9/10/91, with Unit 2 in Mode 6 and defueled, turbine-driven AFWP P-140 steam-supply-check valve MU-005 was found to be damaged (refer to Figure 2). The check valve hinge pins were found to be failed such that the disc was separated from the pins and carried downstream to become lodged in the valve outlet piping. The west hinge pin was found bent about 15 to 20 degrees in the direction of normal steam flow. The east hinge pin was slightly bent and sheared off at the step down area at the end. A subsequent inspection of the valve internals revealed a flow area equal to approximately 15% of the normal maximum flow area. The observed damage was indicative of the disc being subjected to a large impact force, such as might be generated by a mass of water entrained in the steam flow through the piping.

Our preliminary investigation indicates that water (condensed steam), entrained in the steam flow, could impose sufficient impulse force as it impacts the disc and hinge pins to cause the damage observed in check valve MU-005. At this point in our investigation, we have not yet determined when the event occurred or the circumstances that may have led to the accumulation of condensation in the steam piping. The investigation is continuing, and the results will be provided in a supplement to this report.

- b. Check valve MU-005 was removed and replaced in-kind. Flow testing of the valve in the as-found condition is planned such that the effect of the observed damage can be better characterized. This is considered necessary to properly evaluate the safety significance of this event.
