BROWNS FERRY NUCLEAR PLANT UNIT 3 - REPORTABLE DEFICIENCY -
CORE SPRAY INBOARD INJECTION VALVE - IMPROPERLY WIRED MOTOR
BRAKE

ENCLOSURE
BROWNS FERRY NUCLEAR PLANT UNIT 3

IMPROPERLY WIRED MOTOR BRAKE
CORE SPRAY INBOARD INJECTION VALVE FCV-3-75-53
DDN 214

FINAL REPORT

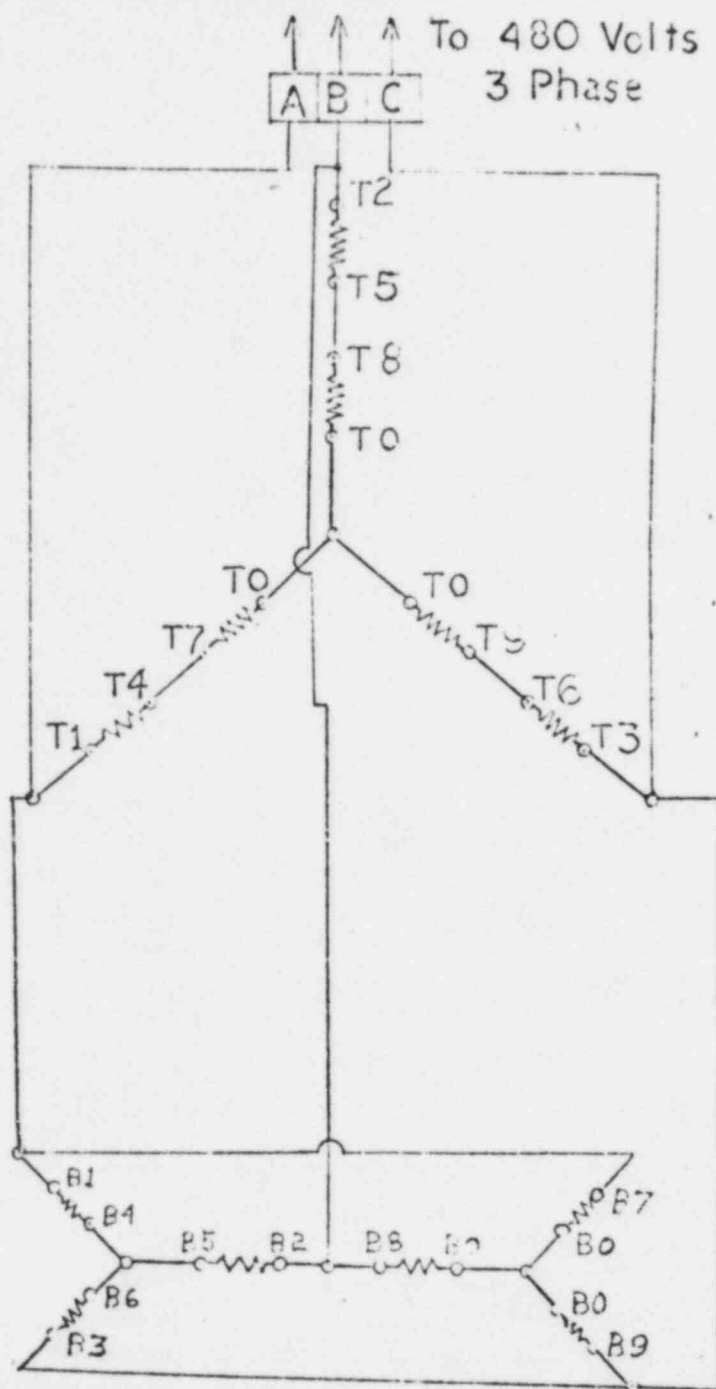
While performing preoperational test G-12, core spray inboard injection valve FCV-3-75-53 locked in midstroke and would not move open or closed. It was then discovered that the valve brake solenoid was smoking heavily.

An inspection later that day revealed that the valve solenoid-operated brake wires had been improperly connected to the motor. The remaining core spray injection line valves (including those on Units 1 and 2) were examined. No deficiencies were found in the valves on Units 1 and 2. However, the other three valves on Unit 3 (FCV-3-75-23, -25, and -51) were also found to have solenoid wires improperly connected to the motor.

The valves were improperly connected by the manufacturer. Attached to this report are Figures 1 and 2. Figure 1 shows how valve FCV-3-75-53 was wired. It can be seen that the motor was wired for 480 volts, 3 phase, but the brake was connected with two "Y" connections in parallel (a 240-volt, 3-phase arrangement). Thus the brake was receiving 480 volts, 3 phase, on a 240-volt scheme.

Wiring Diagram Showing FCV-3-75-53 Before Rewiring.
T0 Through T9 Mark Motor Connections. B0 Through B9
Mark Brake Connections

The valves were rewired as shown in attached Figure 3. The solenoid on valve FCV-3-75-53 was checked carefully for damage and was found to be in satisfactory condition. All four valves were then tested and proven to perform as specified.

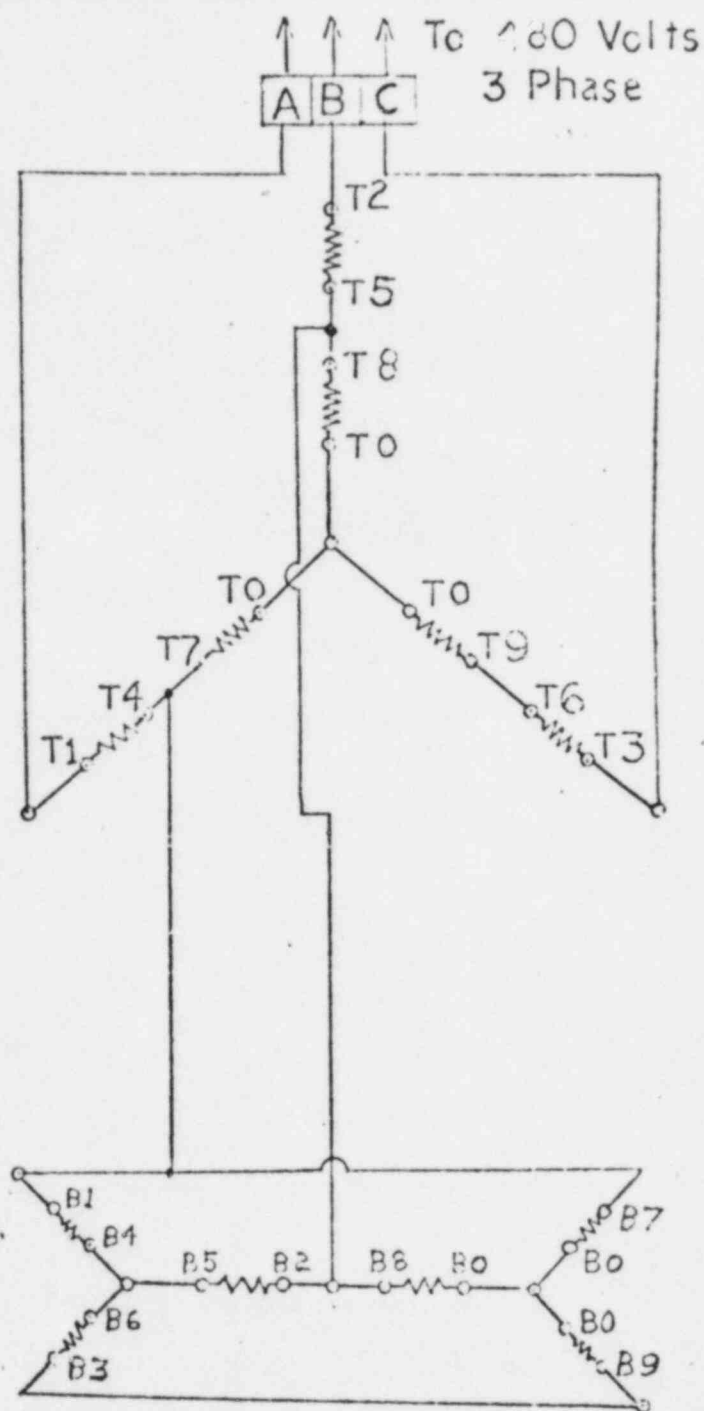
Figure 2 shows how valve FCV-3-75-23, -25, and -51 were connected between the motor windings. This arrangement allowed too much current through the motor windings.

Wiring Diagram Showing FCV-3-75-23,-25,&-51 Before Rewiring. T0 Through T9 Mark Motor Connections. B0 Through B9 Mark Brake Connections.

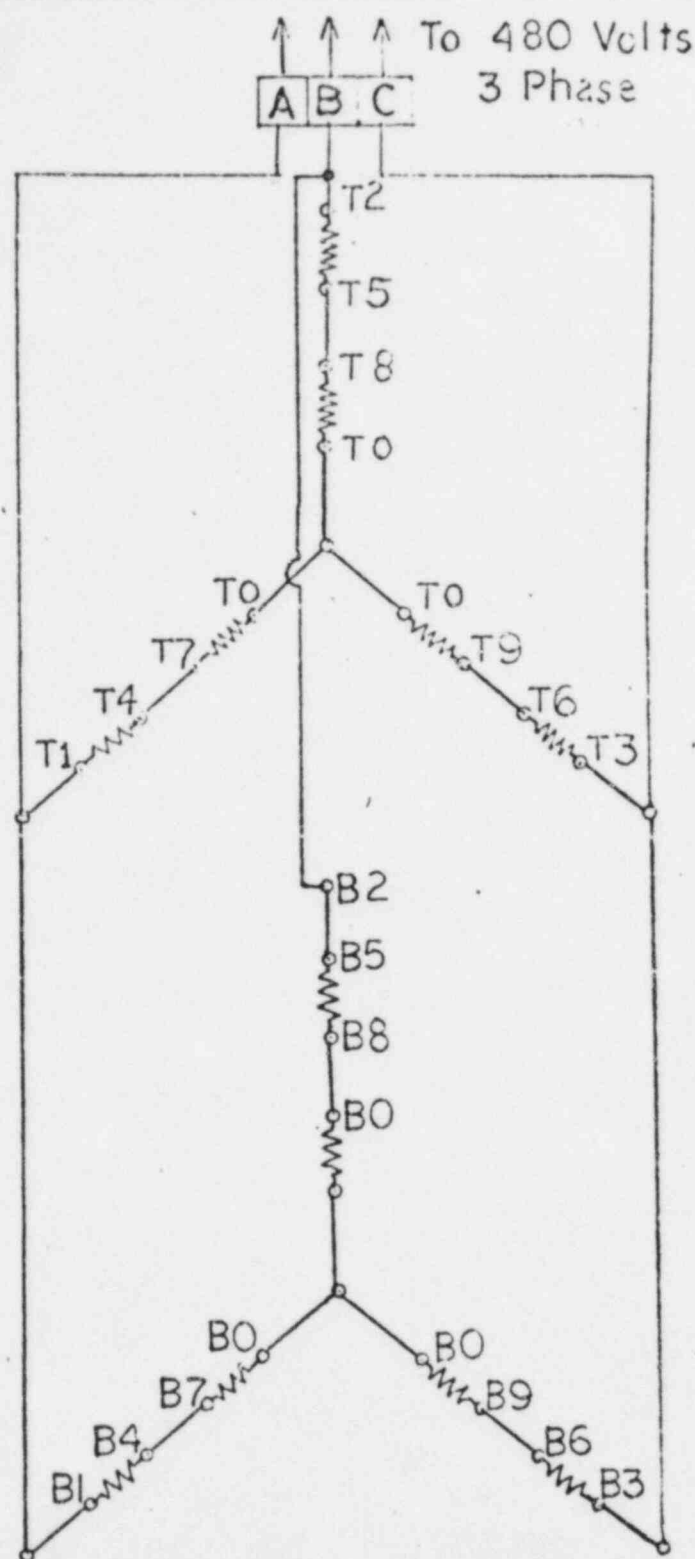
Figure 3

Wiring Diagram Showing FCV-3-75-23,-25,-51, &-53 After Rewiring. TO Through T9 Mark Motor Connections. B0 Through B9 Mark Brake Connections.
