SAXTON NUCLEAR EXPERIMENTAL CORPORATION

DOCKET NO. 50-146
LICENSE DPR-4

SAXTON COOLANT SYSTEM

INSPECTION REPORT

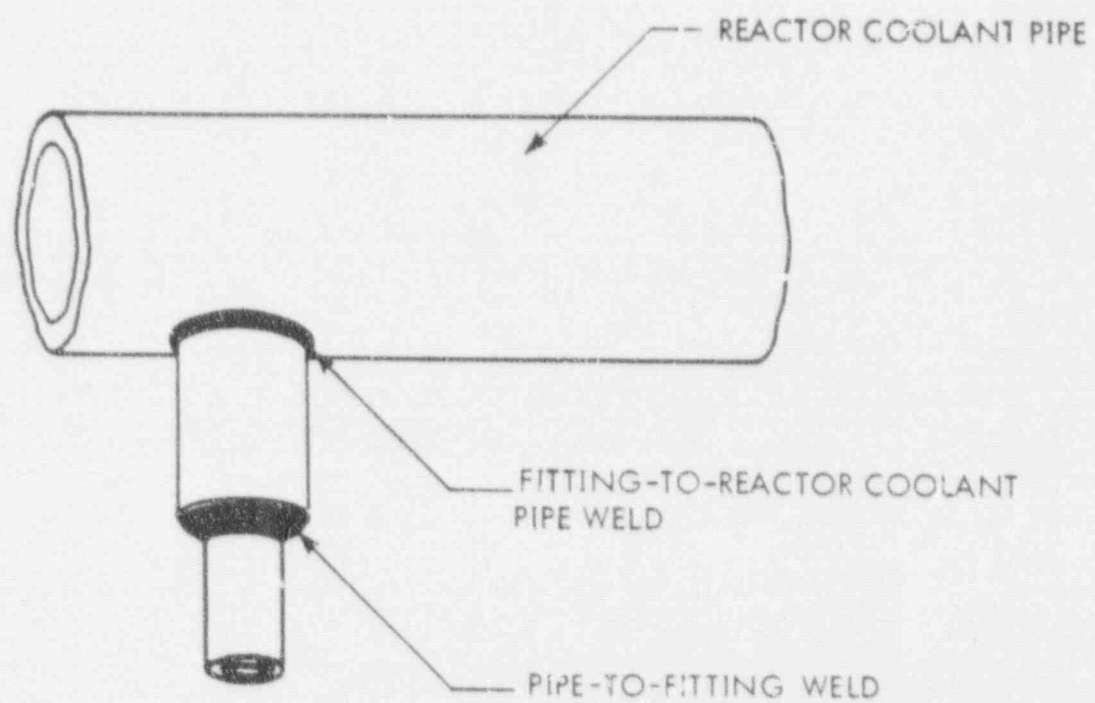
Figure 1. Typical Reactor Coolant Pipe Fitting

The pipe-to-fitting welds, and fitting-to-reactor coolant pipe welds (Figure 1) on the pressurizer surge line, the auxiliary system return and the pressurizer spray line were visually and liquid-penetrant inspected.

Liquid penetrant indications were found in both welds on the auxiliary system return line. The fitting-to-reactor coolant pipe weld had numerous small indications aligned, with what appeared to be grinding marks,

perpendicular to the reactor coolant pipe. Surface conditioning of this area (less than 0.005 inch of metal was removed) was followed by a satisfactory liquid penetrant inspection.

The pipe-to-fitting weld had indications on the weld and numerous linear indications at both fusion lines intermittently around the weld. Surface conditioning (less than 0.032 inch of metal was removed) was followed by a satisfactory liquid-penetrant inspection.

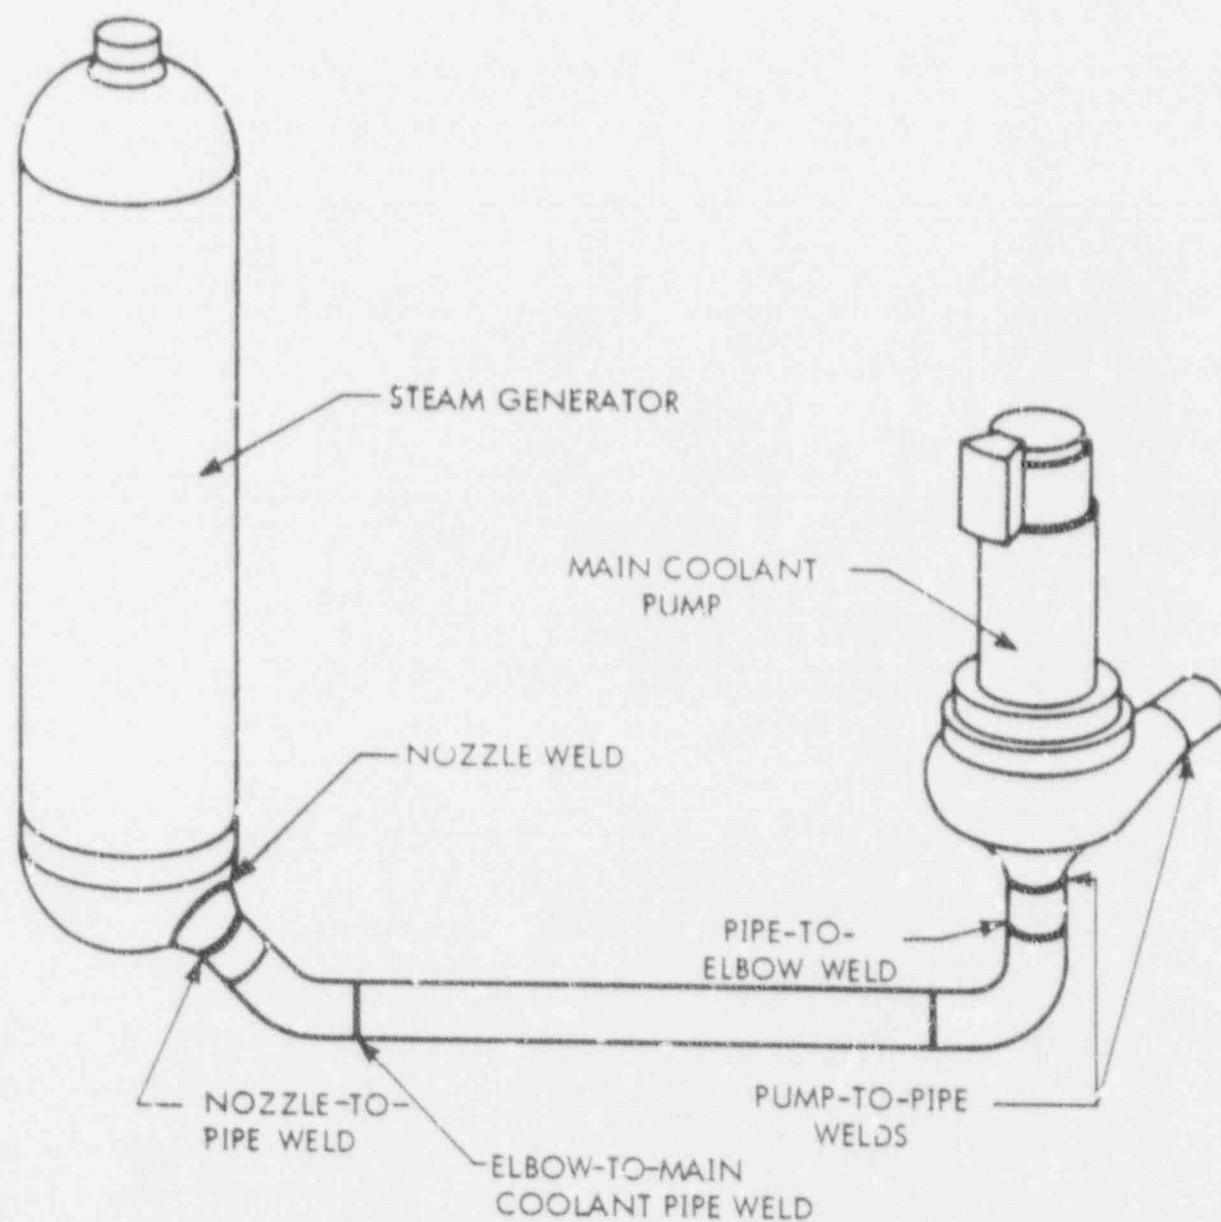
Figure 2. Schematic Diagram of Reactor Coolant Pipe Weldments

The steam generator outlet nozzle weld, outlet nozzle-to-pipe welds, reactor coolant pump-to-pipe and pipe-to-elbow welds were visually and liquid-penetrant inspected (Figure 2). All welds were found acceptable.

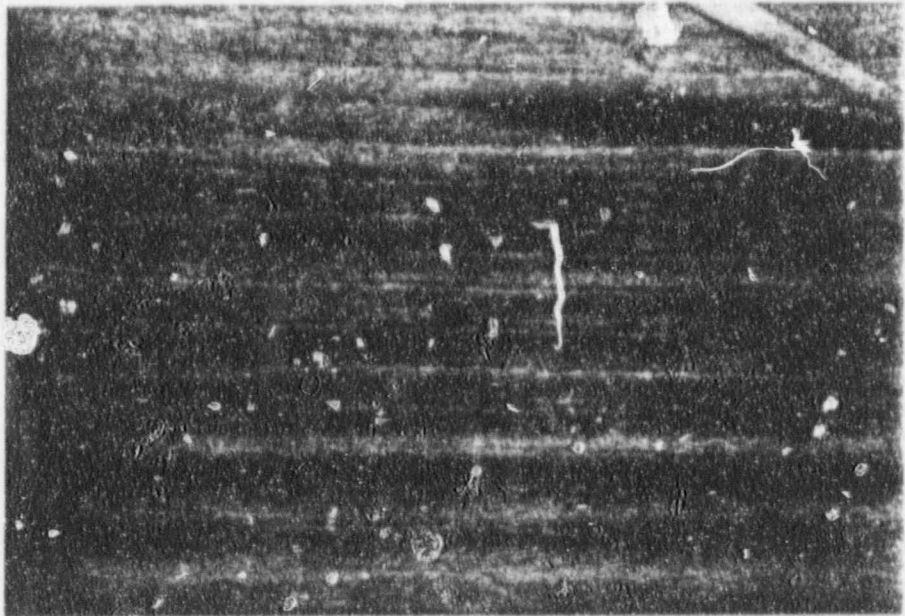
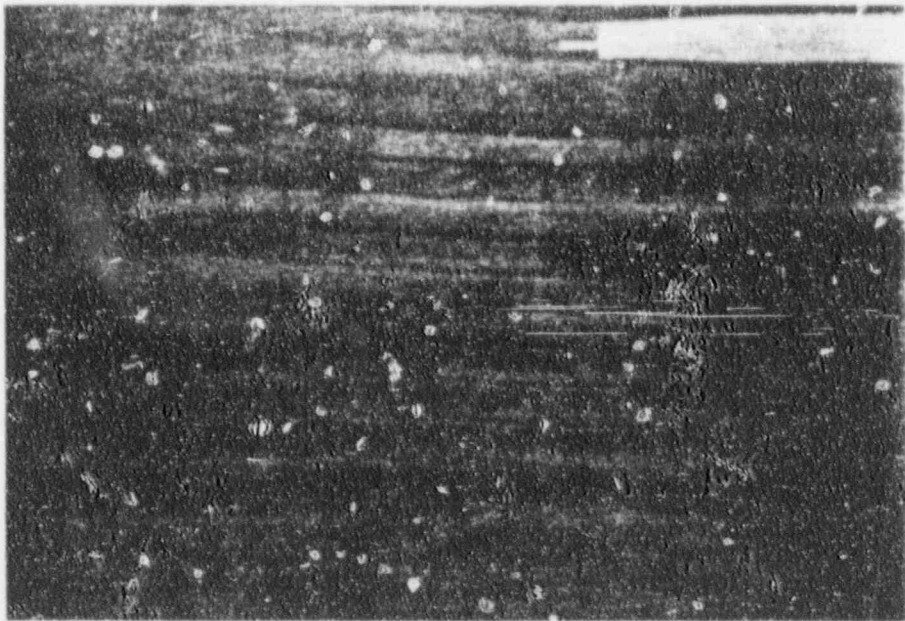
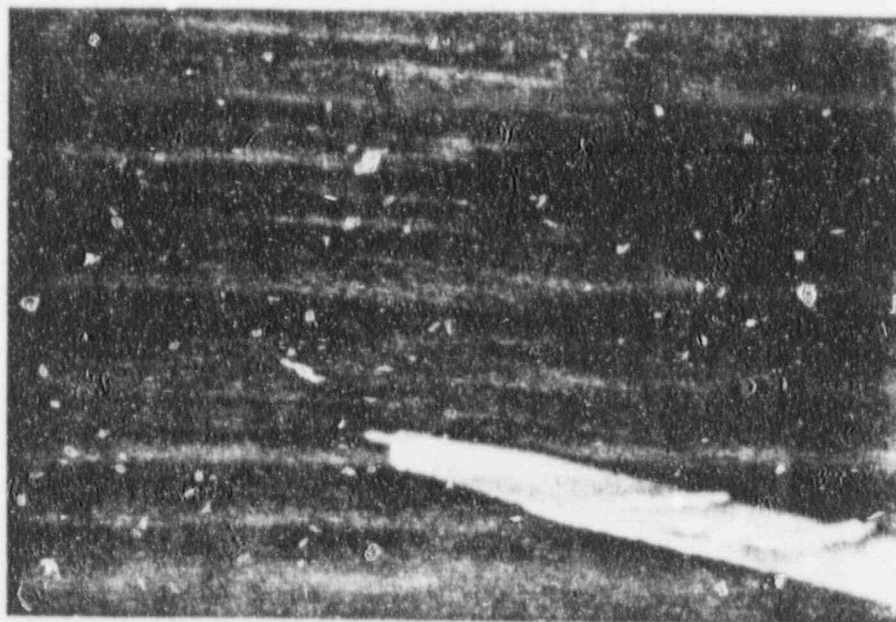
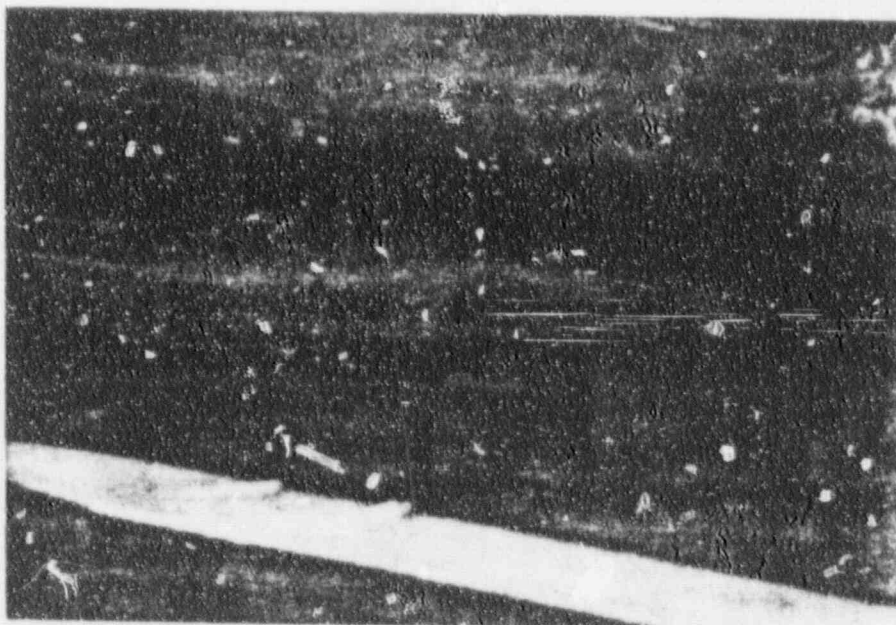
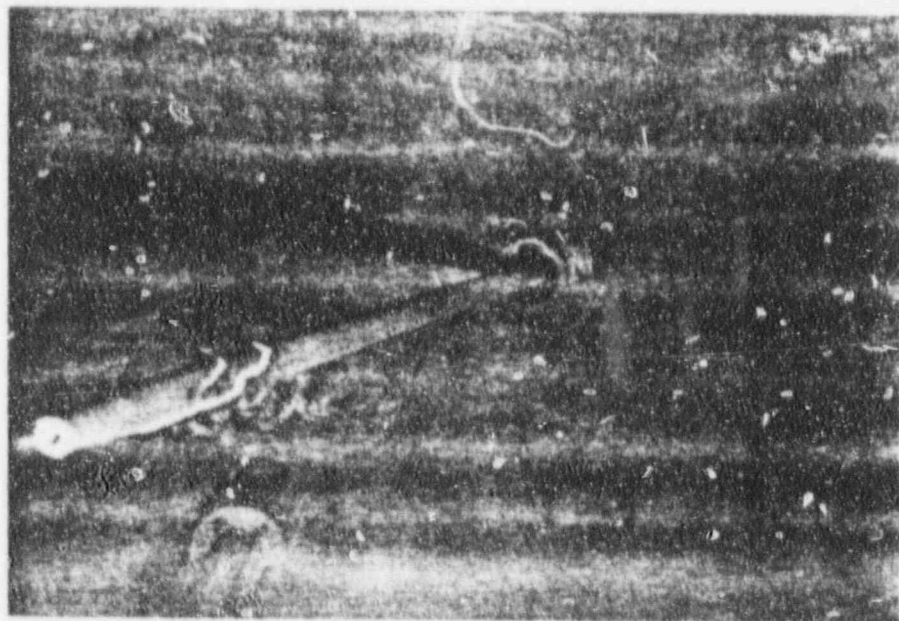
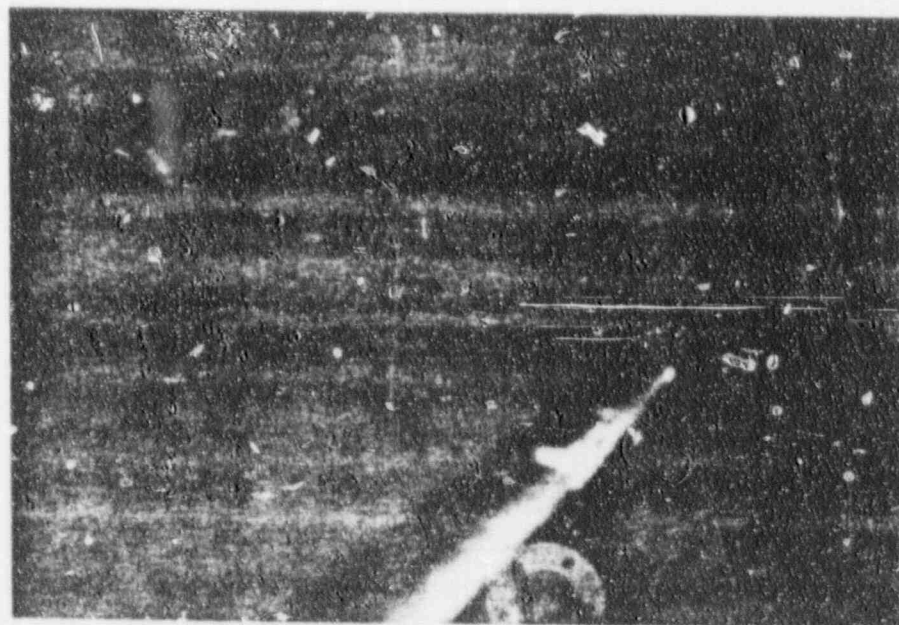
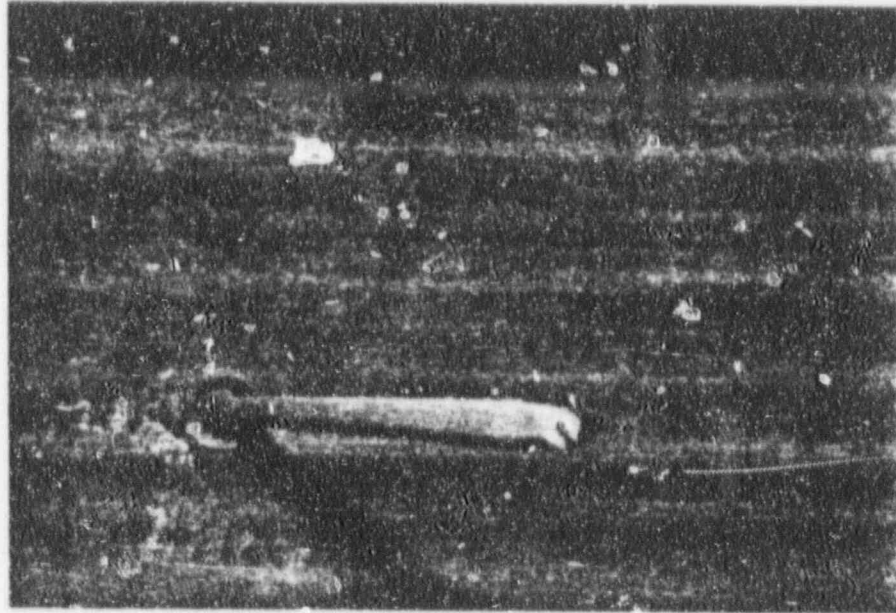
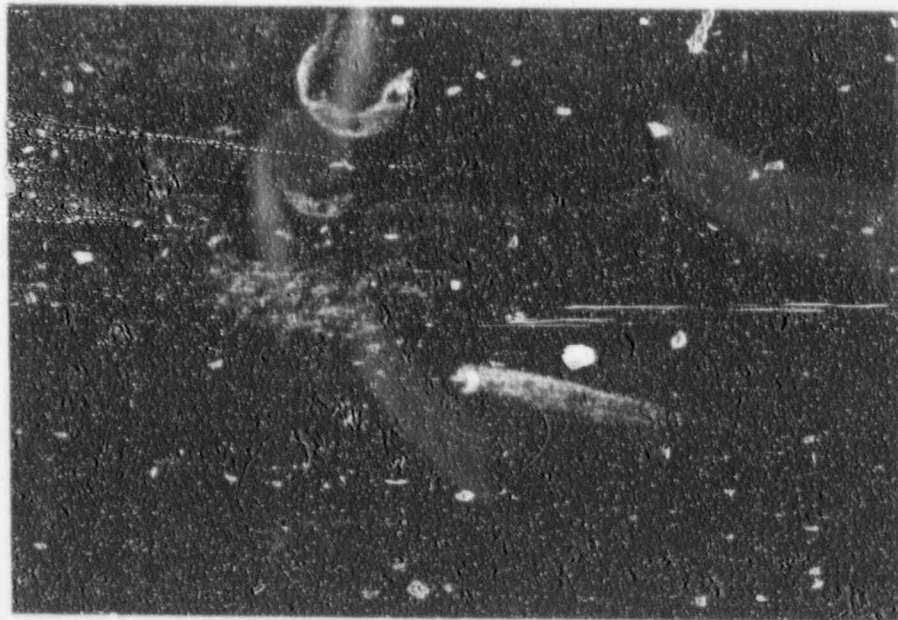
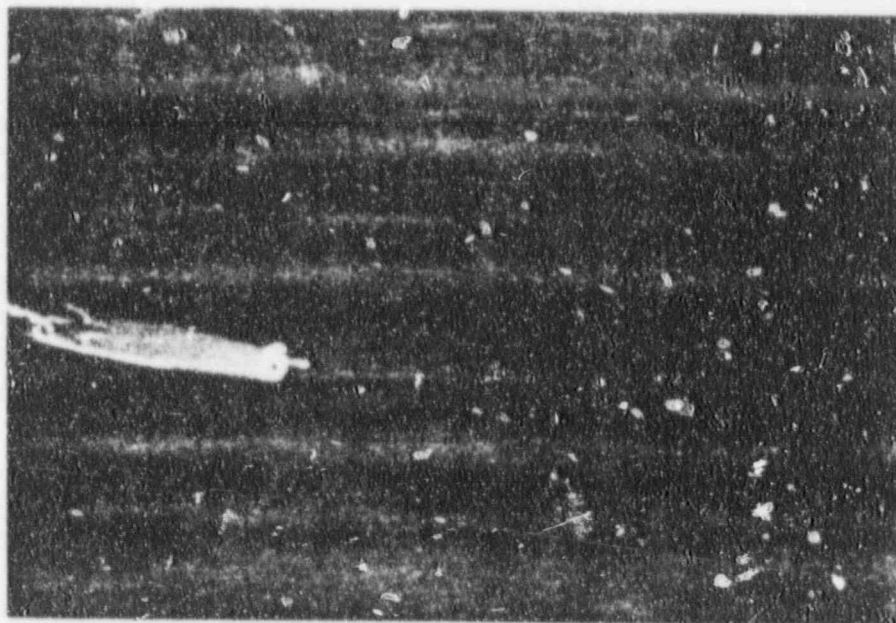
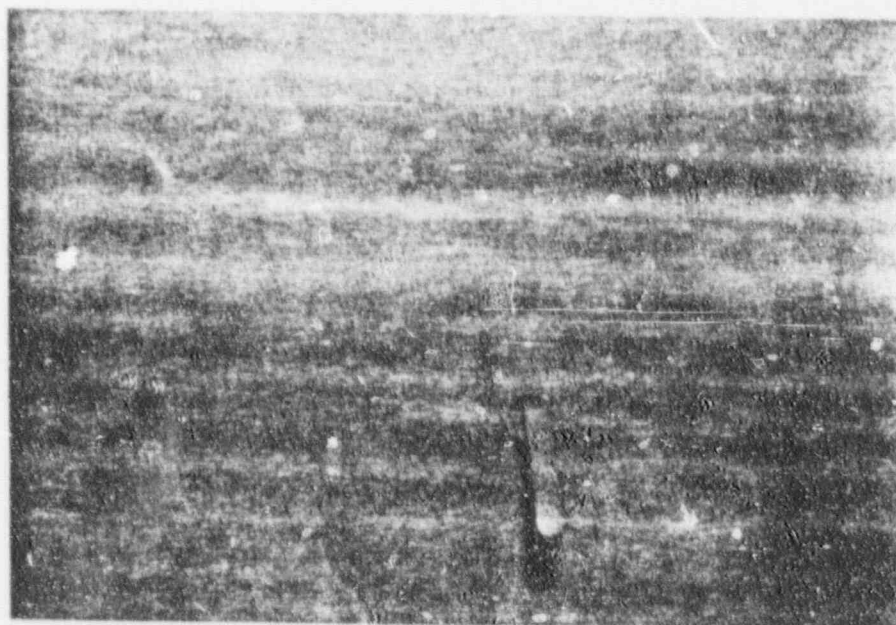
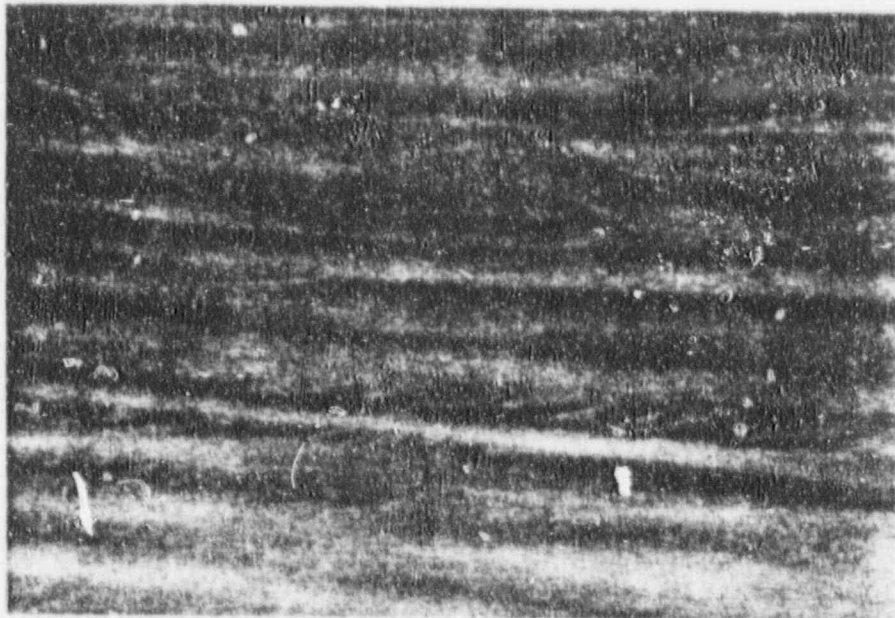
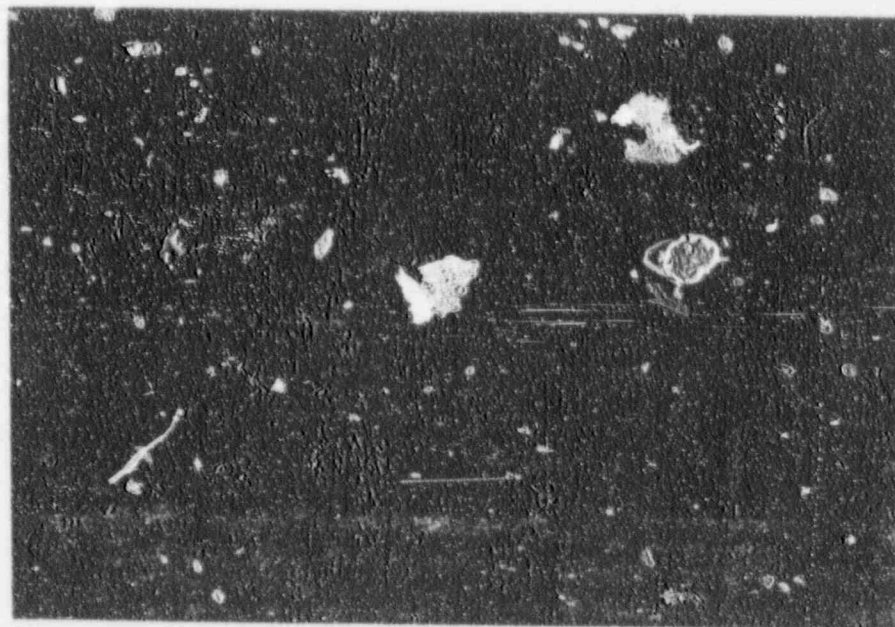
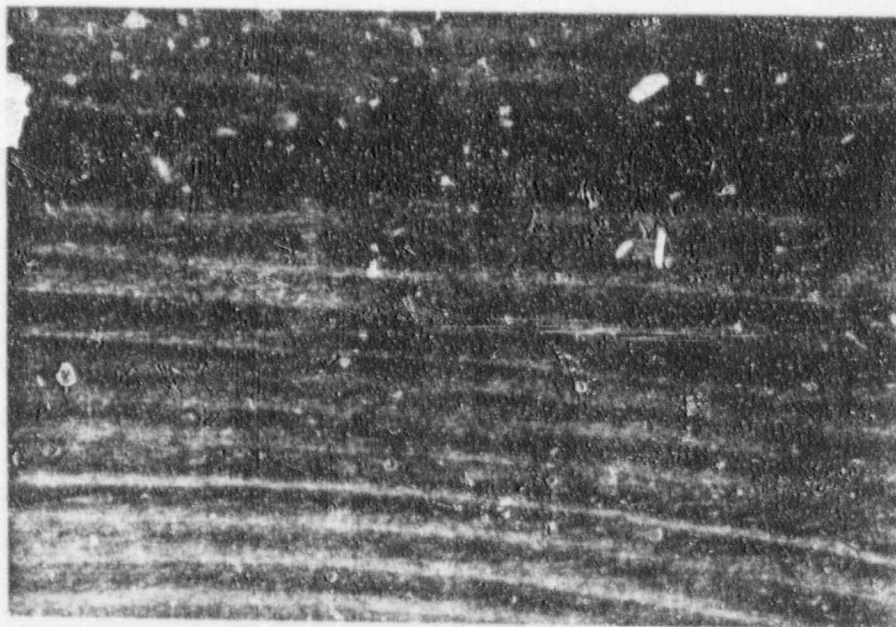
Representative areas of the steam, steam-water, and water surfaces of the pressurizer cladding were photographed and are included in this appendix. The whitish deposits noted on the instrument probes and on the wall of the pressurizer are boric acid crystals.

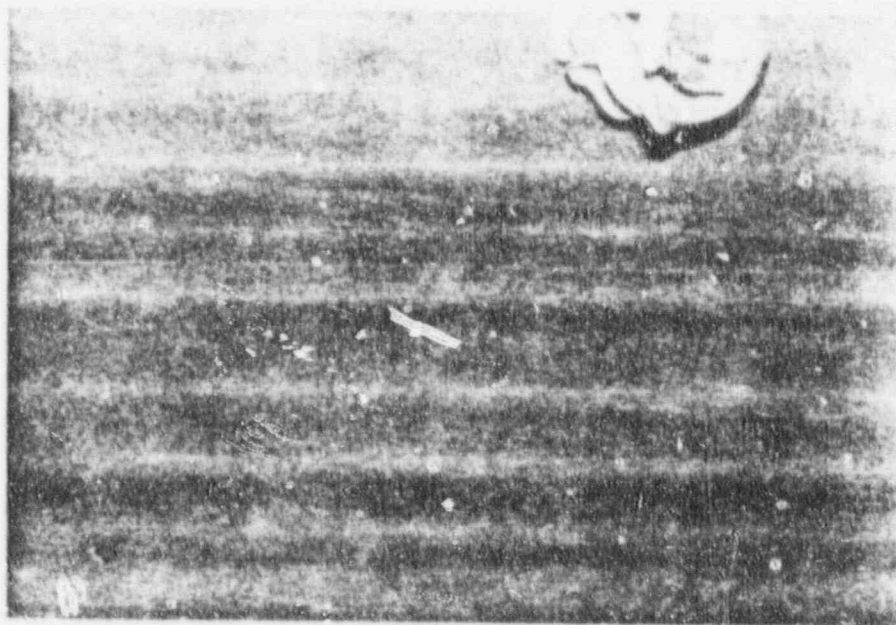
Figure A-13. Saxton Pressurizer Interior -- Steam Area

The stained rag shown in Photograph 13 was used during fit-up of piping to the pressurizer and has been subsequently removed.

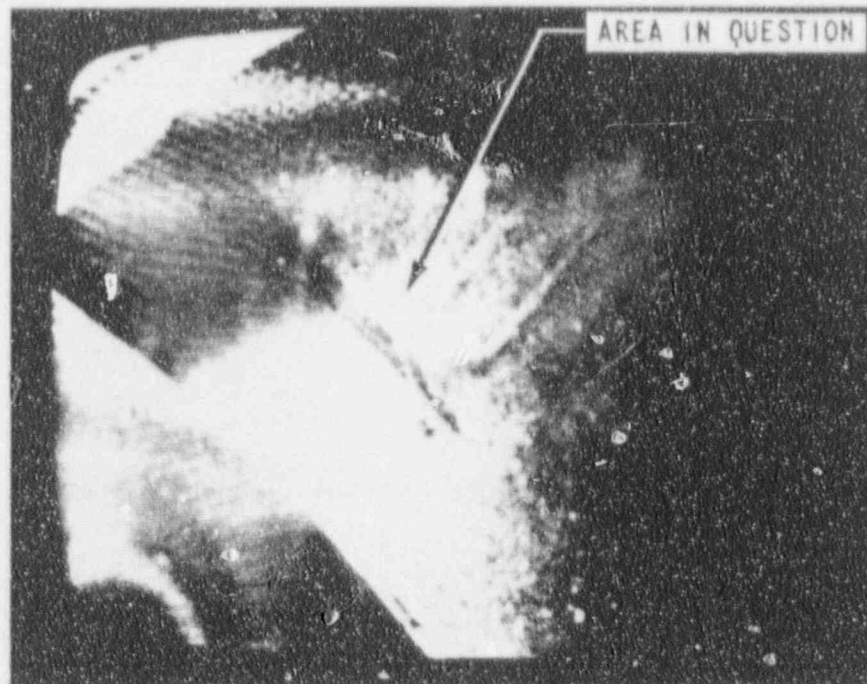
Figure D-2. Photograph of Area from TV Tape

During visual inspection of the lower core support barrel some surface discoloration was observed on the flange support (Figure D-1, Item 7) of the lower core support barrel in the downstream direction from the weld that joins the flange support (Item 7) to the lower barrel (Item 4). The discoloration was parallel to the water flow tapering off at the downstream end. It initiated at the weld which joins the flange support to the lower barrel.

Subsequent inspection by television camera and binoculars confirmed there was a surface discontinuity at the origin of the discoloration. The area was television tape recorded (Figure D-4). The size of the discontinuity was estimated to be 1/4-inch wide, 4-1/4 inches long, and on the order of 1/16-inch deep. It was oriented in the direction of the weld, i.e., perpendicular to the direction of flow. The surface within the discontinuity was not abrupt or indicative of any stress-related structural defect.

In either case, it is normally expected that such contaminants would occur over the entire weld length and corrosion would not be localized as shown in the photograph (Figure D-4).

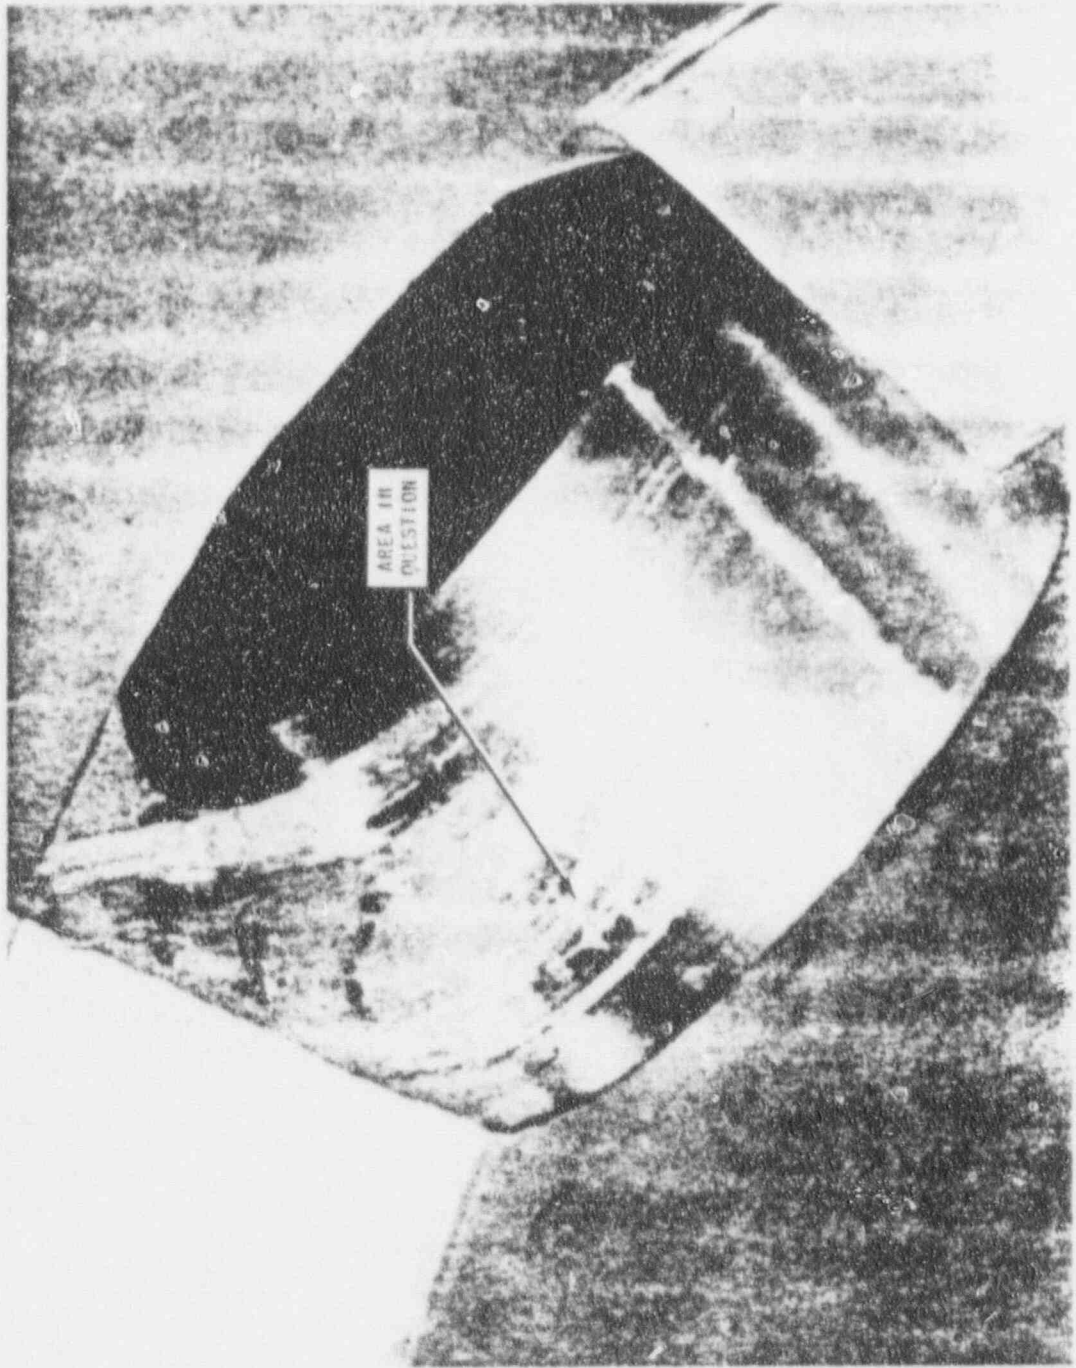
Figure D-4. Enlargement of Vendor's Original Photograph

This check disclosed the existence of a photograph (Figure D-3) showing the Lower Core Support Barrel during fit up of the internals in the manufacturer's plant. An enlargement of the nozzle area is shown in Figure D-3 and may be compared with Figure D-4. The comparison shows that both the discontinuity and some features of the discolored area (lines parallel to flow) can be observed in both pictures. The discontinuity extends round the circumference of the flange support (Item 7), to the interpenetration with the conical section of the barrel (Item 3), at which point a misalignment can be observed in both Figure D-3 and Figure D-4. The discontinuity appears to have been caused by a misalignment of the parts (Items 3, 4 and 7) during manufacture. It appears that a fillet weld was deposited in this area to smooth out the profile. No immediate explanation

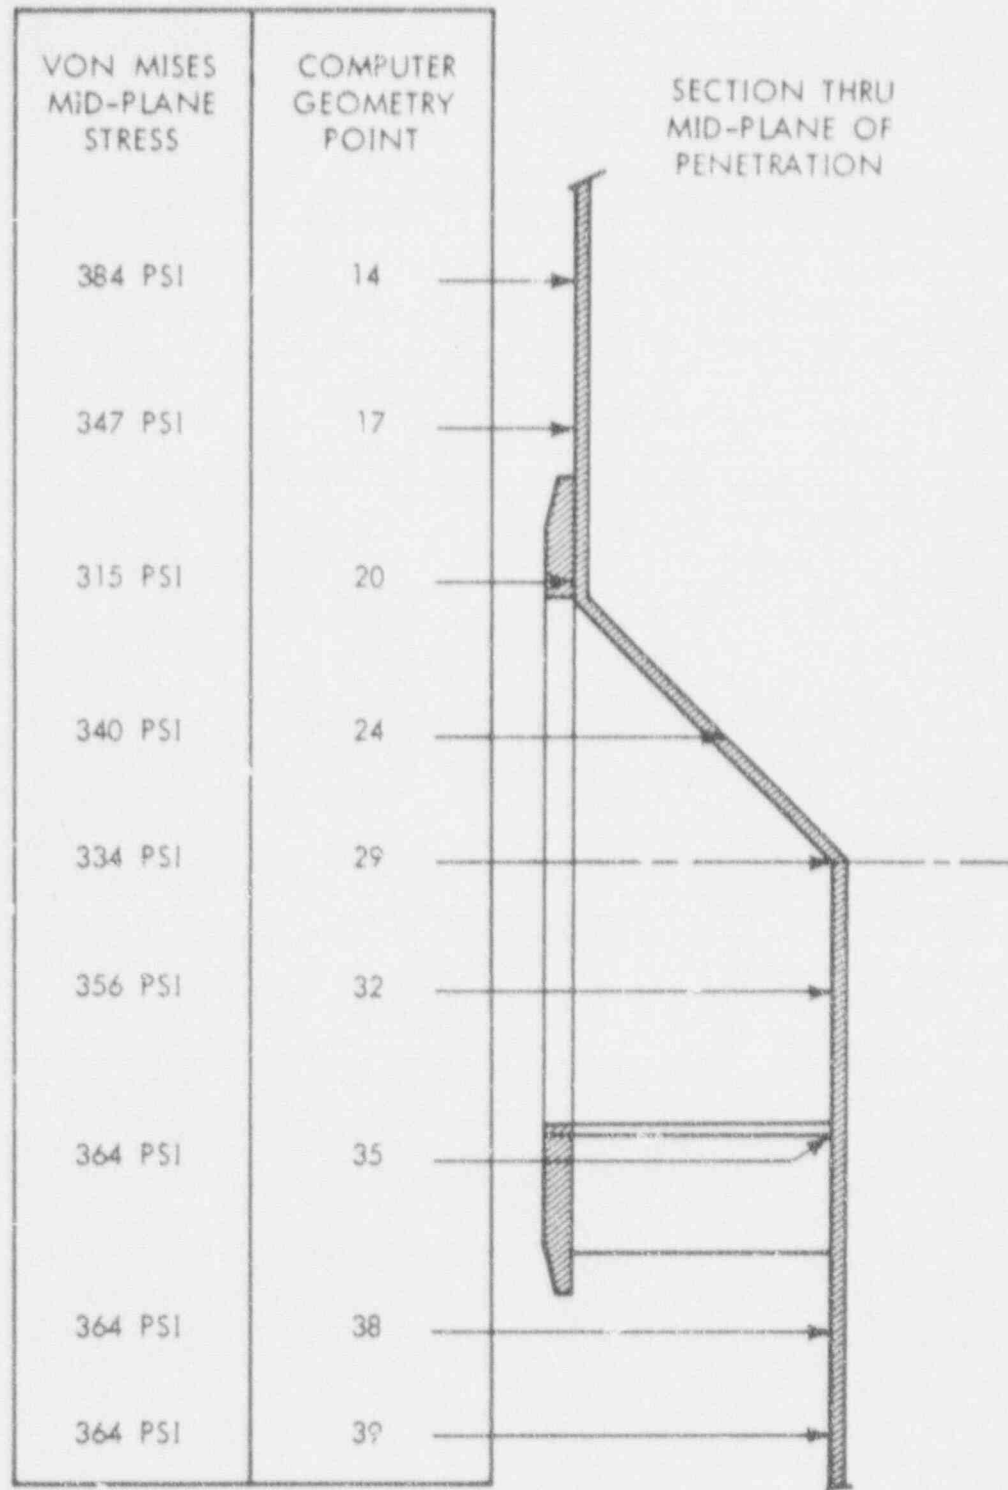
Figure D-5. Saxton Lower Core Barrel Stress Distribution

From "Seal Shell 2" Printout by inspection, the stress field across the penetration at mid-plane is effectively uniaxial and constant at 350 psi (Figure D-5).

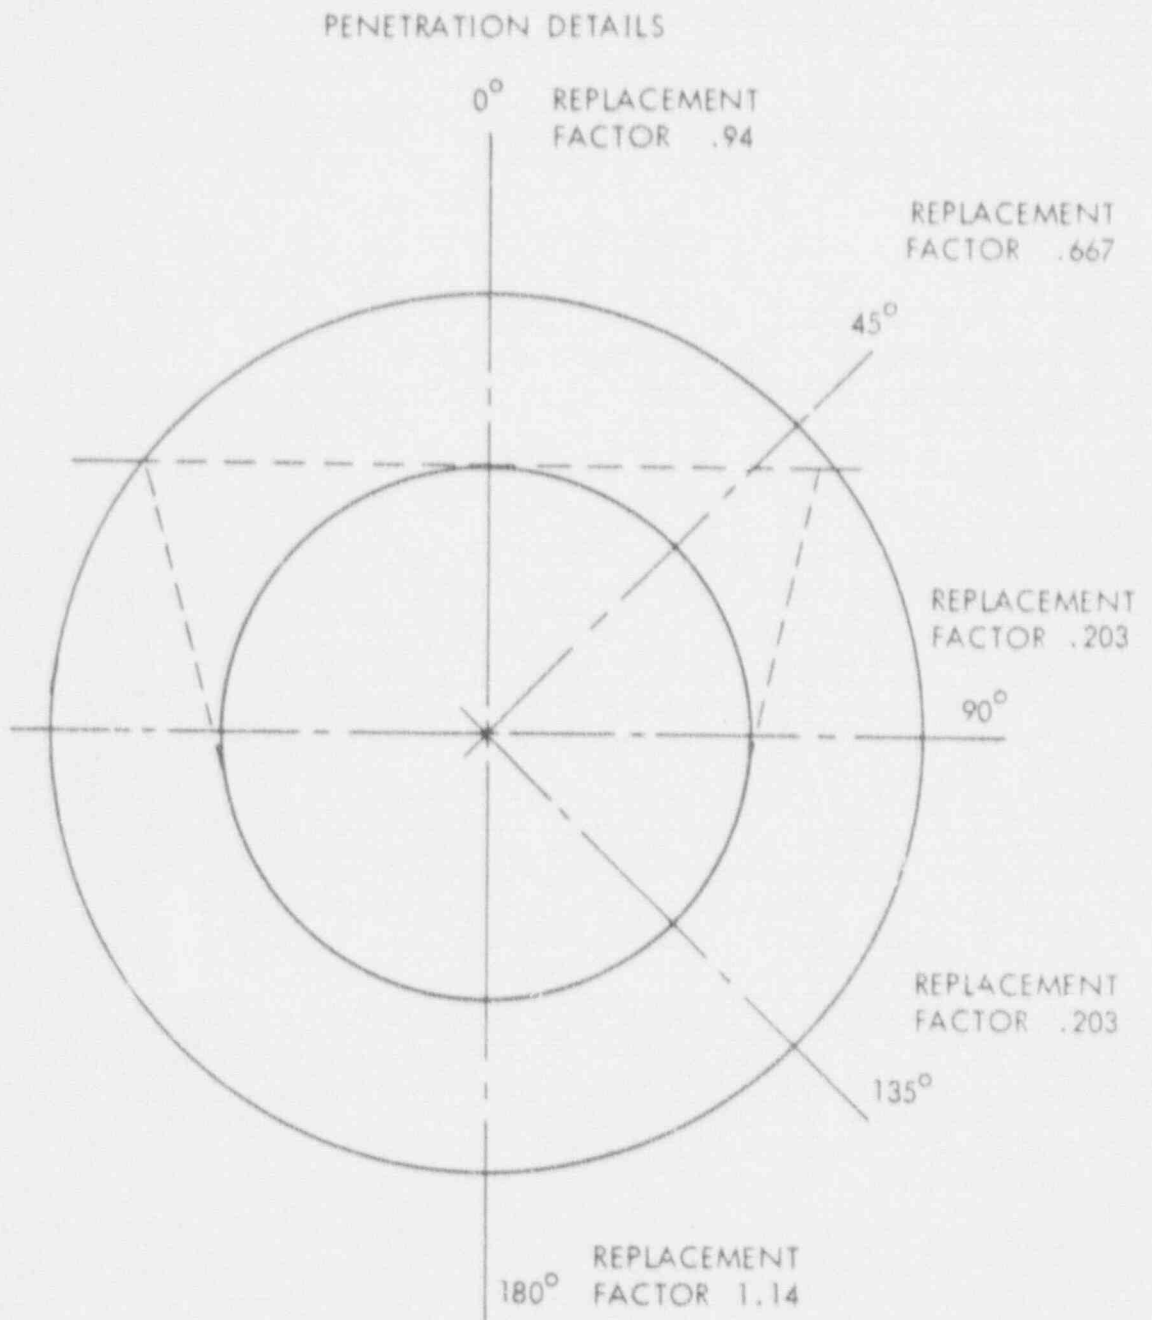
Figure D-6. Saxton Lower Core Barrel

Points of interest are at 90° and 135° as noted (discontinuity lies in this region) i.e., a nozzle type reinforcement in uniaxial stress. (Figure D-6)
