Dresden Nuclear Power Station
R. R. #1
Morris, Illinois 60450
January 25, 1974

SUBJECT: LICENSE DPR-25, DRESDEN NUCLEAR POWER STATION, UNIT #3, REPORT OF
ABNORMAL OCCURRENCE PER SECTION 6.6.B.1 OF THE TECHNICAL SPECIFICATIONS.
ELECTROMATIC 3-203-3A RELIEF VALVE FAILURE.

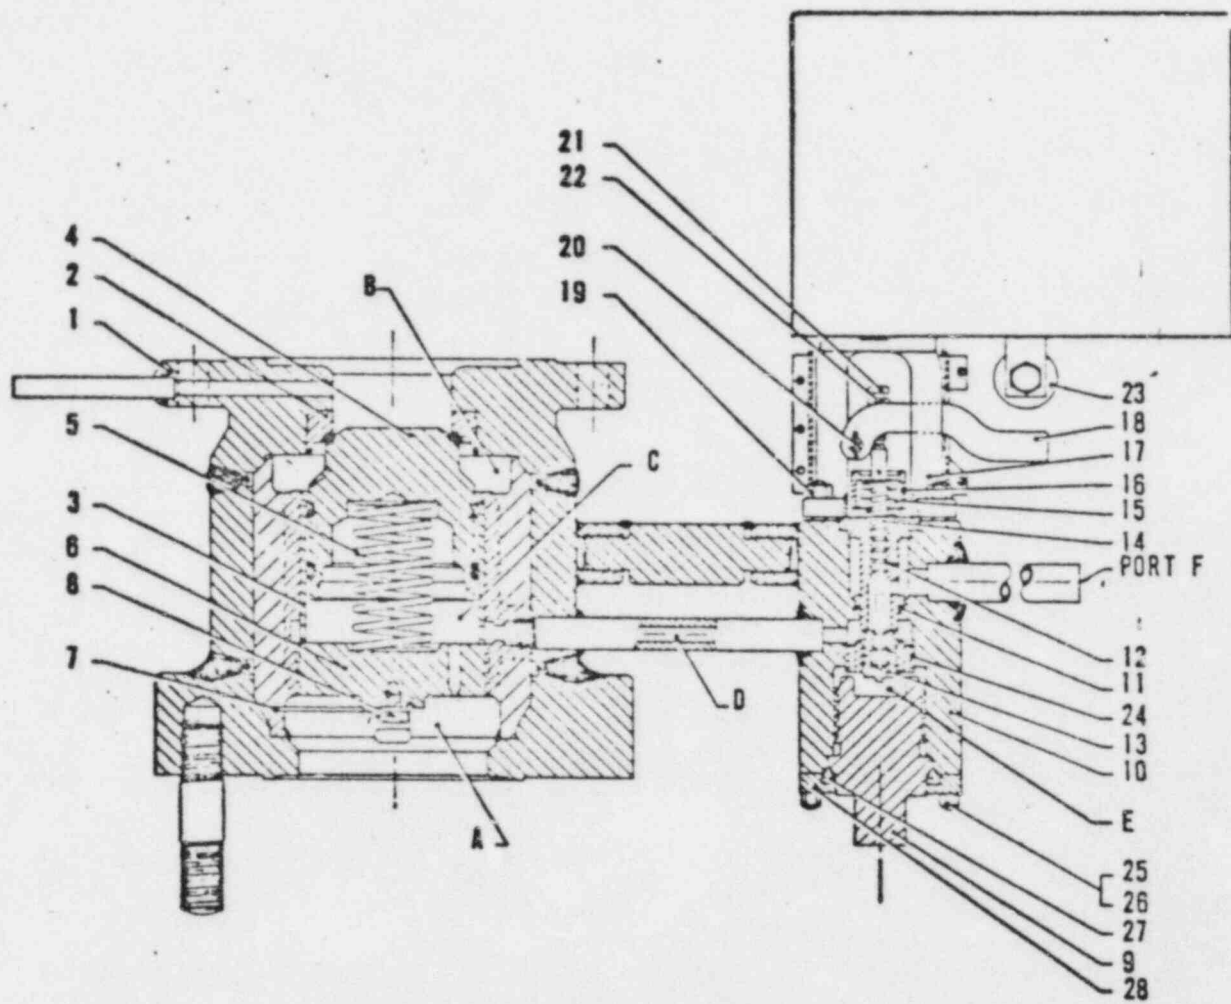
Electromatic 3-203-3A was removed from the drywell and disassembled. The disc retainer, see Part 6 of Figure 1, was found cocked and could not be unthreaded. Upon inspection, it was found that the threads were gone and the disc could be pulled out. It is thought that the threads were destroyed due to vibration as the disc retainer is made of a softer material than the valve body. Then when the pilot valve was opened, the steam leaking past the destroyed threads was sufficient to keep the valve closed.

The threads in the valve body were cleaned and a new disc retainer installed. The valve was then returned to service. The other four valves were checked for a similar failure. The disc on valve 3-203-3B could be moved approximately 1/8 to 1/4 turn. The disc was removed and the threads were found in good condition. The other three valves were found with the disc retainer securely in place.
