SUBJECT: Grand Gulf Nuclear Station
Unit 1
Docket No. 50-416
License No. NPF-29
Update to Reactor Scram Due Inadvertent Actuation of Backup
Scram Valve
LER 95-004-01

GNRO-95/00067

Attached is Licensee Event Report (LER) 95-004-01 which is a final report.

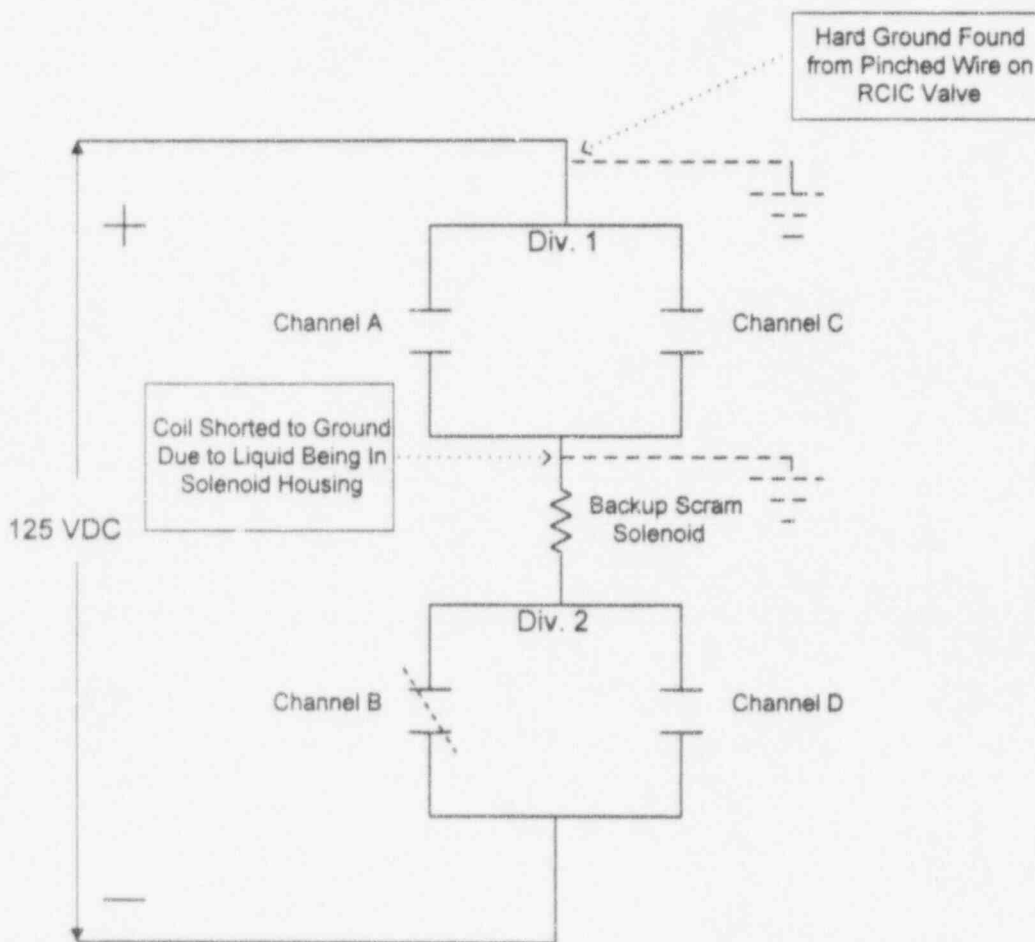
Scram Backup Valve Relay Logic

Immediate investigation of the event revealed that the loss of pressure in the scram pilot valve air header was the result of backup scram valve 1C11F110A opening. 1C11F110A, a direct acting solenoid valve powered by the Class 1E 125 VDC system [EJ], opened shortly following the Div. 2 scram signal that was initiated in accordance with the APRM surveillance. The backup scram valve should not have been affected by performance of any portion of this surveillance. The incident investigation identified a grounded lead on the Reactor Core Isolation Cooling System (RCIC) [BN] minimum flow valve and liquid in the backup scram valve solenoid housing.

The ground on the RCIC valve was due to a wire that had been pinched during the course of maintenance that had occurred a week prior. Even though surveillances had been performed since the valve maintenance that would have resulted in a possible actuation of the F110A, no adverse consequences had been noted. Initial troubleshooting following the scram did not reveal any grounds associated with F110A's solenoid which would have caused the valve to open. Further troubleshooting using a megger (~ 250 VDC) determined that the solenoid was shorted to ground. Upon opening the solenoid valve housing, personnel discovered that the housing contained liquid which provided a current path to ground. Therefore, F110A opened due to a ground that occurred while the APRM surveillance was in progress.

- Ground on Positive Leg of 'A' Battery Due To Pinched Wire in E51F019 (RCIC Min Flow Valve To Suppression Pool) Circuit.
- C11F110A Solenoid Coil Grounded to Housing Through Liquid.
- C71K14B Contact Closed Due to Division 2 Surveillance.

The solenoid for the F110A was replaced. The conduit going to the F110A solenoid housing was sealed to prevent moisture intrusion. (The F110A solenoid is normally deenergized; therefore, sealing the conduit would not result in overheating the valve.) A Material Nonconformance Report was initiated to identify the source the presence of liquid in the solenoid housing. Even though the actual source of the liquid has not been identified, actions were taken to prevent coil failure due to moisture intrusion. The disposition of the nonconformance report required that the non-molded coils for the backup scram valve solenoids be replaced with hermetically sealed coils. These coils are not susceptible to moisture intrusion.
