Florida Power

CORPORATION
Crystal River Unit 3
Docket No. 50-302

Subject: Response to Generic Letter 95-03, "Circumferential Cracking of Steam Generator Tubes"

Generic Response to GL 95-03 for B&W OTSG
Relative to Circumferential Cracking of Steam Generator Tubes

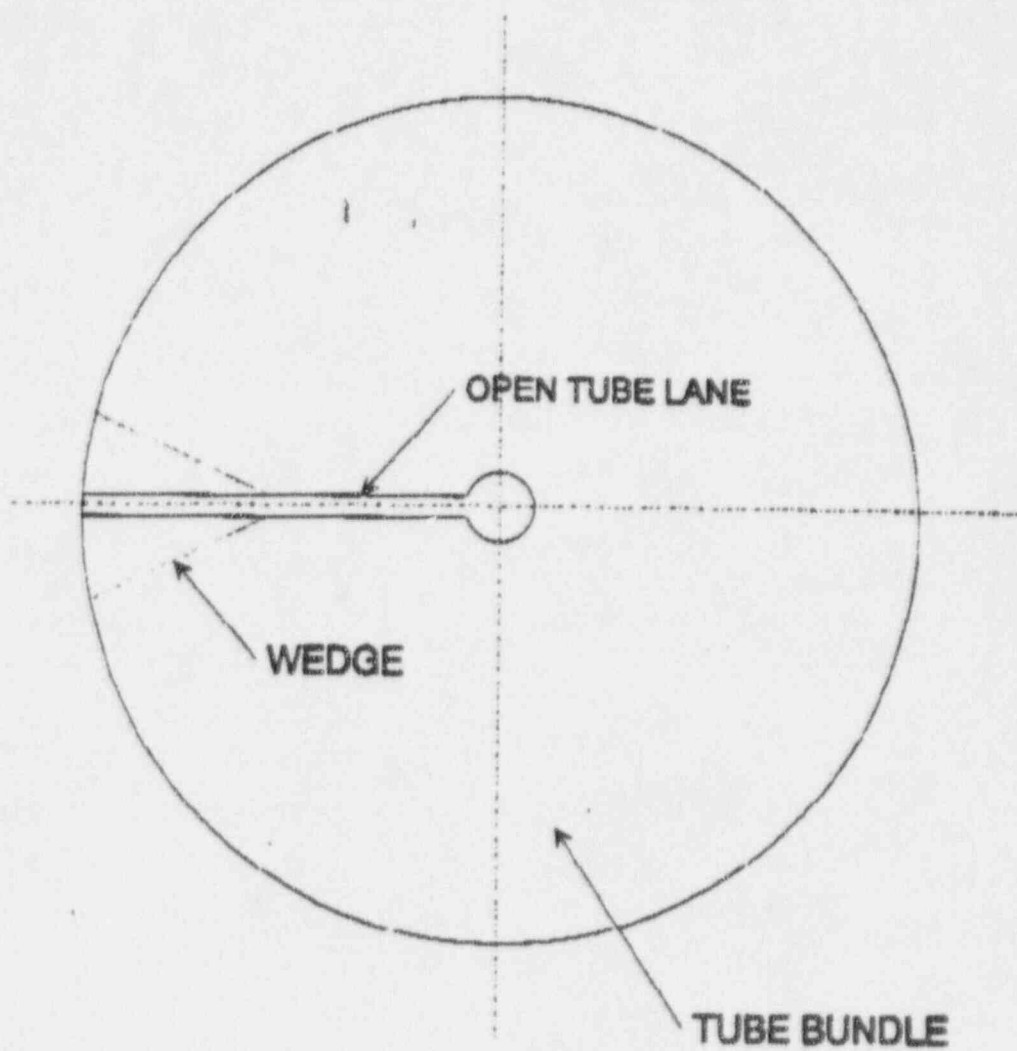
Figure 2
OTSG Lane/Wedge Region

This region consists of tubes in the lane/wedge region at elevations between the upper tubesheet secondary face (UTSF) and the uppermost tube support plate (15th TSP). The inspection lane is an un-tubed channel which extends from the periphery to the center of the tube bundle along Row 76 of the tube layout. The lane/wedge region has been defined as a region of tubes which abuts the outer half of this lane and then flares out into a wedge shape near the periphery of the tube bundle, per the attached Figure 2.

The steam flow in the uppermost tube span is primarily across the tubes as it turns to exit the bundle. The open lane is a cooler area of the generator which in turn lets wet steam deposit contaminants higher in the bundle, contributing to local degradation. The lower flow resistance of the lane/wedge region results in higher crossflow velocities, and this high velocity steam may cause flow-induced vibration of these tubes. This vibration could result in high cycle fatigue failure (Reference NRC Information Notice 91-43).

There have been 41 OTSG tube leaks which have been attributed to circumferential cracks caused by high cycle fatigue in the lane/wedge region. These cracks generally occur where the bending is restrained at the upper edge of the 15th TSP and at the secondary face of the upper tube sheet, initiating in any local discontinuities. Tube failure due to high cycle fatigue usually progresses rapidly after crack initiation, with primary to secondary leakage typically occurring within a period of hours.

The OTSG plant licensees have relied upon the installation of preventative sleeves in the top span of these tubes to minimize tube failures. The 80-inch mechanical sleeve stiffens the tube and provides an inner pressure boundary. All OTSG plants now have completed sleeving tubes in their defined lane/wedge regions. The annual rate of OTSG tube leaks decreased as the preventive sleeving program neared completion, confirming the effectiveness of this program. Note that sleeving mitigates the consequences of fatigue failures, and it is not dependent upon inspection by non-destructive examination.

Tubes in the lane/wedge region have been preventively sleeved in the uppermost span to mitigate the consequences of fatigue failures. A one-tube wide border of un-sleeved tubes in service around the lane/wedge region of sleeved tubes will be examined to confirm that the sleeved region is still adequately bounded. This examination will consist of inspection of the 15th TSP and UTSP areas of each tube. Examination of sleeved tubes is addressed in item III.1.4 below.
