UNUSUAL EVENT

FORT ST. VRAIN NUCLEAR GENERATING STATION
PUBLIC SERVICE COMPANY OF COLORADO
P. O. BOX 361
PLATTEVILLE, COLORADO 80651

REPORT NO. 50-267/75/10

Preliminary

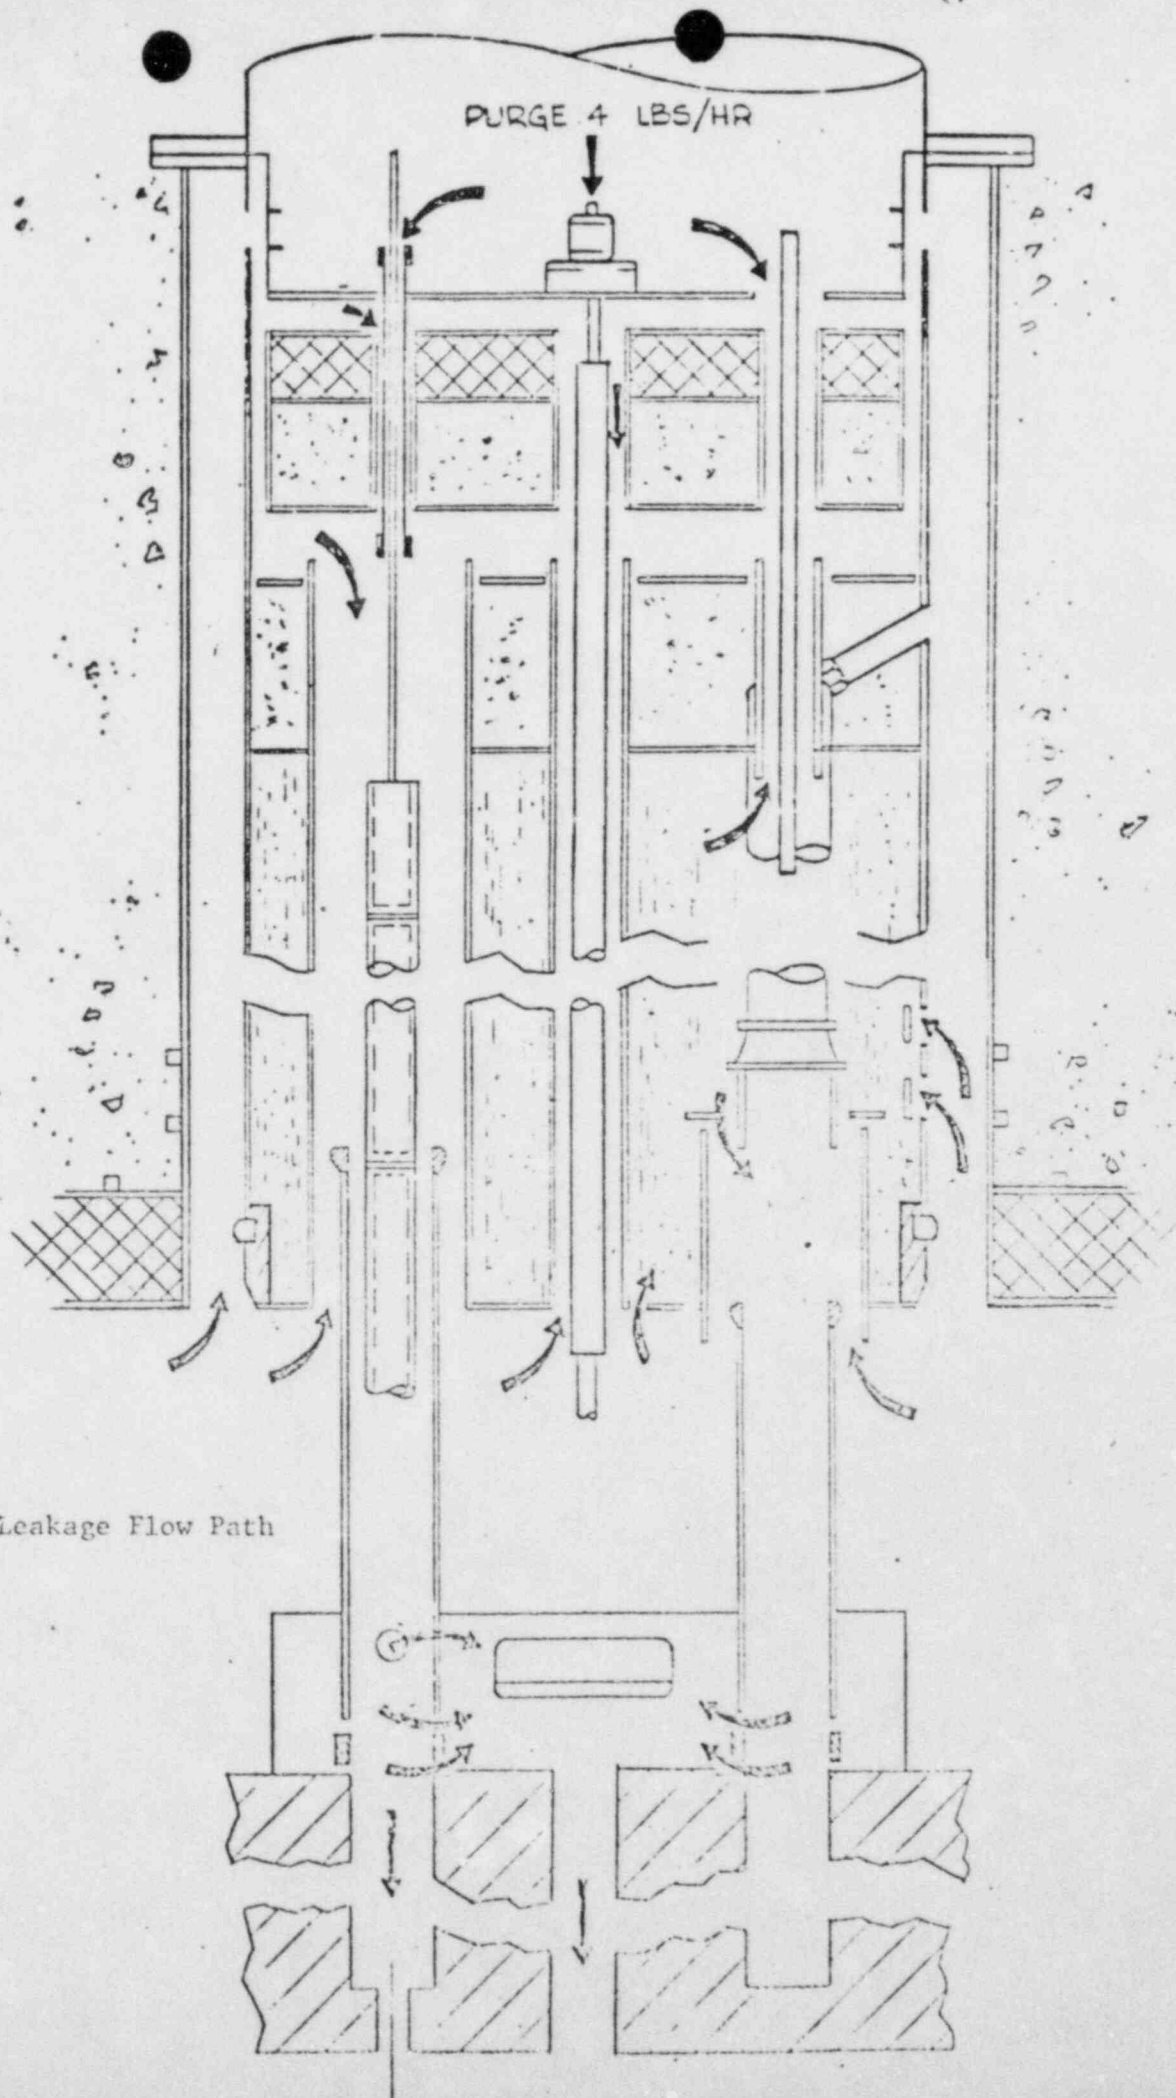
SKETCH - Leakage Flow Path

The leakage of hot gas into the annulus between the control rod drive housing and the refueling penetration liner has been determined to be the cause of the unusual temperature rise associated with top head tubes T-39, T-40, T-41, and T-42. This gas flow is caused by pressure differentials which exist between the inside and outside of a control rod drive unit.

To determine the specific flow paths that exist in the CRD assembly, a series of diagnostic tests were performed on a spare control rod drive unit. The results indicated that the flow entered the drive housing through numerous access and maintenance ports, and exited from the control rod guide tubes and from the duct which directs the reserve shutdown material from the drive unit into the receiver channel in the core.

The design of corrective seals at specific locations both inside and outside of the control rod drive unit is currently in progress. Basically, the drive housings are expected to be modified as follows:

- 1) A modified flexible seal will be installed at the lower outside end of the housing in place of the existing anti-convection ring currently in use.
- 2) A spring-loaded piston ring/cable bushing assembly will be positioned at the upper end of each control rod guide tube.
- 3) A seal welded piston ring seal will be positioned between the inner and outer feed pipes below the rupture disc assembly of the reserve shutdown hopper contained in the control rod drive unit. This seal is so designed that it in no way impedes the flow of reserve shutdown material which would flow through this tube if released by the rupture disc above.

These three seals are expected to reduce the leakage flow to an acceptable level.
