UNUSUAL EVENT

FORT ST. VRAIN NUCLEAR GENERATING STATION
PUBLIC SERVICE COMPANY OF COLORADO
P. O. BOX 361
PLATTEVILLE, COLORADO 80651

REPORT NO. 50-267/75/5

FAILURE OF PV21105-1

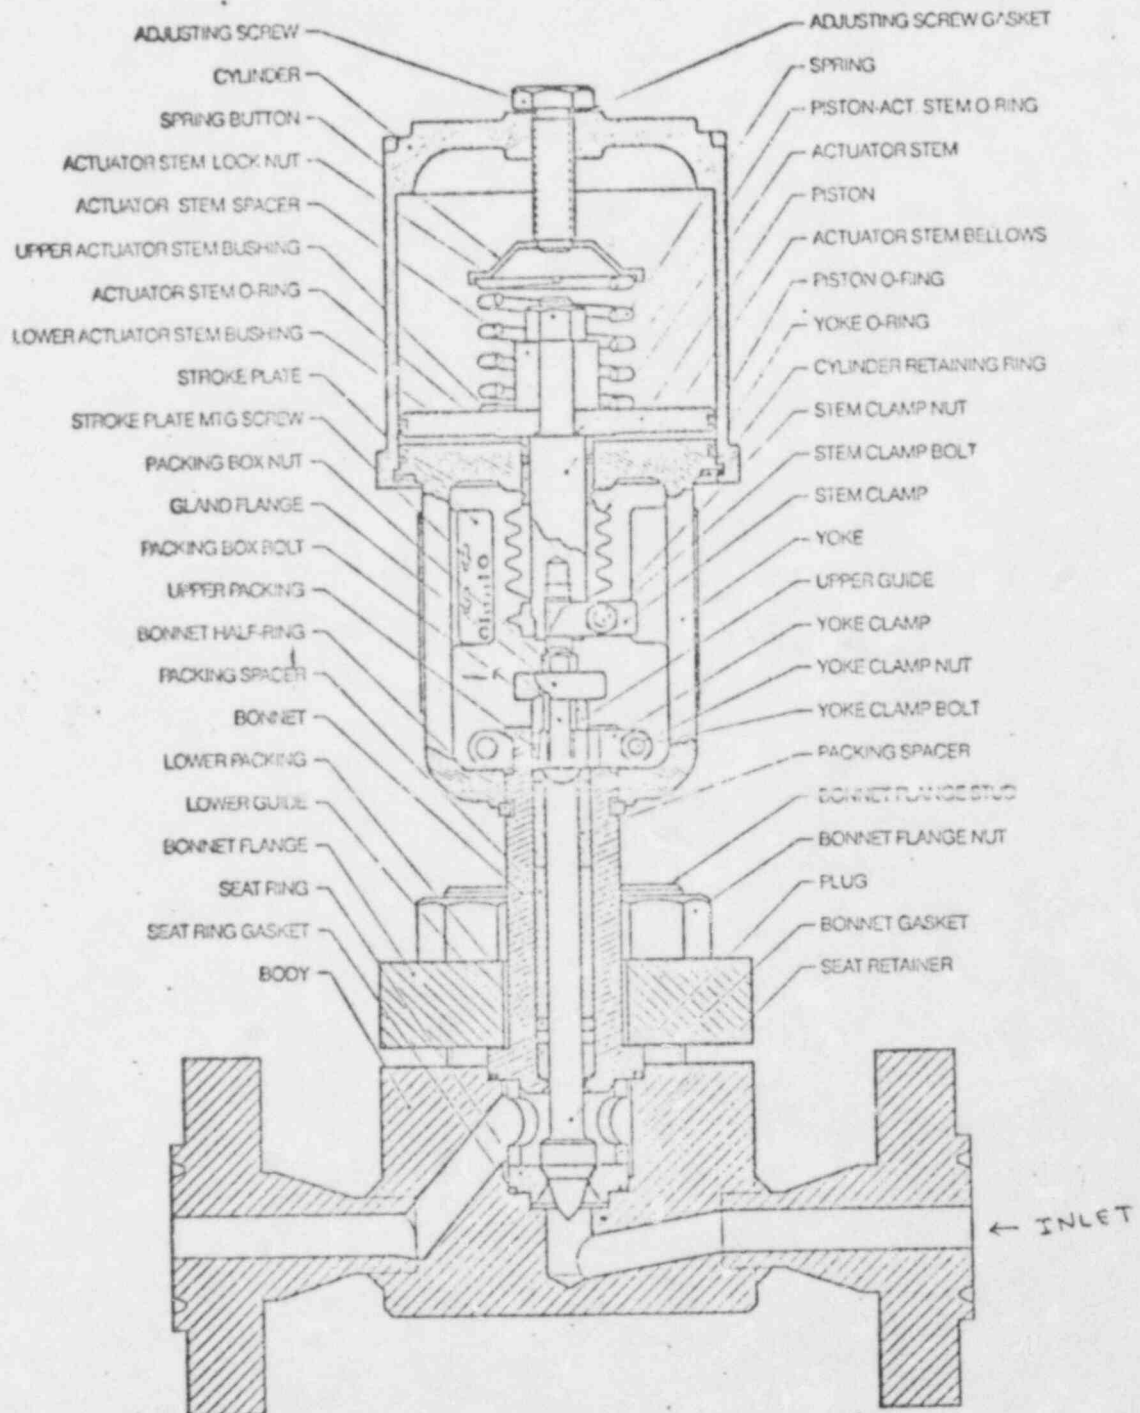
Emergency Feedwater Header pressure pushing up against the valve plug was approximately 4,000 psig. The yoke clamp failed, causing the plug assembly to push upward lifting the operator assembly, packing spacers and packing retainer (not shown in attached drawing). This allowed high pressure water to blow out of the stem guide area.

Examination of the yoke clamp revealed a fractured area. This fractured area appeared to have existed for a considerable time, as evidenced by discolored surfaces in the fracture.

A manufacturer's representative investigated the failure on April 11, 1975. Damaged parts were replaced and this valve (PV-21105-1) along with two other Valtek valves (PDV-2191-1, 2192-1) were disassembled and inspected. All yoke clamps were dye penetrant checked. The pressure containing components on PV-21105-1 were also radiographed or dye penetrant checked.

As a follow-up a review of the piping and valves making up this system is in process to verify pressure capabilities, surge responses, relief valve capacities, and proper supports and hangers.

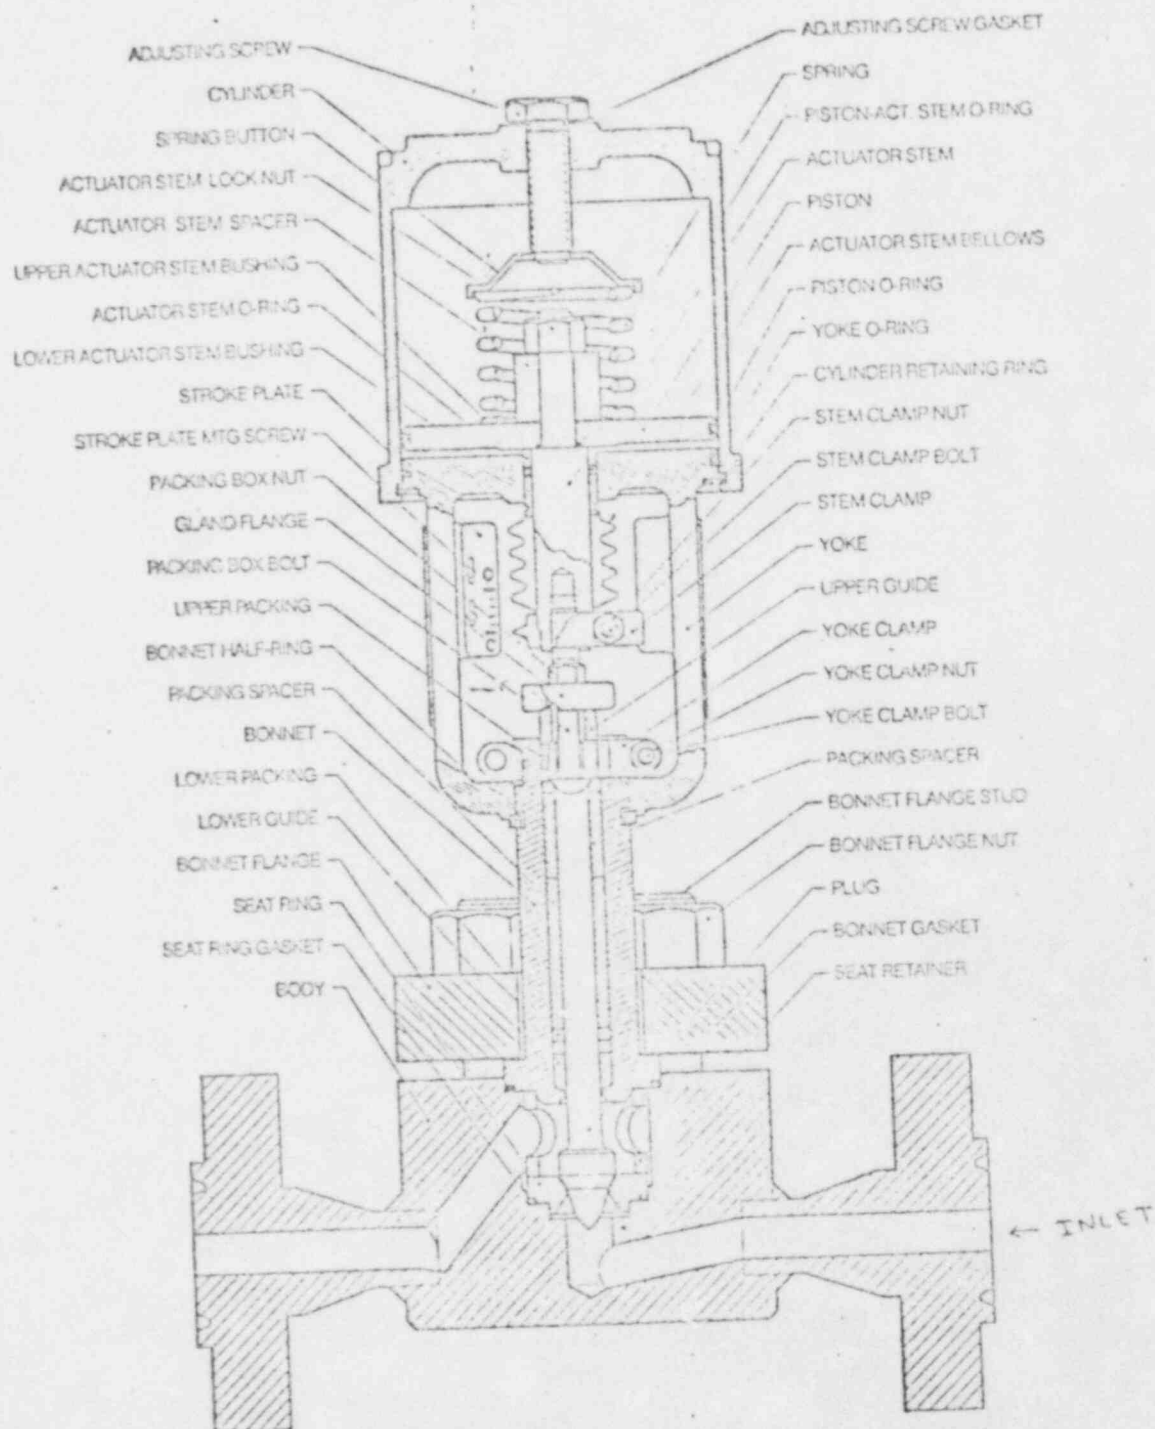
Emergency Feedwater Header pressure pushing up against the valve plug was approximately 4,000 psig. The yoke clamp failed, causing the plug assembly to push upward lifting the operator assembly, packing spacers and packing retainer (not shown in attached drawing). This allowed high pressure water to blow out of the stem guide area.

Examination of the yoke clamp revealed a fractured area. This fractured area appeared to have existed for a considerable time, as evidenced by discolored surfaces in the fracture.

A manufacturer's representative investigated the failure on April 11, 1975. Damaged parts were replaced and this valve (PV-21105-1) along with two other Valtek valves (PDV-2191-1, 2192-1) were disassembled and inspected. All yoke clamps were dye penetrant checked. The pressure containing components on PV-21105-1 were also radiographed or dye penetrant checked.

As a follow-up a review of the piping and valves making up this system is in process to verify pressure capabilities, surge responses, relief valve capacities, and proper supports and hangers.
