# LICENSEE EVENT REPORT

UNUSUAL EVENT 75/03A

FORT ST. VRAIN NUCLEAR GENERATING STATION  
PUBLIC SERVICE COMPANY OF COLORADO

REPORT NO. 50-267/75/03A

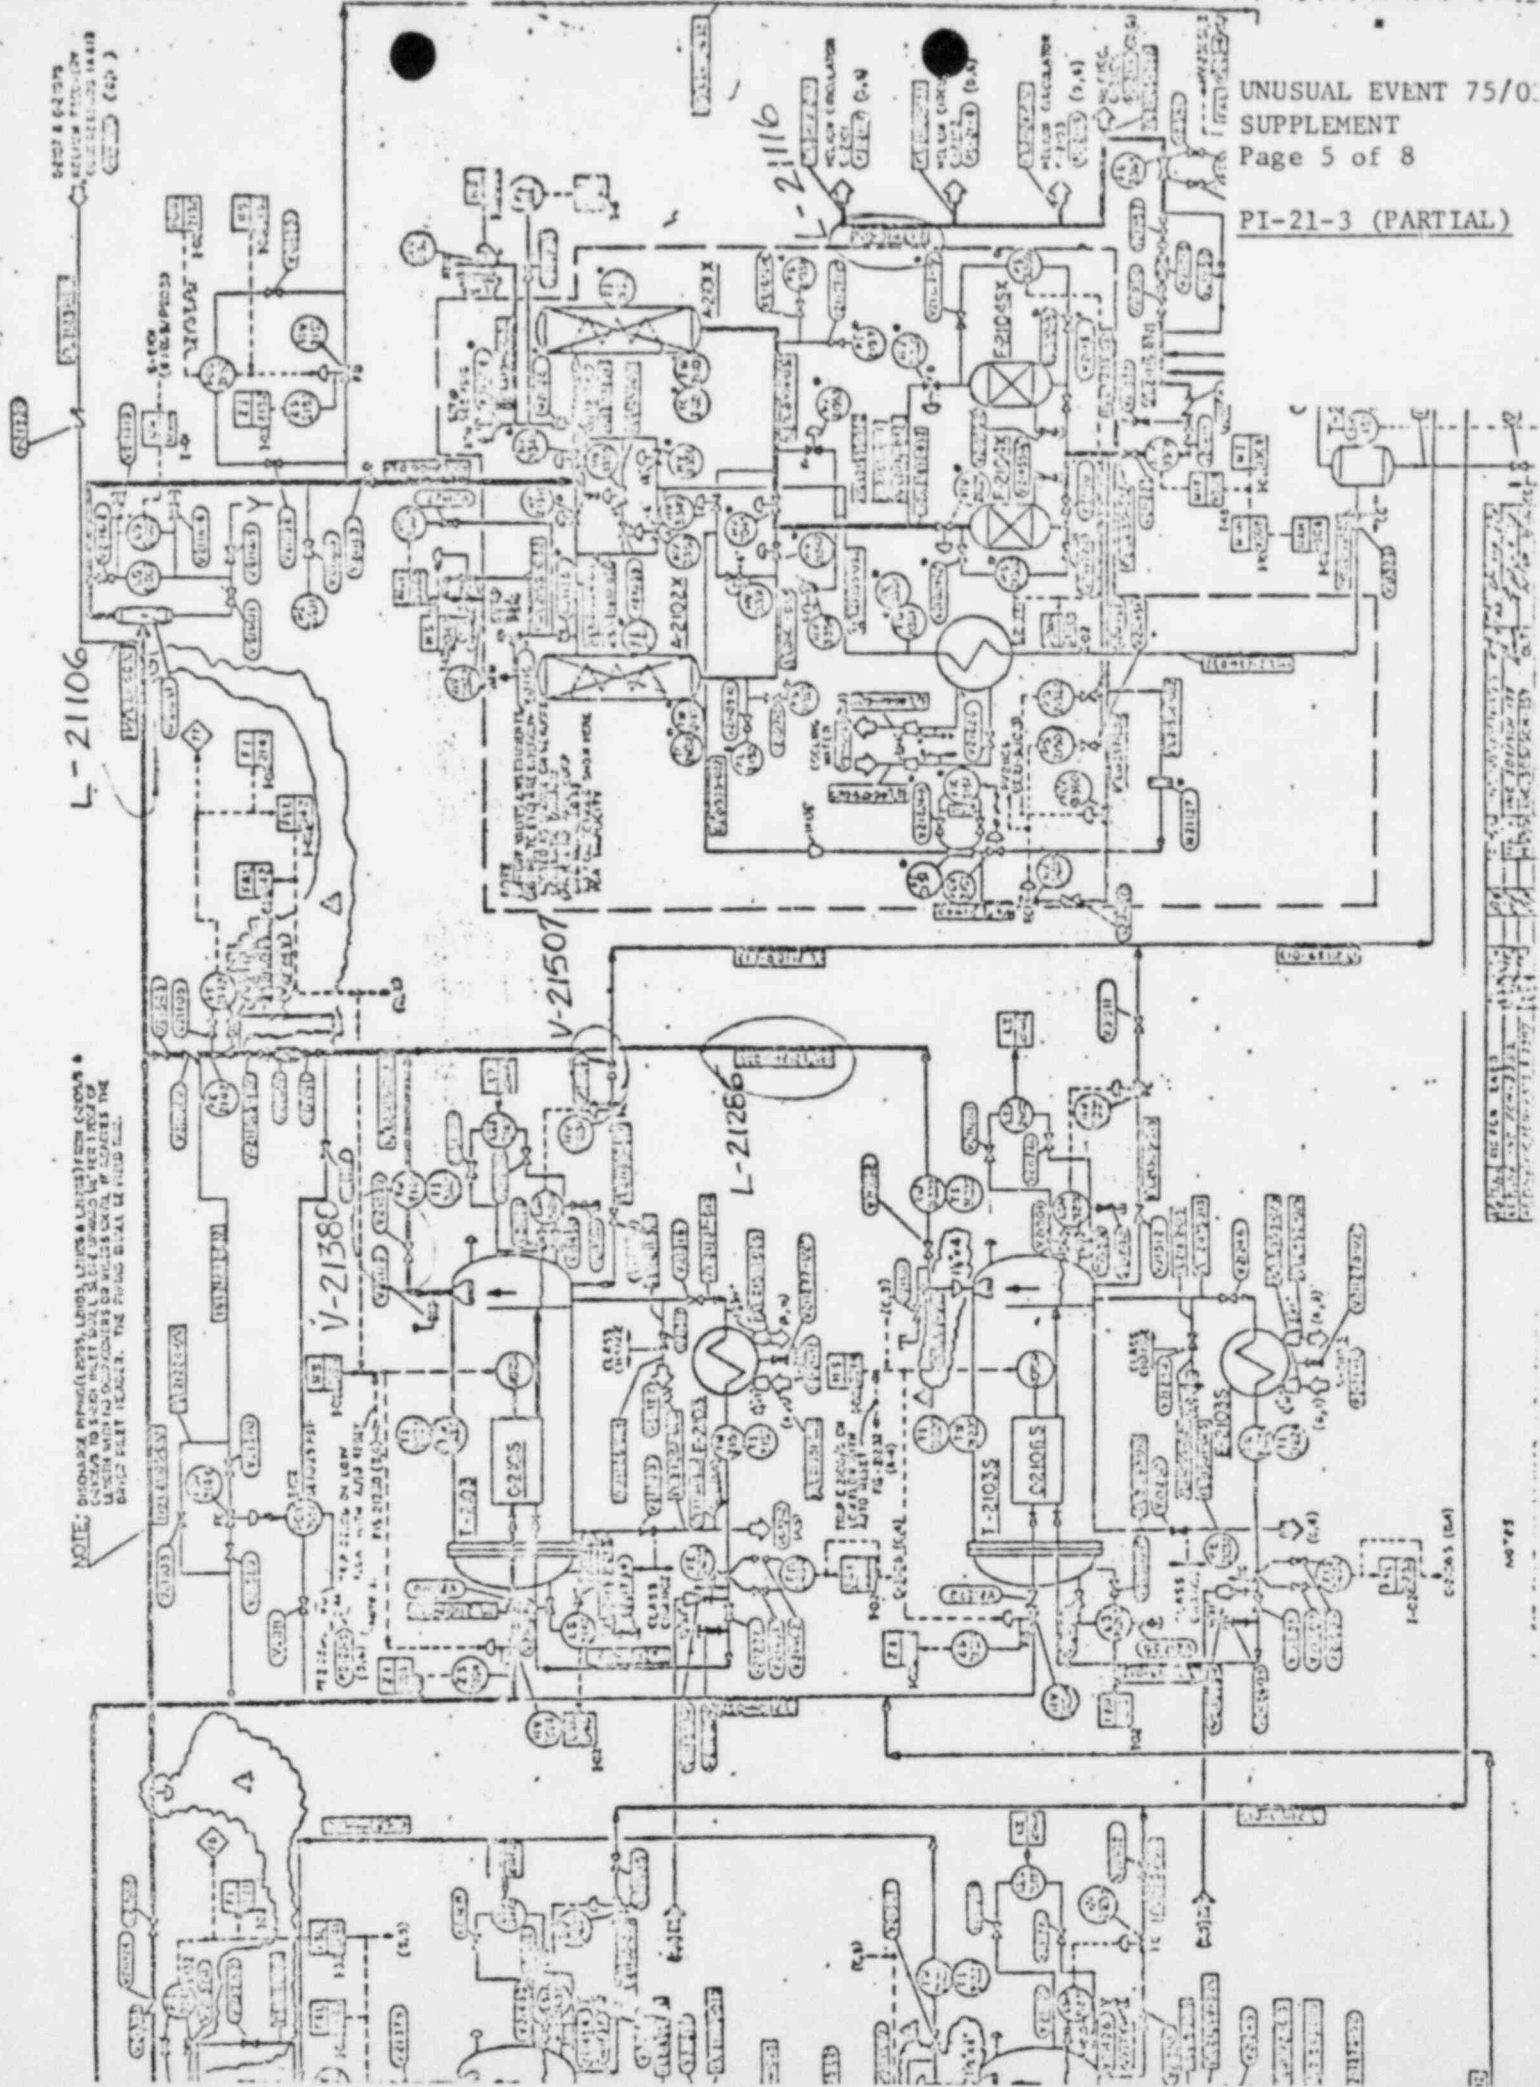
PI-21-3 (PARTIAL)

In this occurrence, the operator was directed to return recirculator C-2106 to service. The operator opened V-21507, then slowly "cracked" open V-21380 (reference PI-21-3, attached). Opening V-21380 allowed helium from 1 1/2" L-21286 to flow into and pressurize T-2103. The helium flow into T-2103 reduced the pressure in 1 1/2" L-21106 and therefore in 2" L-21116, which is the buffer supply header to the circulators.

The effect of losing buffer helium supply flow to 1B circulator was to decrease the pressure in the buffer seal cavity. The pressure decrease reduced the buffer cavity to surge tank differential pressure, which is the driving force for buffer helium return flow. This was followed by a flow reversal from the helium water drain to the buffer supply. This flow reversal caused a negative buffer-mid-buffer pressure which was sensed by PDIS-21155, PDIS-21157, and PDIS-21159 (reference PI-21-8, attached). When this flow reversal reached a negative pressure differential of 9" water, the PDIS instrument outputs tripped after which the Plant Protective System tripped the circulator.

This pressure reduction could not be immediately restored by the purified helium header and as a result, the helium supply flow to 1B circulator was reduced. When the pressure decreased to the point that it could not overcome the check valve resistance, 1B circulator buffer helium supply flow decreased to zero.

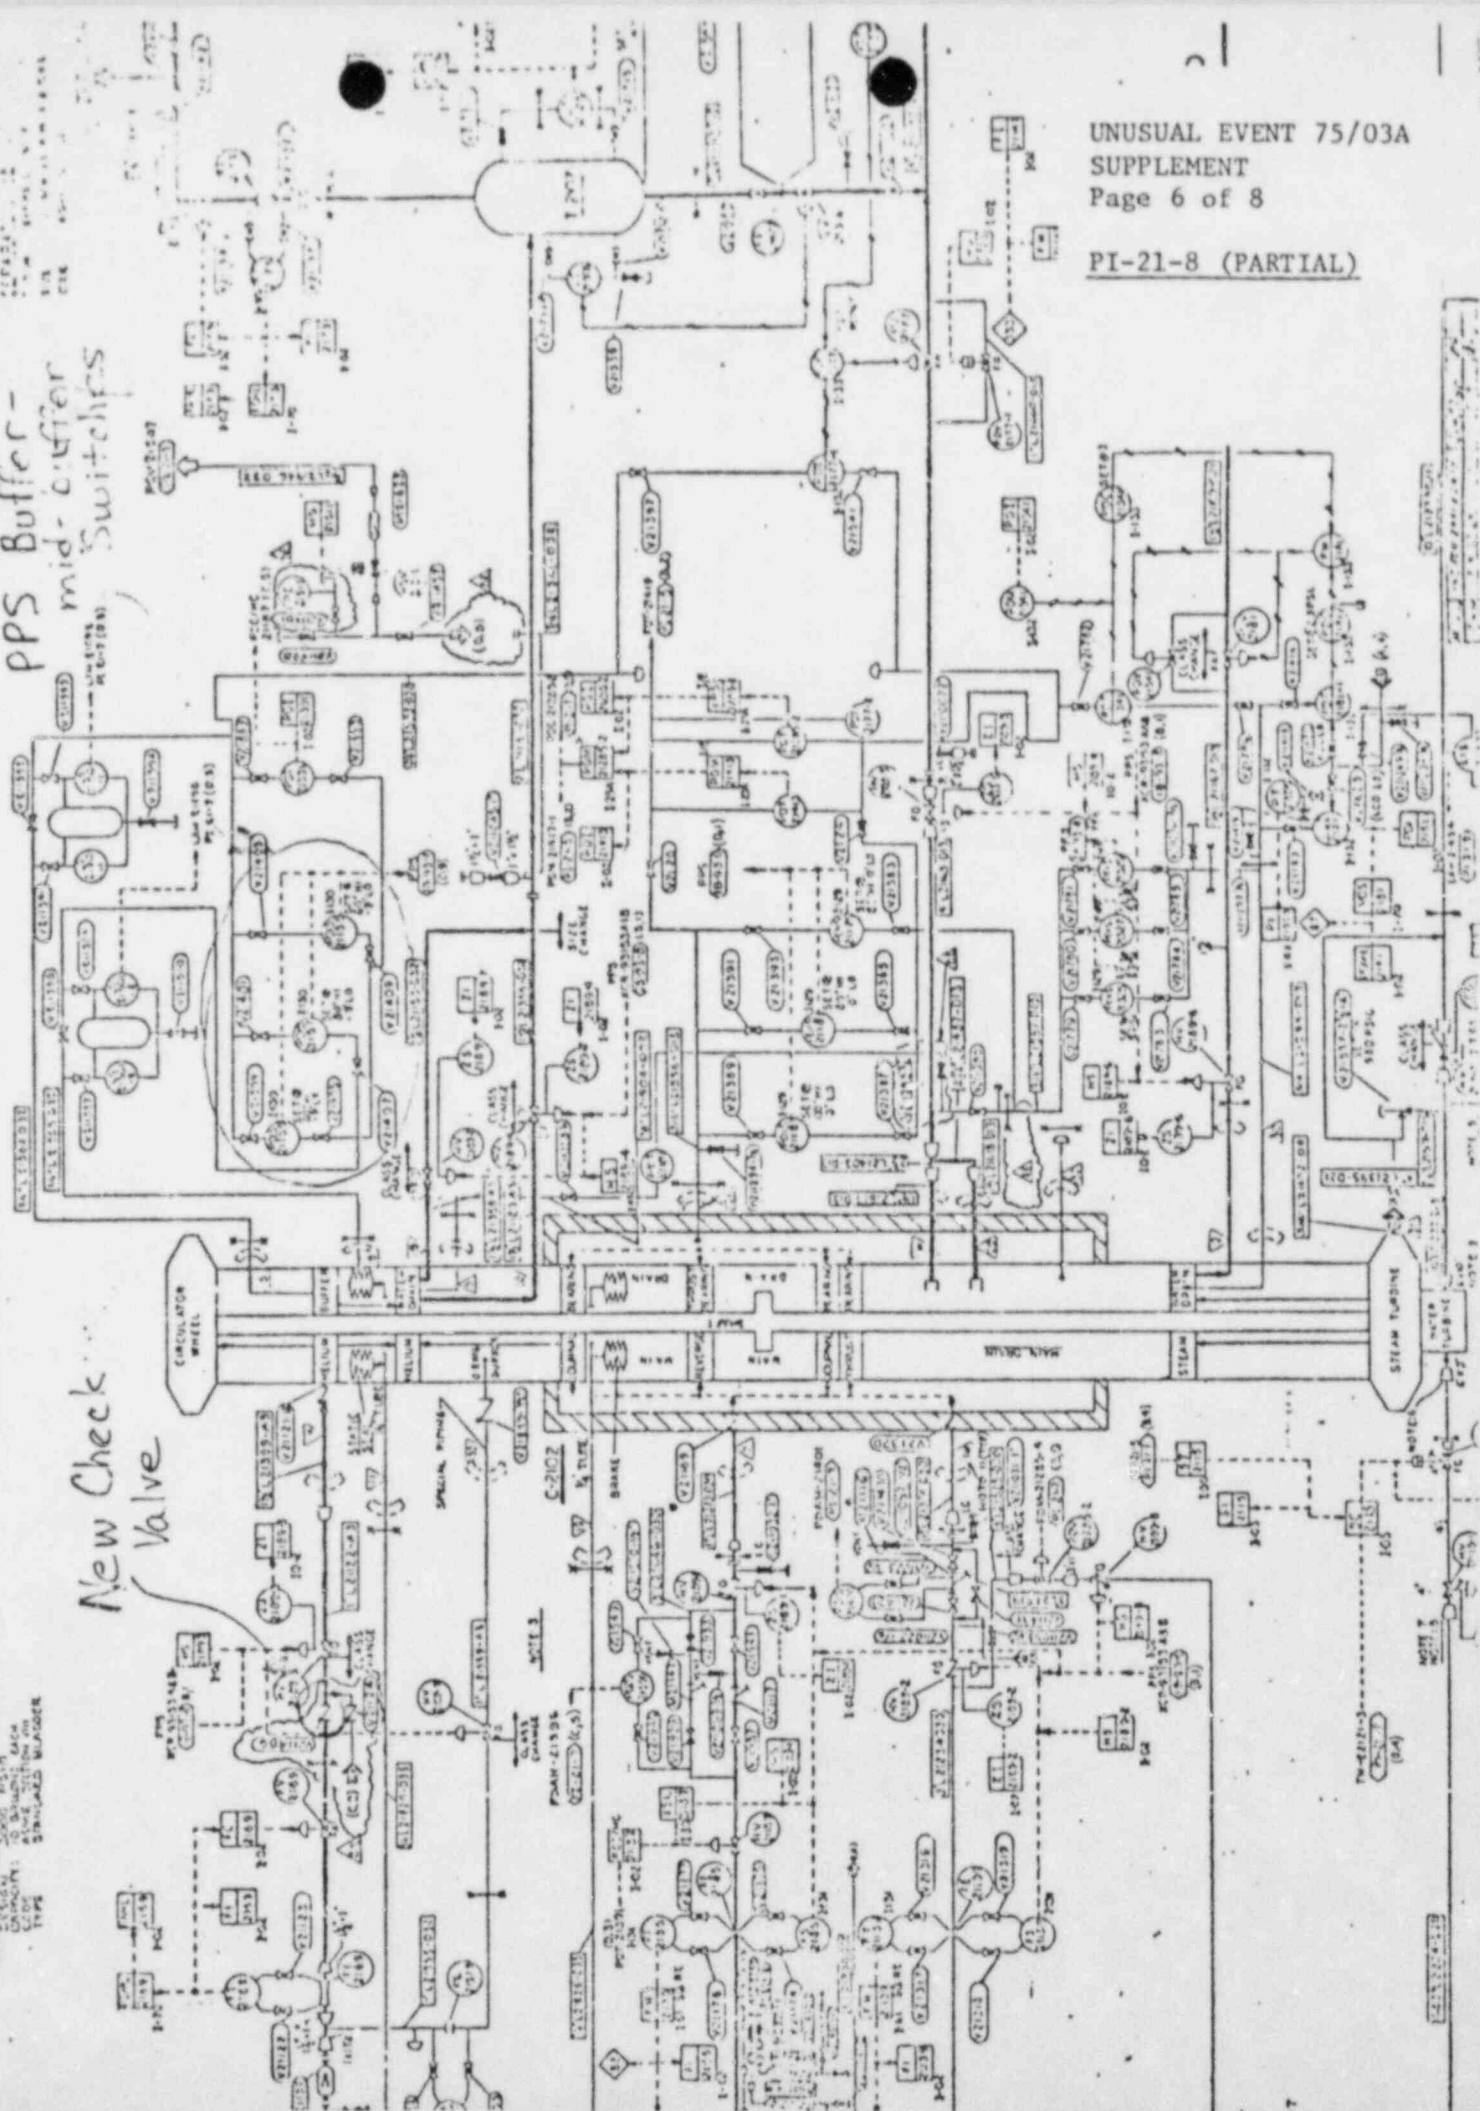
PI-21-8 (PARTIAL)

Prior to February 9, 1976, circulator 1B buffer helium supply line (1" L-21122) had been altered by field change notice 2512A/2910, which installed a check valve upstream of HV-2189-3 (reference PI-21-8, attached). This check valve is part of a modification to facilitate opening the circulator mechanical shaft seal with the bearing water surge tank depressurized to less than primary loop pressure. Similar check valves were to be installed on the remaining three circulators, pending completion of tests to determine that the installation would facilitate opening of the mechanical shaft seal.

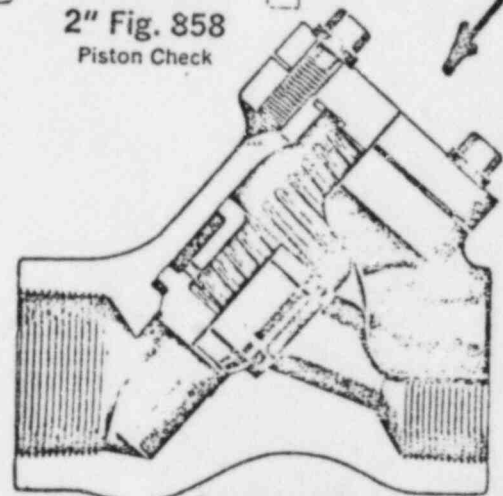
FIGURE 1

The check valve (Figure 1) was selected on the basis of availability at the plant site. Note that it is a spring loaded check valve.

**STANDARD MATERIALS**—Bodies and covers are of forged carbon steel or chromium-molybdenum F11 alloy steel. Piston disks for 1" size and smaller are of cobalt-chromium-tungsten stainless steel. Piston disks for 1 1/4" and larger are of F11 alloy steel hardfaced with projection welded Stellite. Spring is of stainless steel to insure fast piston-check action. See material specifications on pages 48 & 49.

The spring in the check valve was removed, after it was determined that the valve would perform its function without the spring. As a result of removing the spring system operating pressures returned to near normal values. The check valve (without spring) is being added to the remaining circulator buffer helium supply lines.
