ABNORMAL OCCURRENCE 76/07

FORT ST. VRAIN NUCLEAR GENERATING STATION
PUBLIC SERVICE COMPANY OF COLORADO
P. O. Box 361
PLATTEVILLE, COLORADO 80651

REPORT NO. 50-267/76/07

IDENTIFICATION OF
OCCURRENCE:

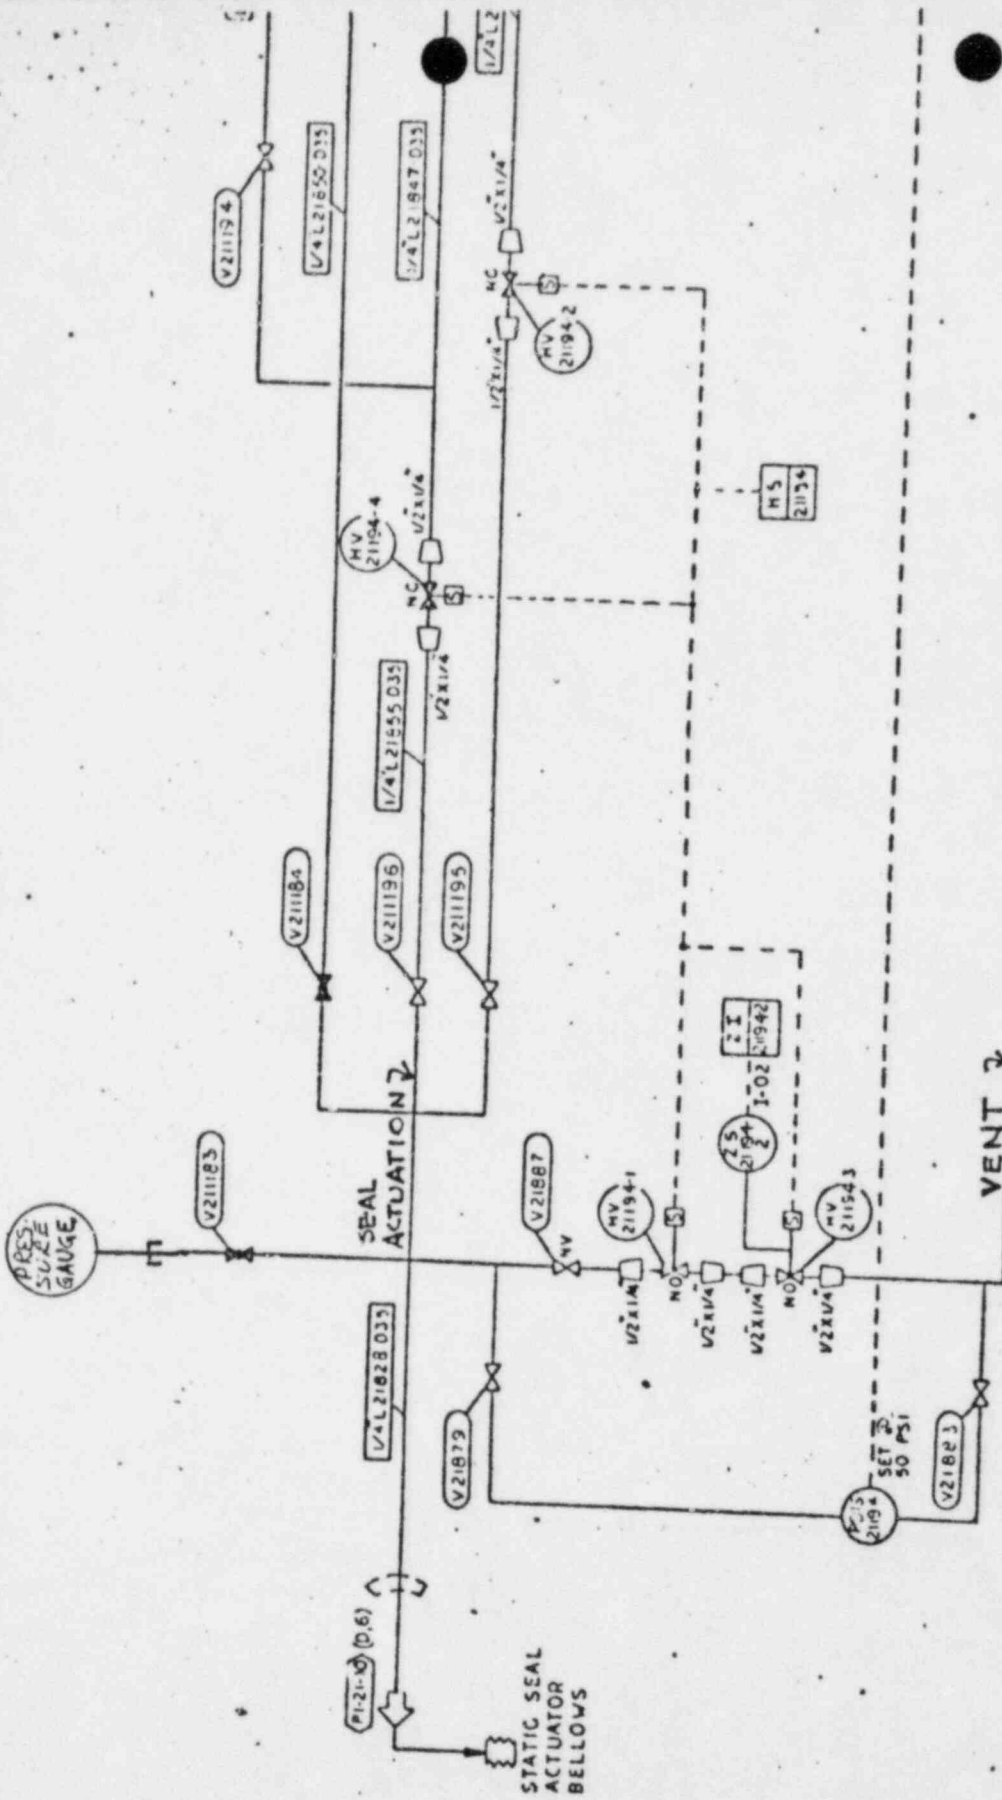
During the 8-4 shift of March 10, 1976, the equipment operator observed a rapidly decaying pressure for Circulator 1D (serial number C-2102) brake and seal gas pressure bottle. A leak check of the appropriate fittings was made. No external leaks were detected. It was further noted that bottle pressure only decayed with the seal actuation valves, HV-21194-4 and HV-21194-2, open (refer to Figure 1).

The following shift (4-12), a pressure gauge was connected to the system as shown on the attached Figure 1. The system valves were aligned as follows:

V-21184	Closed
V-211196	Closed
V-211195	Closed
V-21879	Closed
V-21883	Closed
V-21887	Closed
V-211201	Closed
V-211183	Open

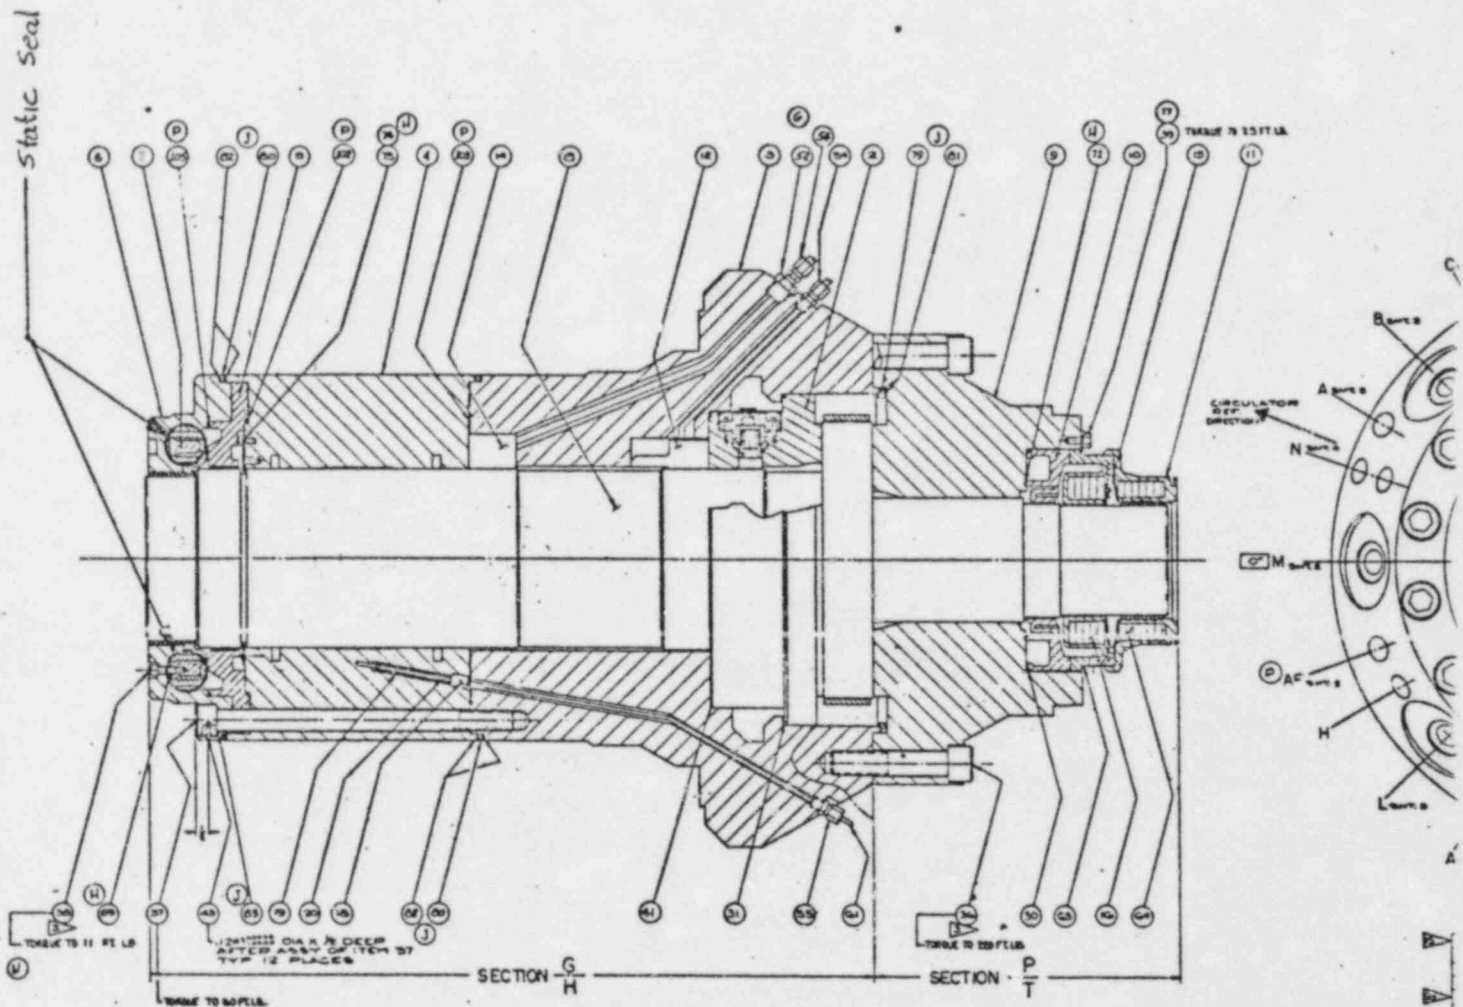
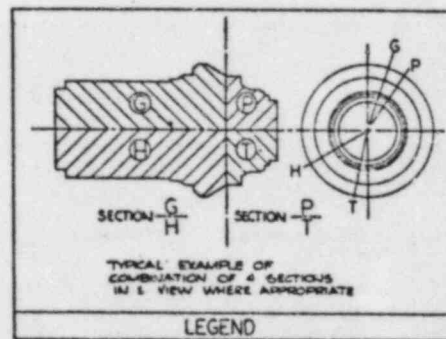
A/O 76/07 - FIGURE 2

08 THE PRESUMED CAUSE IS THAT THE STATIC SEAL BELLOWS IS FAILED. THIS
09 BELLOWS IS PART OF HE CIRC SN C-2102 (SUPPLIED BY GENERAL ATOMIC
10 CO.), WHICH WILL BE REMOVED FOR INSPECTION.

The primary coolant pressure was then cycled between 61 psig and 83 psig by use of the Helium Transfer Compressor (C-2401). The readings observed on the gauge followed closely the known primary coolant pressure. The only explanation for this observation is that the static seal bellows is open to primary coolant pressure (reference Figure 2).

Circulator 1D (serial number C-2102) will be removed and the static seal inspected. Further corrective action will be determined following that inspection. The spare circulator (serial number C-2101) will be placed in penetration D following the removal of Circulator 1D (serial number C-2102).
