UNUSUAL EVENT 76/03

FORT ST. VRAIN NUCLEAR GENERATING STATION
PUBLIC SERVICE COMPANY OF COLORADO
P. O. BOX 361
PLATTEVILLE, COLORADO 80651

REPORT NO. 50-267/76/03

IDENTIFICATION OF
OCCURRENCE:

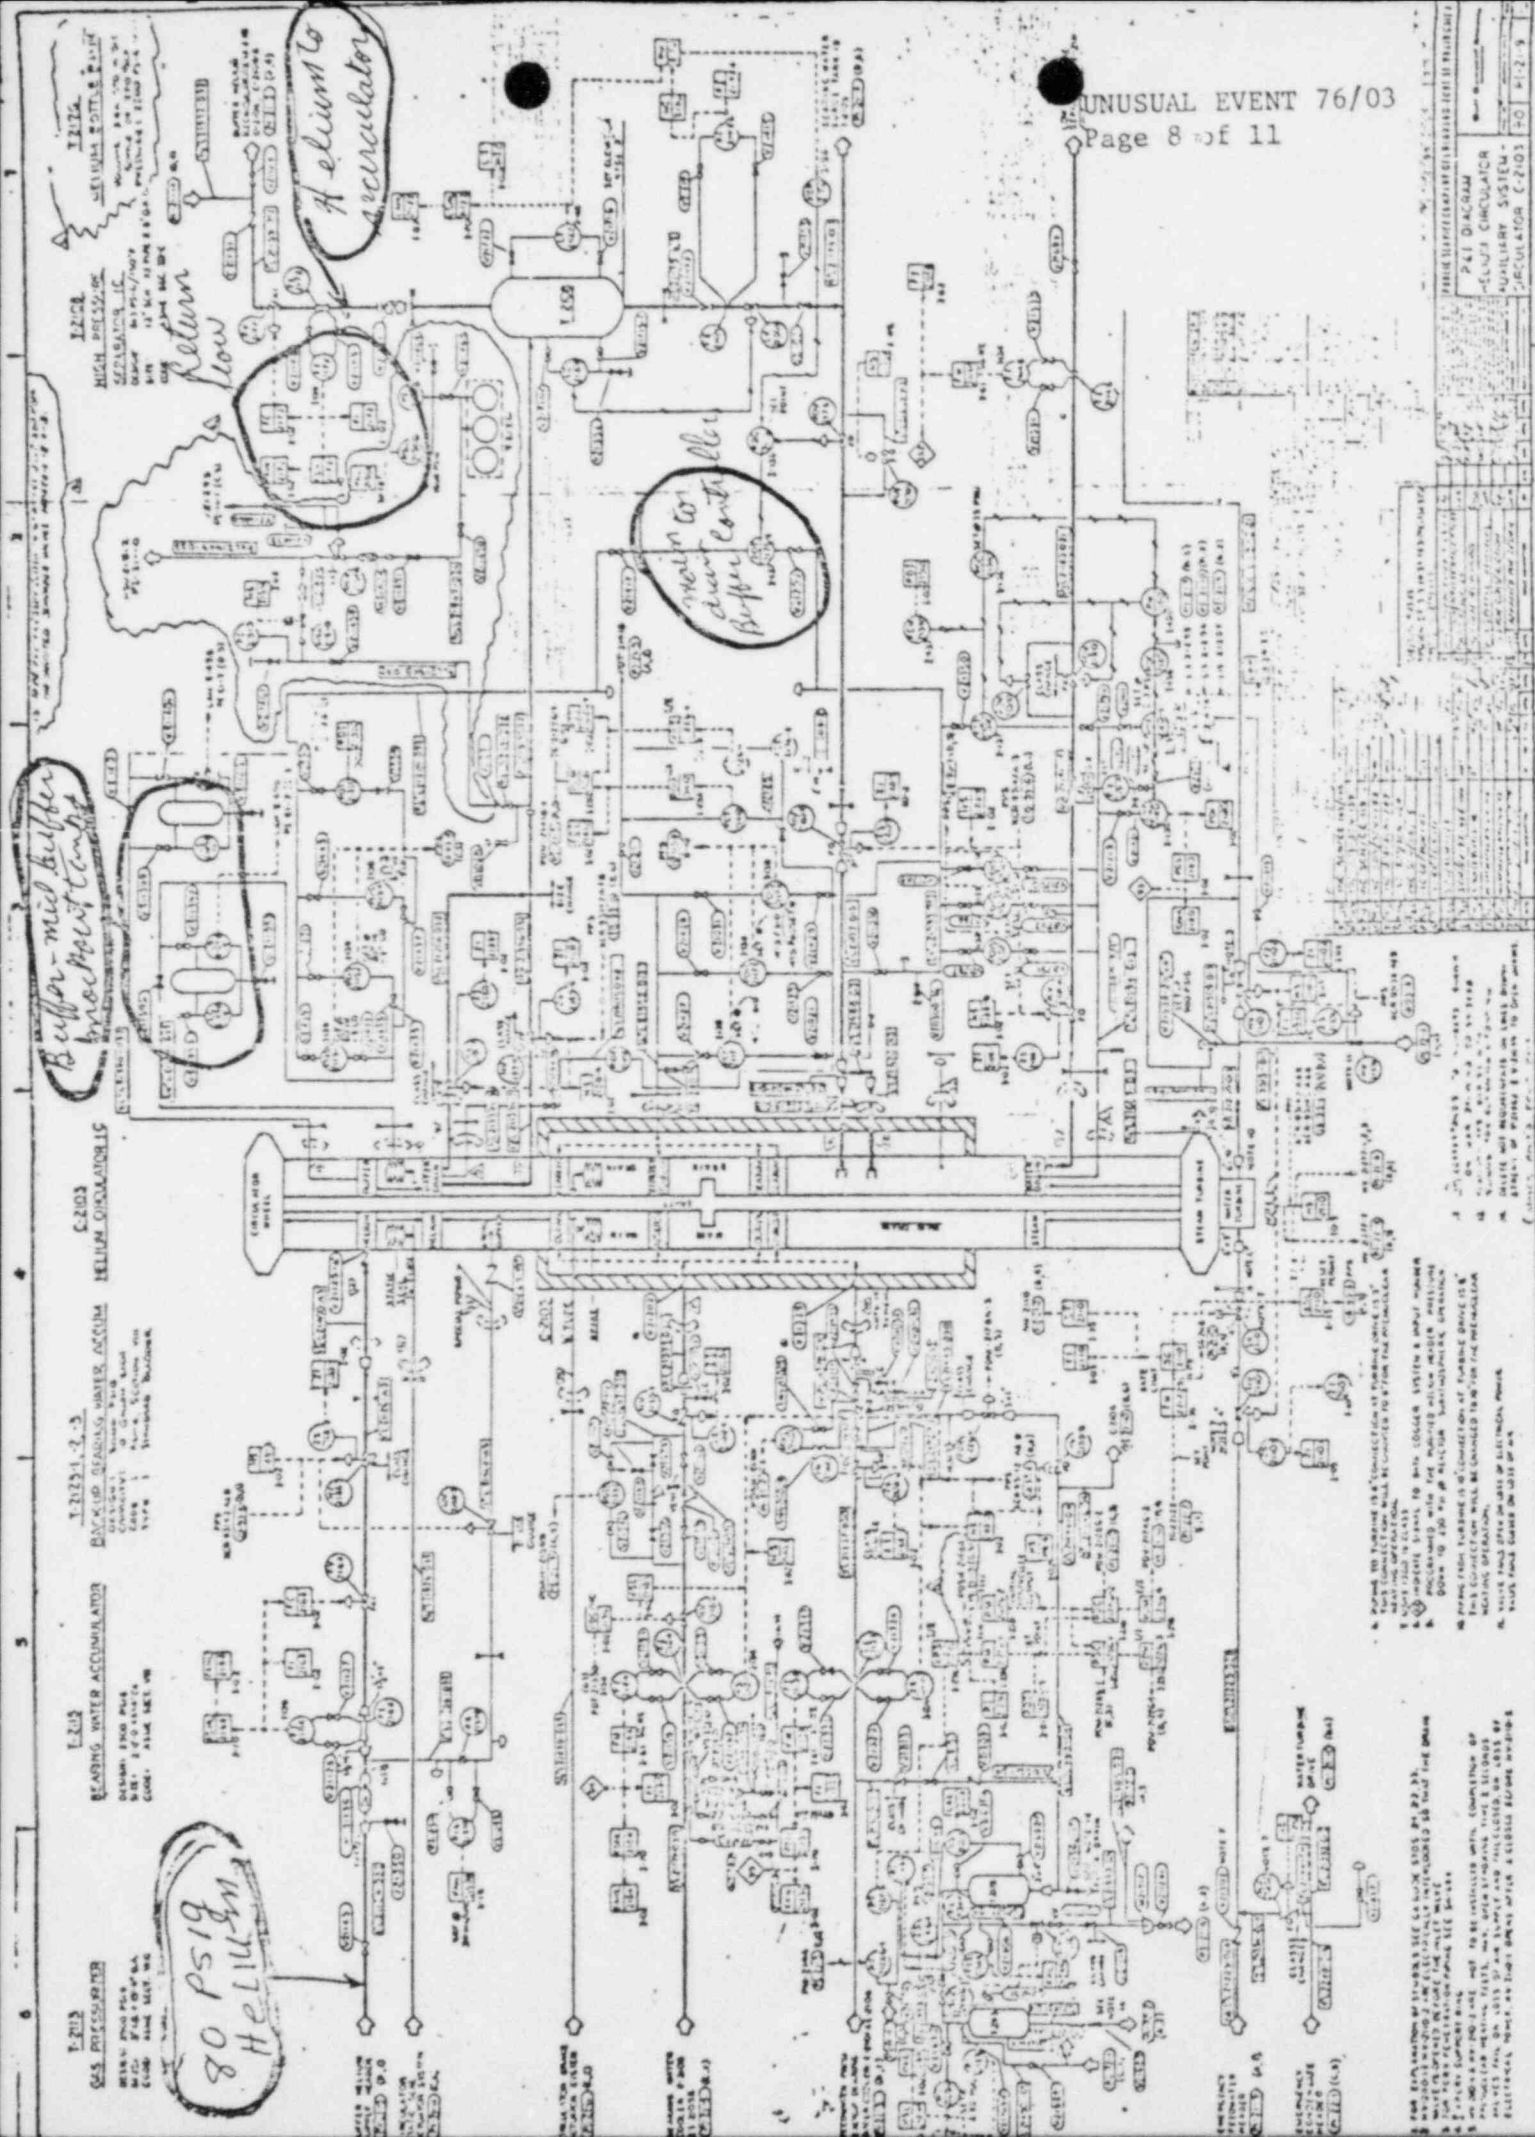
1C Circulator

At approximately 6:25 pm, the circulator buffer helium return flow decreased rapidly to zero ACFM (① on attached recorder traces). All other readings remained normal. Approximately five minutes later the circulator buffer-mid-buffer differential pressure changed from a plus ten inches of water differential pressure to zero inches of water differential pressure. It then decreased to a minus ten inches of water differential pressure. The negative differential indicates flow up the circulator shaft. No automatic trip of the circulator was initiated because a Loop 1 shutdown trip inhibits a Loop 2 circulator trip due to a buffer seal malfunction.

The attached curves show that while self-turbining 1C and 1D circulators, the buffer helium return flow rapidly decreased to zero (0) ACFM (① on the attached curves). This occurred when the power cord to PDC-2367 became disconnected.

The buffer helium supply flow remained constant and the loss of buffer return flow permitted all supply flow to pass up the circulator shaft and into the PCR.V. With loss of helium flow to the helium-water drain, the buffer-mid-buffer pressure decreased to a negative value ((2) on the attached curves). The negative buffer indicates flow up the circulator shaft and into the primary coolant. The Loop 2 circulators did not automatically trip, on negative buffer-mid-buffer pressure, because there was a Loop 1 shutdown trip which inhibited the Loop 2 helium circulator buffer-mid-buffer trips.

It is postulated that this action filled the buffer-mid-buffer differential pressure instrument lines with water and caused the buffer differential pressure change to a high positive indication ((4) on the attached curves). The high buffer ΔP differential pressure was a false indication.

An operator was sent to check the buffer-mid-buffer water knockout tanks (reference PI-21-9, attached) for water and subsequently removed a significant quantity of water. This action probably upset the buffer to main drain differential pressure and caused the high pressure separator to flood ((5) on attached curves. Also note discussion on PDT-2176-1 on Page 4). It is speculated that water out of the high pressure separator flooded the buffer return laminar flow element and gave a false high indication of buffer return flow. The high level in the high pressure separator served to aggravate the water flow into the primary coolant. The major portion of water ingress, occurred on 1C circulator, during operation with the high pressure separator flooded; however, water was flowing up the shaft of both 1C and 1D circulators as indicated by the negative buffer-mid-buffer differential pressure.

This condition existed for thirty five minutes at which time the operators manually tripped and isolated 1C circulator ((6) on the attached curves). The curves for 1D circulator are similar to 1C except the high pressure separator level remained near normal so the circulator was allowed to continue to self-turbine.

The failure mode of PDV-2367-1 will be changed to fail closed on loss of controller power or instrument air.
