ABNORMAL OCCURRENCE 76/02A

FORT ST. VRAIN NUCLEAR GENERATING STATION
PUBLIC SERVICE COMPANY OF COLORADO
P. O. BOX 361
PLATTEVILLE, COLORADO 80651

REPORT NO. 50-267/76/02A

Supplement

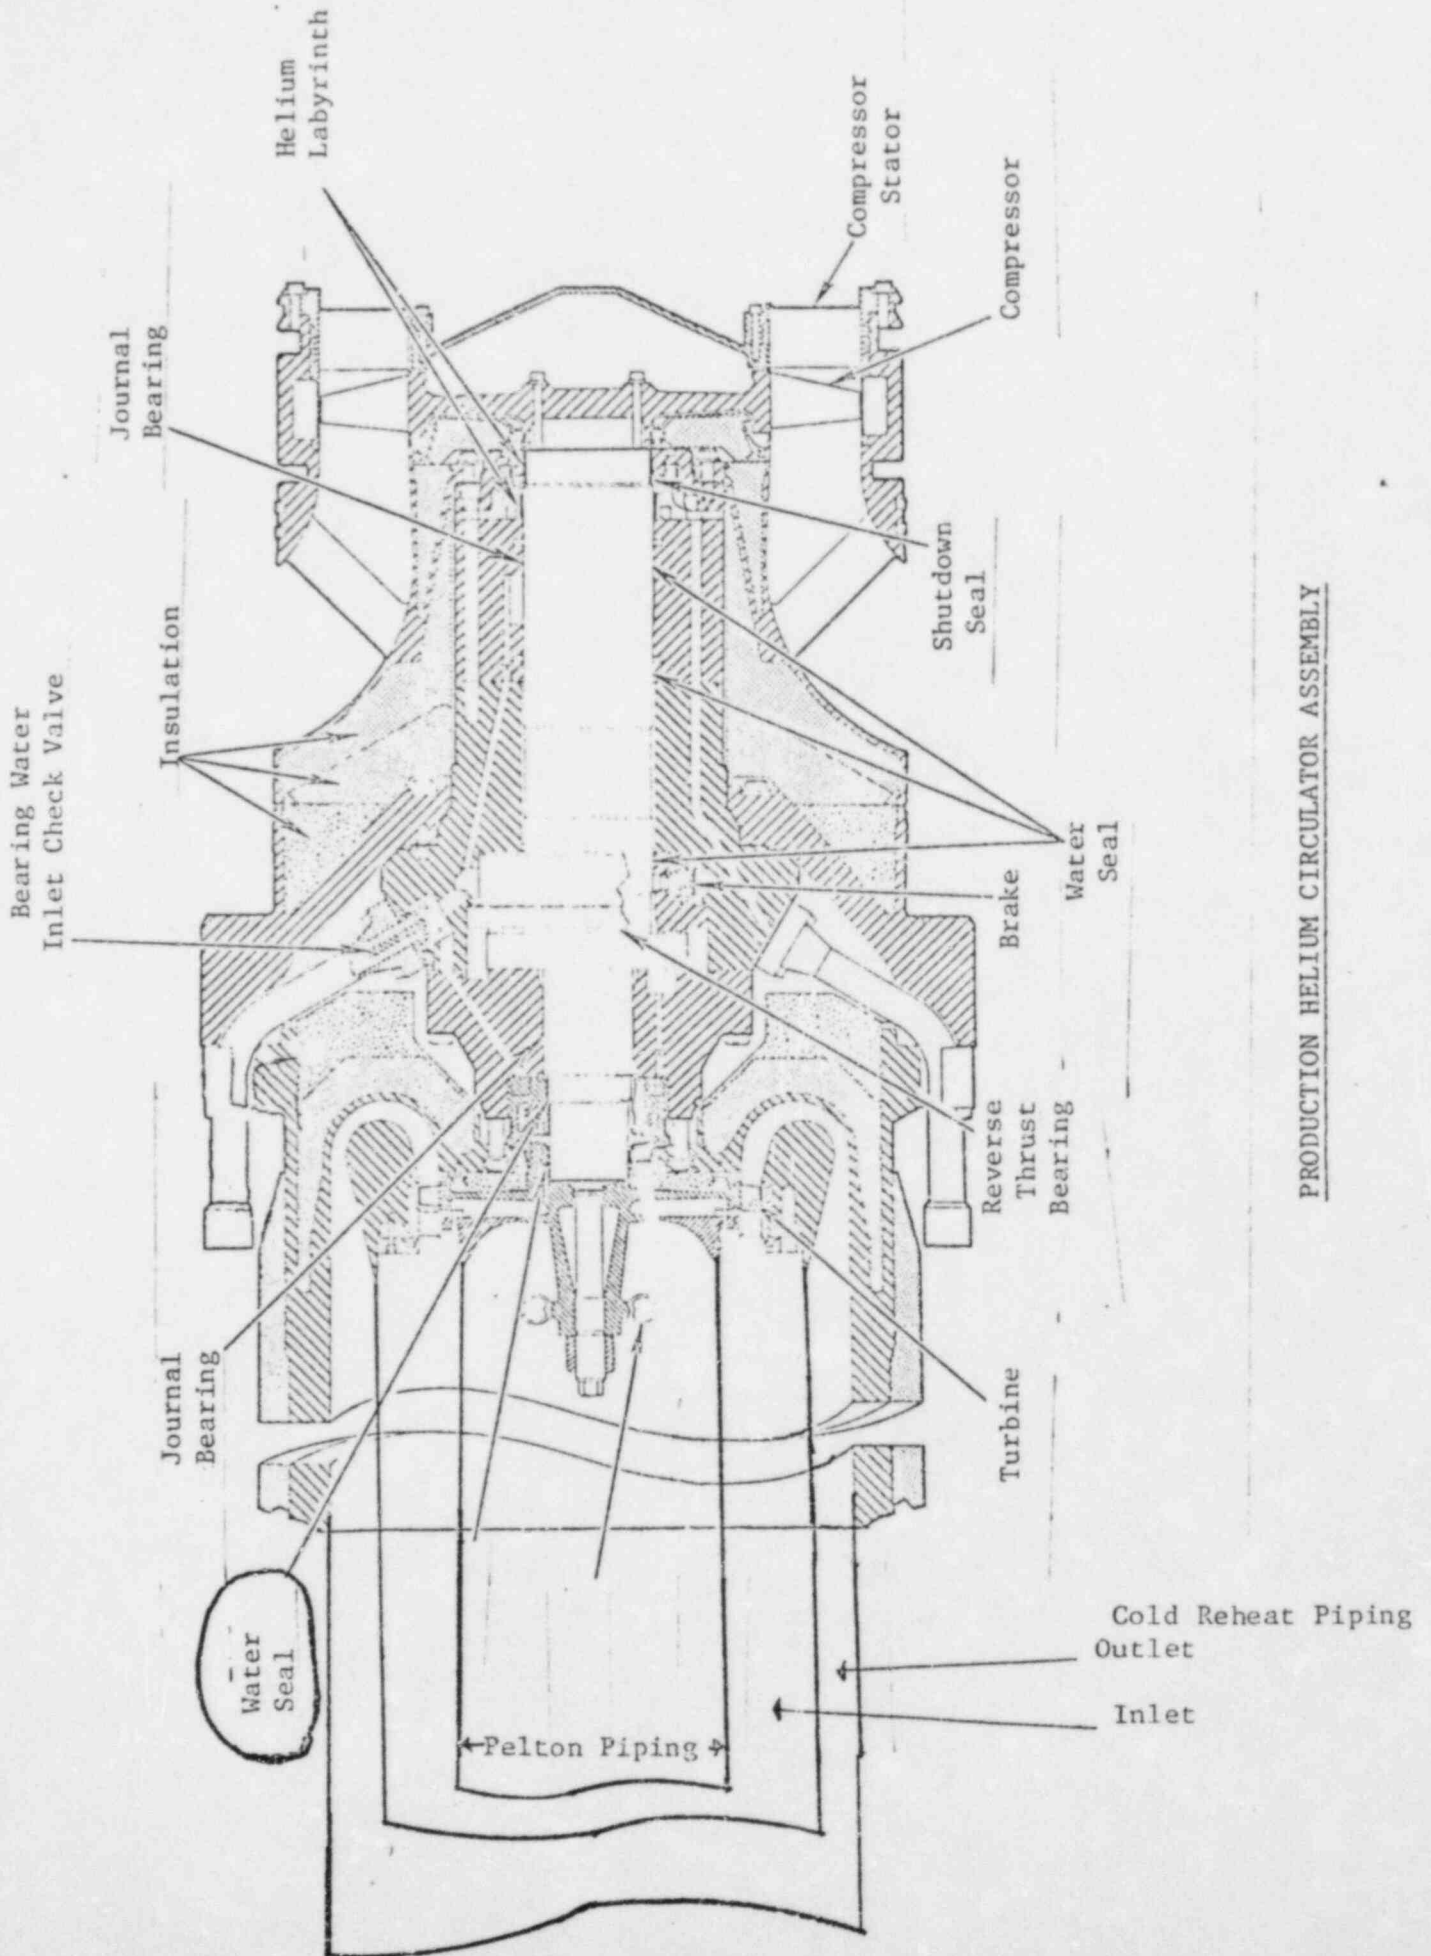
PRODUCTION HELIUM CIRCULATOR ASSEMBLY

Incidents of the circulator speed reduction, due to water accumulation in the steam turbine scroll case, have occurred during normal operating conditions with either feedwater or condensate driving the Pelton wheels.

Reference attached helium circulator drawing. Bearing water flows down the circulator shaft and forms the lower water seal. This water then flows past the steam labyrinth and into the steam turbine scroll case, and the cold reheat piping. The water in the cold reheat piping does not drain out of the piping traps. These traps are designed for steam operation and do not allow water flow equal to the water flow to the piping. Eventually the piping fills with water and submerges the steam turbine. The submerged turbine increases the circulator drag and reduces speed. When the trap bypass valves are opened the water flows out of the piping and circulator speed returns to normal.

The problem of steam turbine flooding is being investigated. Test, T-22, has been approved to determine whether the steam traps are performing the desired function while operating the circulators on Pelton drive. Per agreement with Region IV, Inspection and Enforcement, no further incidents of steam turbine flooding will be reported until the problem has been resolved.
