**Southern California Edison Company**

Subject: Docket No. 50-361  
Voluntary Report  
Licensee Event Report No. 95-003  
San Onofre Nuclear Generating Station, Unit 2

LICENSEE EVENT REPORT (LER)

Facility Name (1) SAN ONOFRE NUCLEAR GENERATING STATION, UNIT 2										Docket Number (2) 0   5   0   0   0   3   6   1   1   of   0   7				Page (3) 1 of 0 7				
Title (4) UNIT 2 LOW PRESSURE TURBINE ROTOR CRACKING																		
EVENT DATE (5)			LER NUMBER (6)				REPORT DATE (7)			OTHER FACILITIES INVOLVED (8)								
Month	Day	Year	Year	///	Sequential Number	///	Revision Number	Month	Day	Year	Facility Names			Docket Number(s)				
0	2	2	5	9	5	9	5	0	6	2	NONE							
OPERATING MODE (9)			THIS REPORT IS SUBMITTED PURSUANT TO THE REQUIREMENTS OF 10CFR (Check one or more of the following) (11)															
POWER LEVEL (10) 0   0   0			20.402(b)				20.405(c)				50.73(a)(2)(iv)				73.71(b)

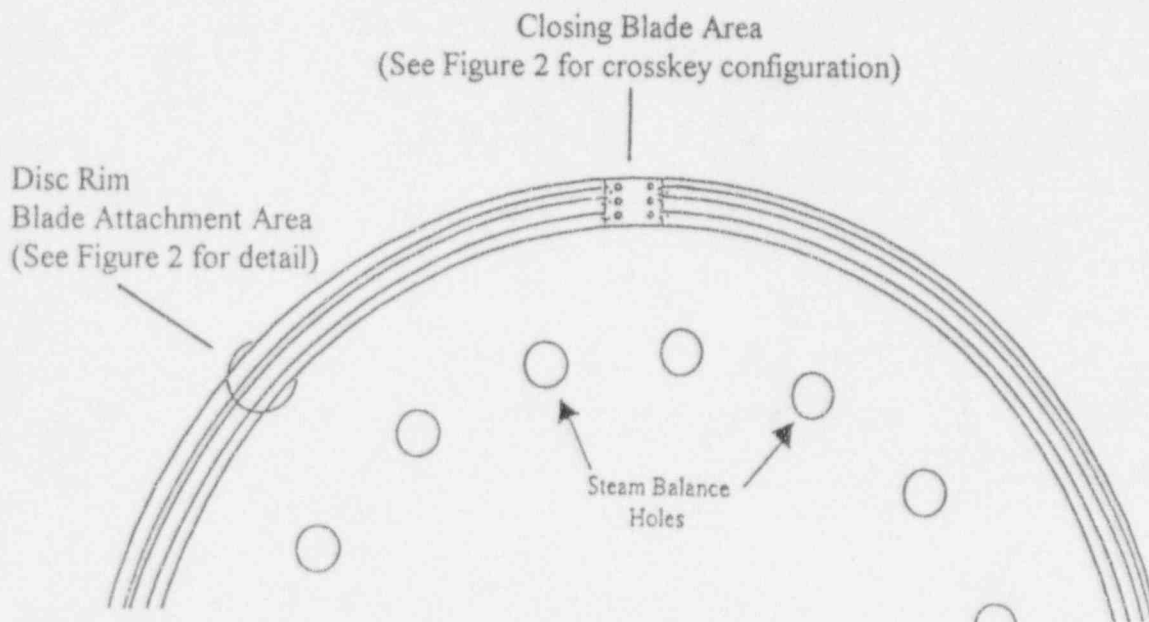
FOURTH STAGE DISC

Each of the stage 4 discs has 17 equally-spaced steam balance holes. Cracks were found emanating from some of the steam balance holes in the stage 4 discs extending radially toward the disc rim and hub. A larger number of cracks were found on the discs in LP1. In addition, less significant cracking was identified in some of the stage 5 steam balance holes.

Edison determined the likely cause of the Unit 2 LP turbine cracking to be SCC; however, the formal root cause analysis has not been issued. The cracks were primarily centered around higher stress locations in the stage 4 discs. The fourth stage is the first stage where the quality of the steam is below the Wilson line (the point at which superheated steam becomes saturated steam). The cracks appear to be typical of SCC found in turbines manufactured with the "shrink-fit" process as evidenced by industry experience. Detailed analysis of the fracture surface at the closing blade area of one disc revealed intergranular branching SCC. Surface analysis of the steam balance hole cracking revealed branching cracking associated with pitting typical of SCC.

Cracks in steam balance holes were removed by excavation and/or machining. In most cases, cracks were first removed by local milling until they were completely excavated as indicated by MT examination. The holes were then machined to circular shape for the least stressed configuration. When cracks were shallow and did not extend the entire width of the disc, a combination of machining and/or excavation was used to remove these cracks. The surfaces of all steam balance holes were also shot peened.

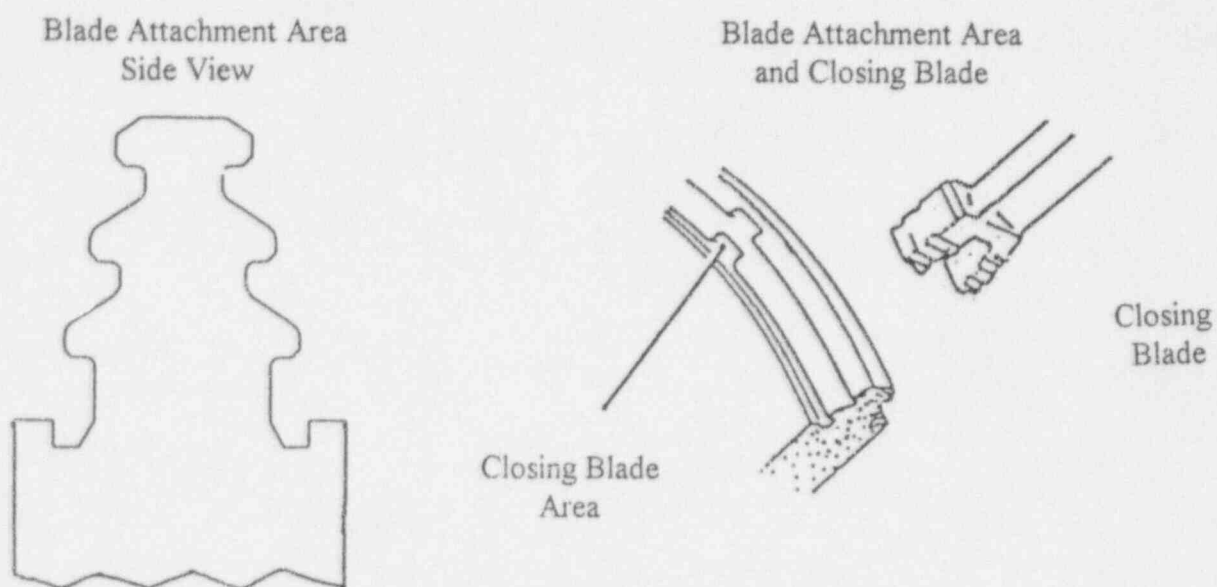
DISC RIM BLADE ATTACHMENT AREA DETAIL

Cracking was discovered in some of the stage 4 discs of LP1, LP2, and LP3 in the disc rim blade attachment area. The cracks extended in the tangential direction of the disc. In addition, some very minor cracks were identified in the stage 7 blade attachment area.

All cracks found in the disc rim blade attachment area were removed by excavation. The surface material was removed until MT examination confirmed the cracks had been completely removed. After repairs, all root surface areas were shot peened. Crosskeys (see attached figure) were used to attach adjacent blades at some locations to allow some blade load to be shared by adjacent blades.

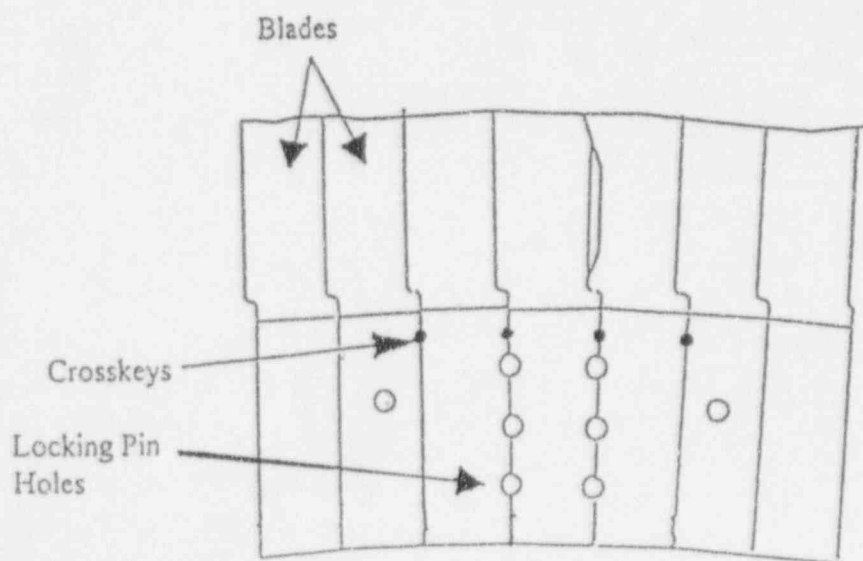
CLOSING BLADE CROSS KEY CONFIGURATION

The closing blade on the LP turbine is attached to the stage 1-6 discs by a set of locking pins inserted through the base of the blade (blade root) and the disc rim parallel to the axis of the rotor. Cracking was found in the closing blade locking pin hole area on the LP3 stage 4 front disc. Cracks were found extending between the pin holes, and from the outermost (top) hole to the rim of the disc. Cracks were also found extending from the innermost (bottom) hole in the radial direction toward the disc hub. In addition, minor cracks were identified in the pin holes on other LP rotor stage 4 discs.

The significant cracks in the disc rim closing blade pin holes were removed by excavation followed by shot peening. The disc rim pin holes were also enlarged to eliminate interference between the mating pin and disc rim pin hole surface. In addition, crosskeys were added in the blade root of the locking blade and two adjacent blades (total of four pins interconnecting five blades). This was done to transfer the load created by the locking blade to the adjacent blades. Thus, the disc rim pin hole no longer carries the loads imposed by the locking blade.
