UNUSUAL EVENT 75/16
Page 1 of 4

FORT ST. VRAIN NUCLEAR GENERATING STATION
PUBLIC SERVICE COMPANY OF COLORADO
P. O. BOX 361
PLATTEVILLE, COLORADO 80651

REPORT NO. 50-267/75/16

Apparent failure of control system for "C" circulator high pressure separator resulted in flooding of the high pressure separator.

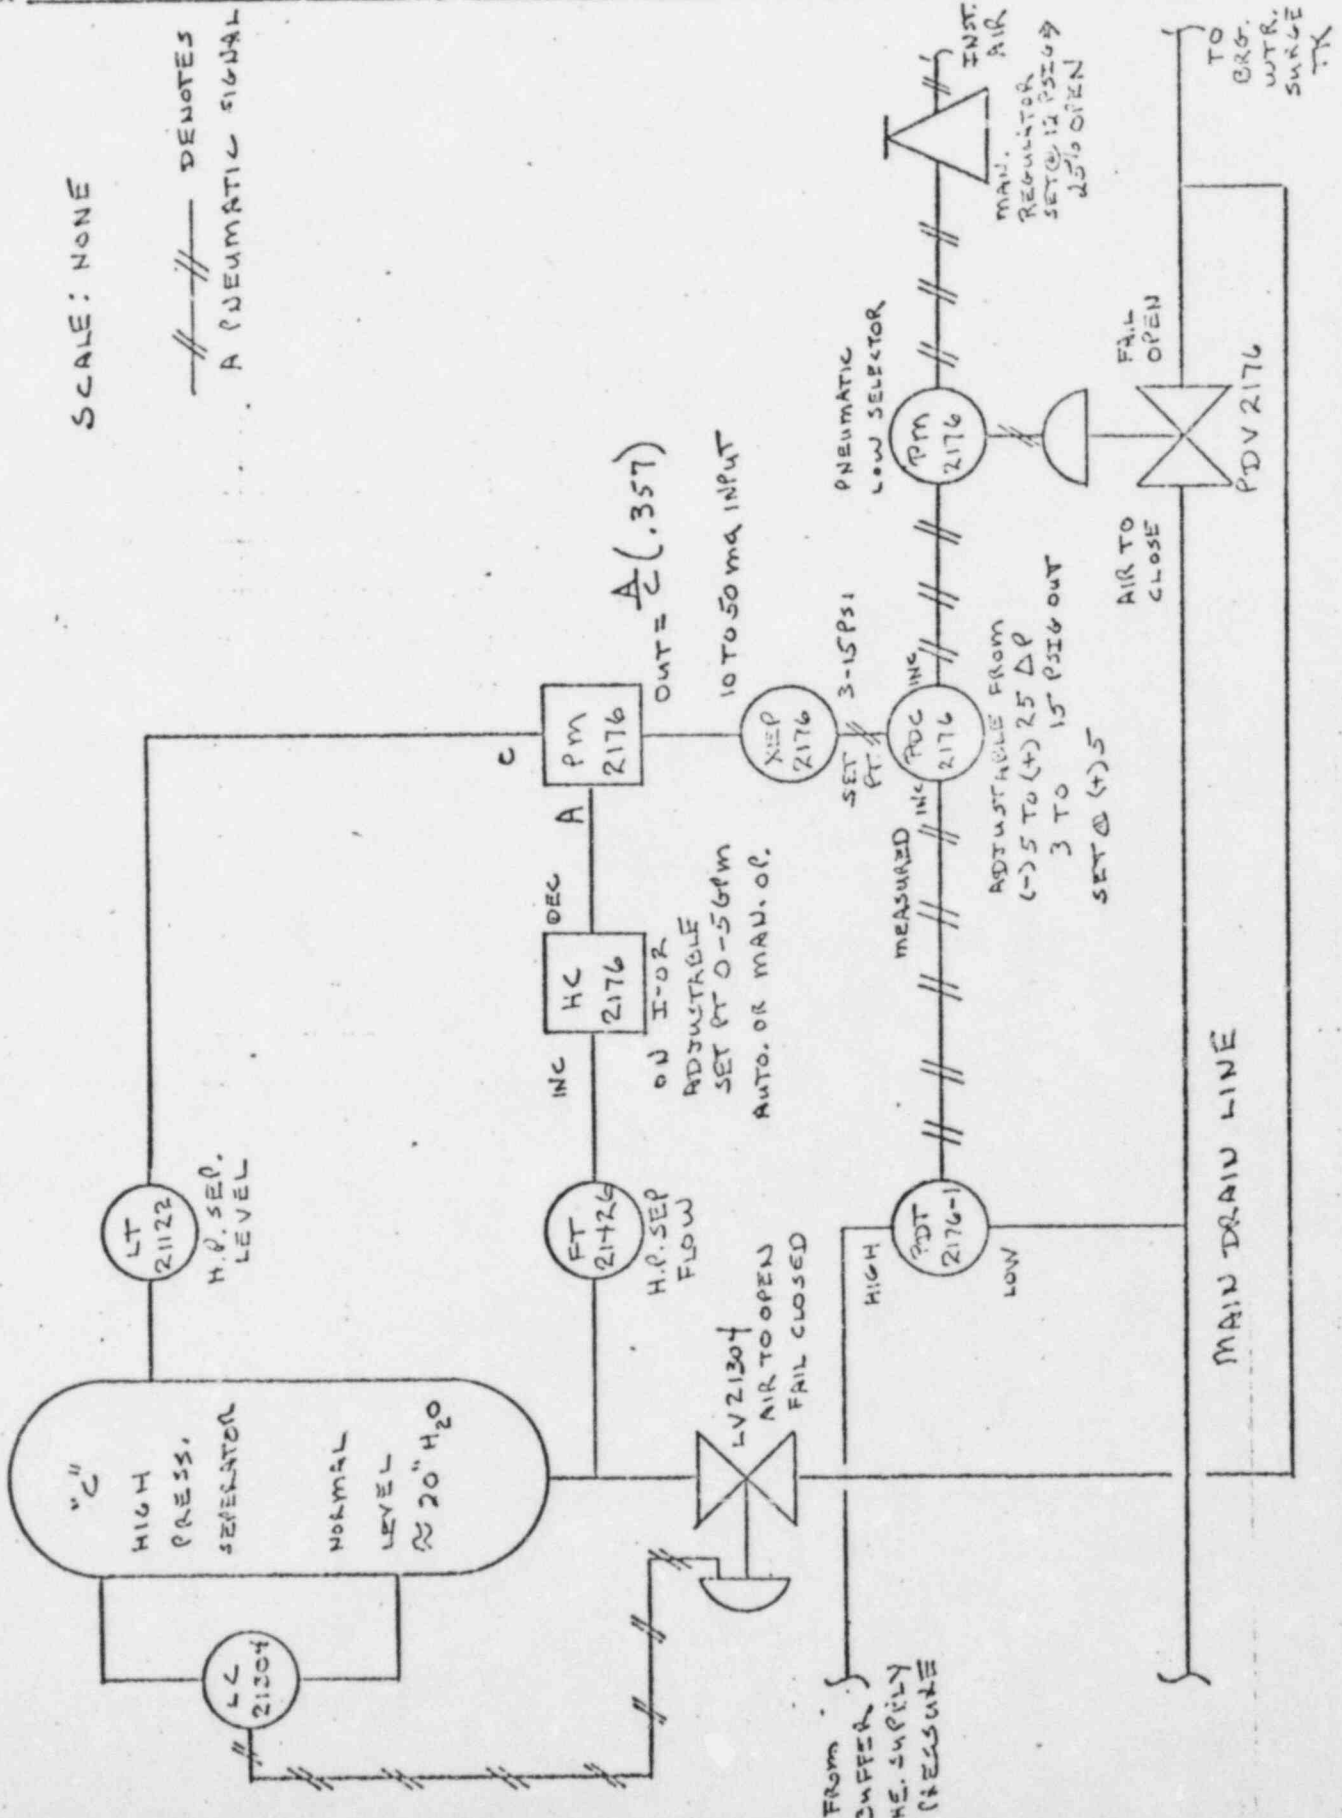
Results Department personnel reported to the control room and found the reactor operator had placed HC-2176 ("C" circulator main drain valve controller) in manual and to the full open position. (See attached drawing for schematic of controls.)

It was first believed that a control offset signal was generated by a failure of the pneumatic low selector. A manual regulator in the system, set at 12 psig (equivalent to a 25% open position on PDV-2176) supplies an input to the low selector to prevent the main drain valve from going beyond 75% shut. However, no failures could be found to support this supposition.

Analysis indicated that the high pressure separator flooding probably occurred during the manual stroking of PDV-2176 with the "C" circulator operating at 4,000 rpm. The valve was stroked after repairs were made on the broken air line to the XEP. Although PDV-2176 is a fail-open valve, a control signal offset could have caused the valve to fail shut. This could cause the high pressure separator to flood.

The low selector was removed, disassembled, inspected, and cleaned since failure of this component could be the only way PDV-2176 could have shut. No problems of any kind were found with the pneumatic low selector. The main drain control system and valve were completely checked out and operated under simulated conditions for all inputs. The system operated correctly as designed. LV-21304, high pressure separator drain valve, was observed to be operating properly.
