UNUSUAL EVENT 75/19

FORT ST. VRAIN NUCLEAR GENERATING STATION  
PUBLIC SERVICE COMPANY OF COLORADO  
P. O. BOX 361  
PLATTEVILLE, COLORADO 80651

REPORT NO. 50-267/75/19

A spare control and orifice assembly had been modified by addition of new seals to reduce helium bypass flow. When an attempt was made to install the assembly in the core, the assembly was hindered in the refueling penetration, preventing installation.

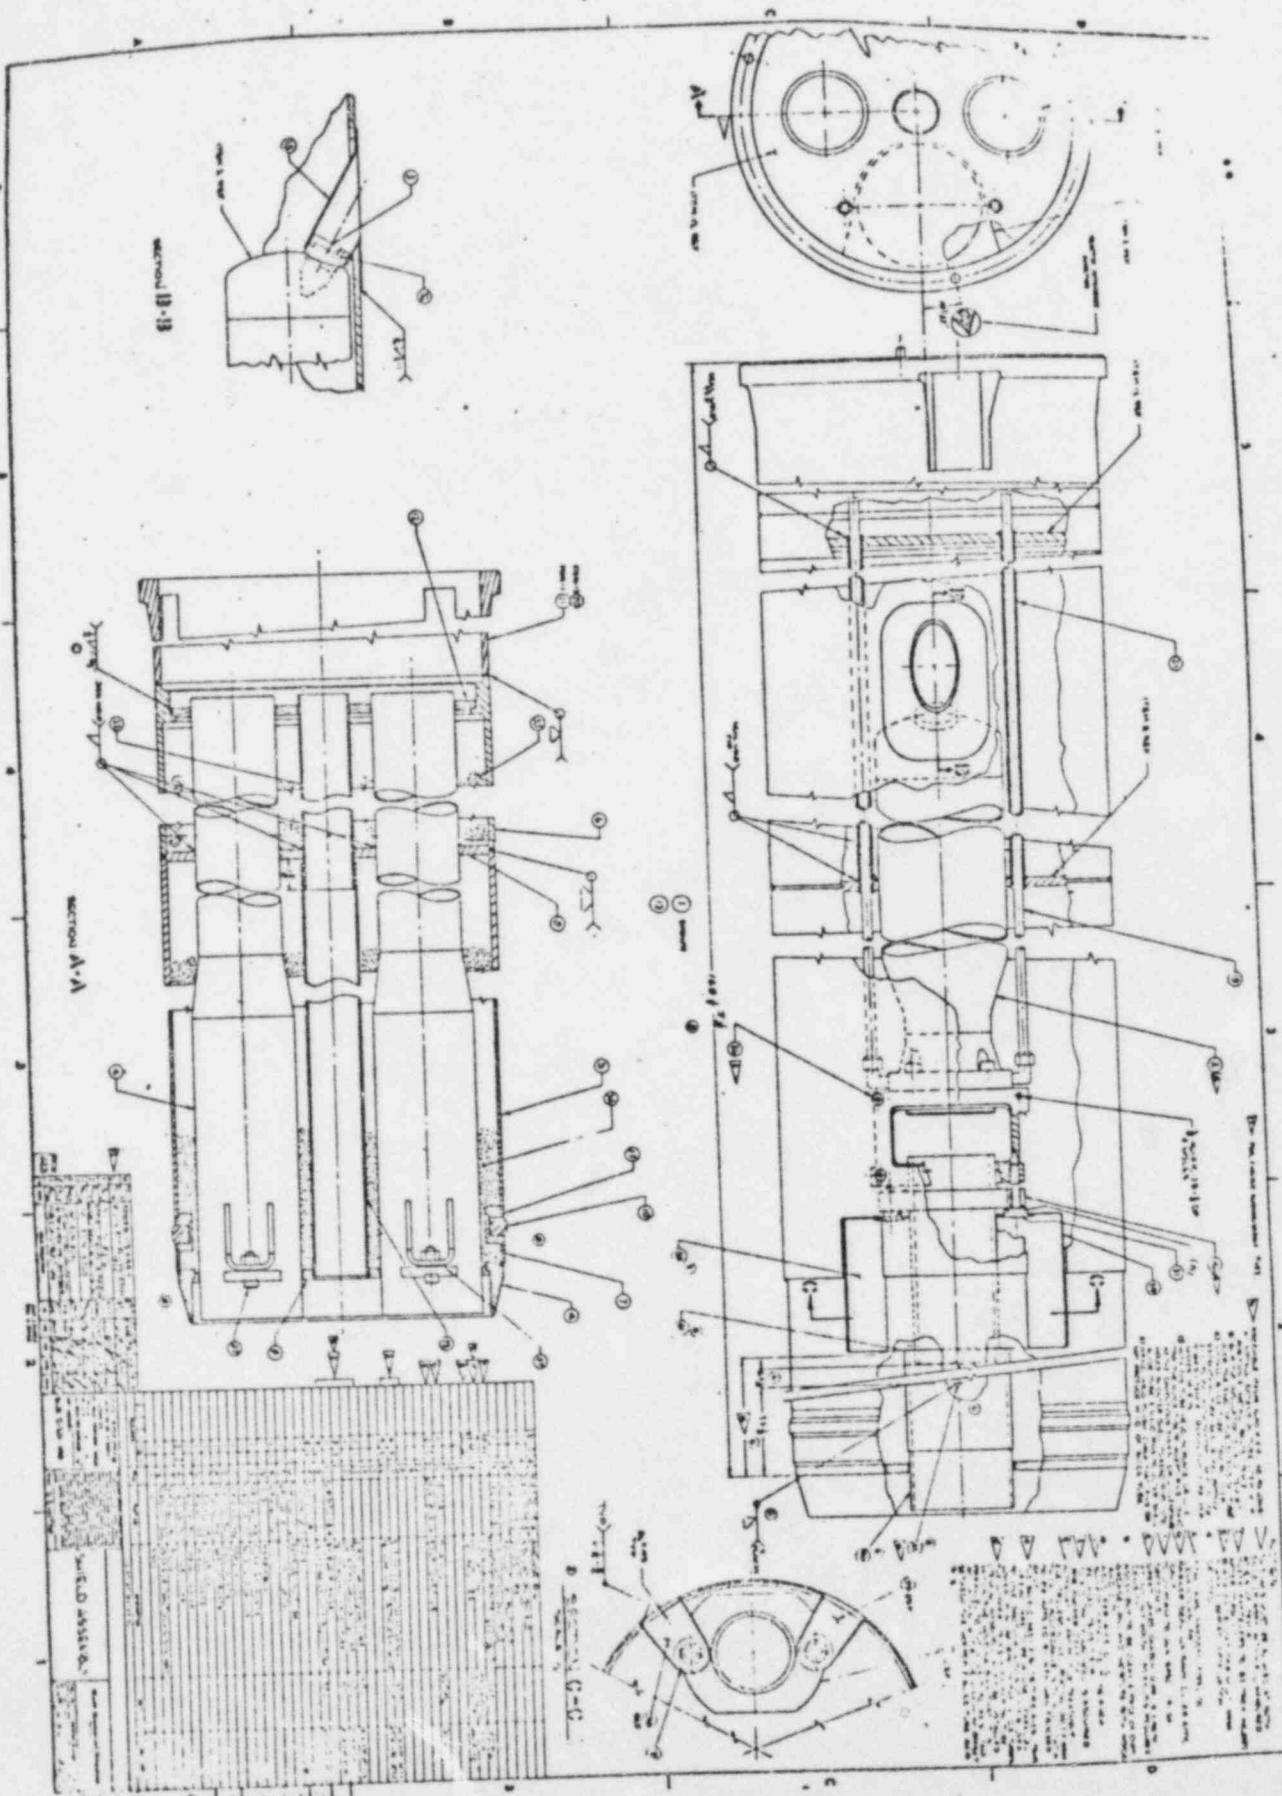
When the control and orifice assembly was placed in a work stand for inspection it was found that the new seal ring (10 on drawing SLR D1201-700, attached) showed signs of rubbing over almost its entire periphery. This indicated that the ring had been fully compressed during installation of the assembly and had been the cause of the observed weight decrease when the seal ring began to bind in the refueling penetration. The apparent cause of the occurrence is therefore a seal ring slightly larger in outside diameter than the inside diameter of the refueling penetration.

A dimensional check of the seal ring was made and the outside diameter of the ring was found to be 17.980 inches. A check of dimensions at the seal ring area where the penetration necks down and joins the cavity liner revealed that the penetration is slightly elliptical with a maximum diameter of 18.070 inches and a minimum diameter of 17.968 inches. The diameter of the penetration at the elevation where the seal ring was binding is believed to be of the same order.

The specified design size of the seal ring is  $17.960 +.005, -.000$ . The source of the increase in size over the design value was traced to a nitriding treatment. A total of 5 seal rings have been identified as having been nitrided with the original procedure, which resulted in these rings being slightly oversized. Of these 5 rings, the ring which was on assembly #28 and two others which were on assemblies outside the core at the time of this occurrence have been modified to bring them back within design tolerance. The remaining 2 rings are part of modified assemblies which had been successfully installed in the core before the problem occurred.

The seal ring on assembly #28 which caused the binding was removed and replaced with a new ring. The outside diameter of the new ring was 17.968\* inches. The assembly was reinstalled in region 21 with no indication of binding observed during installation.

The nitriding treatment has been modified to maintain seal ring size within tolerance. A check will be made of seal ring size prior to installation on each assembly.
