ABNORMAL OCCURRENCE 75/18A

FORT ST. VRAIN NUCLEAR GENERATING STATION
PUBLIC SERVICE COMPANY OF COLORADO
P. O. BOX 361
PLATTEVILLE, COLORADO 80651

REPORT NO. 50-267/75/18A

Damage to helium circulator during installation preparation.

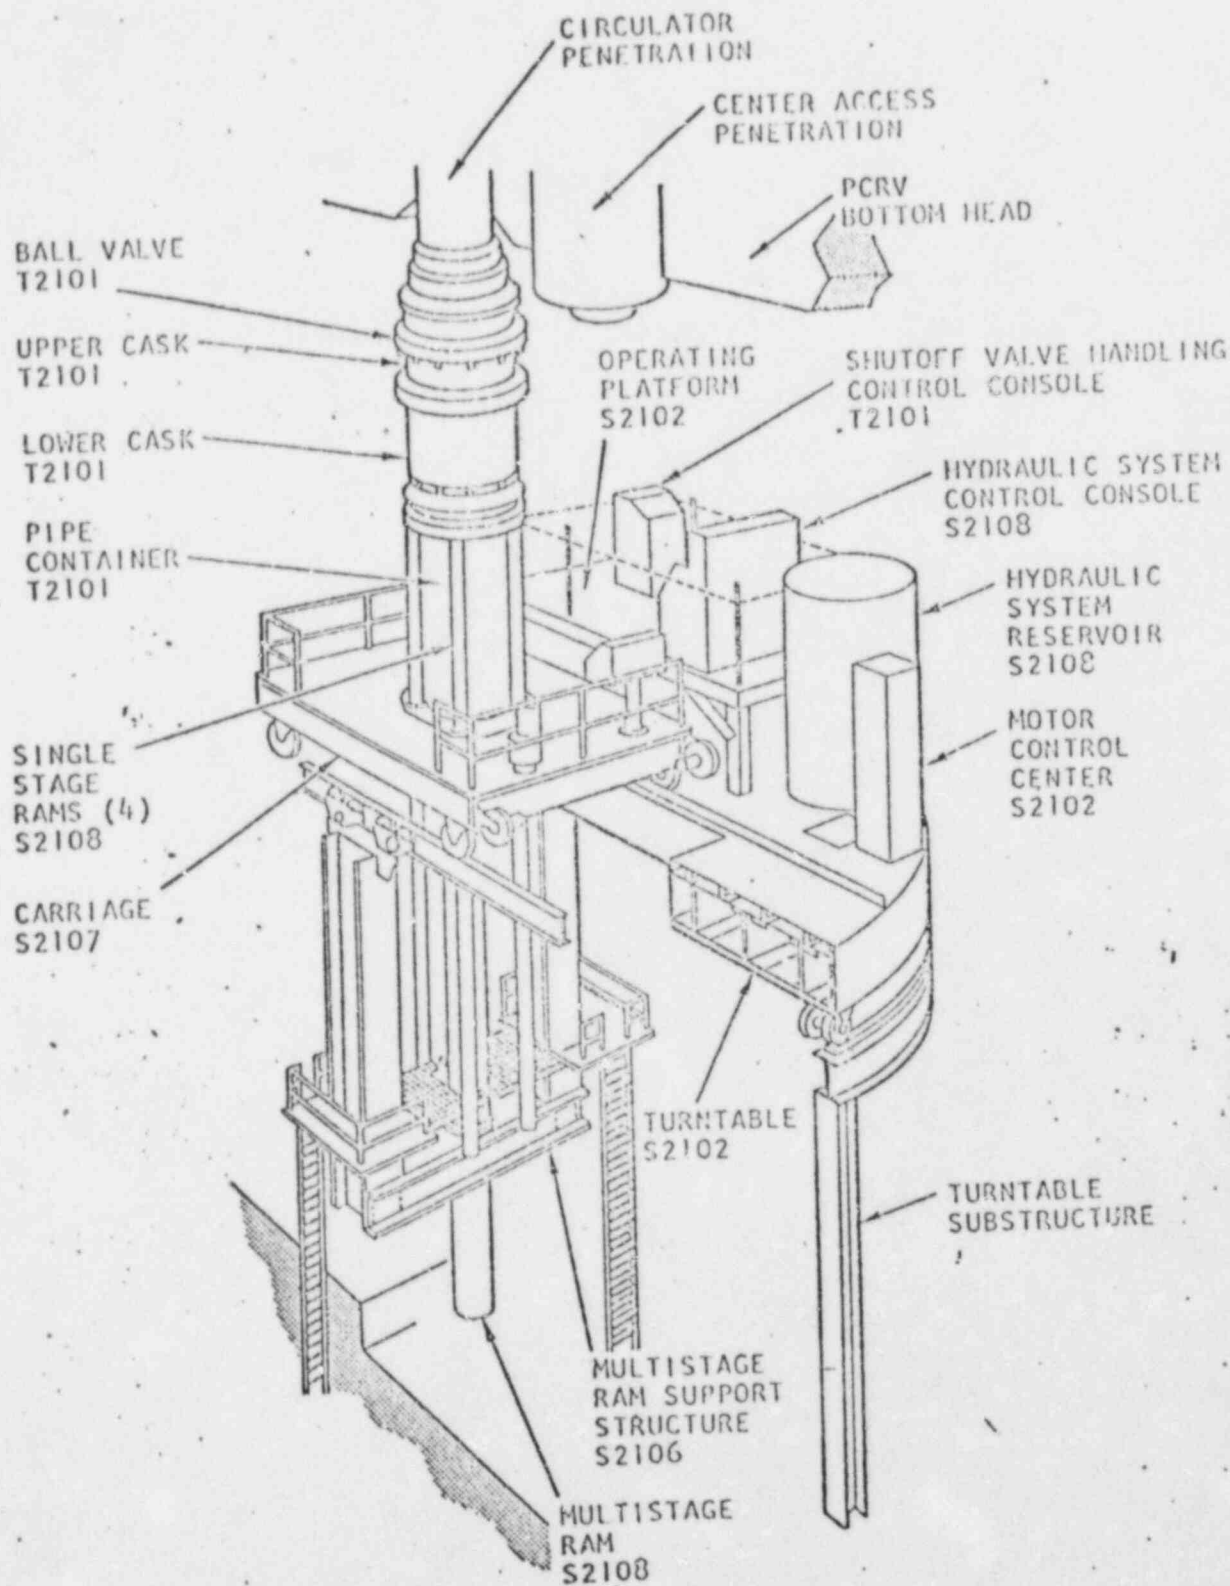
Fig. 1-1. Helium circulator handling equipment

During preparation of helium circulator, S/N C-2101 for installation, into the "B" circulator penetration, damage to the circulator was sustained as the handling cask assembly was lowered while the circulator within the cask was being supported by the multi-stage ram. This action resulted in the transfer of the cask assembly support from the single stage rams to the multi-stage ram through the circulator.

The contact for load transfer occurred between the closed ball valve and the helium circulator. The occurrence was a result of failure to adhere to approve procedures. (See Figures 1.1 and 1A).

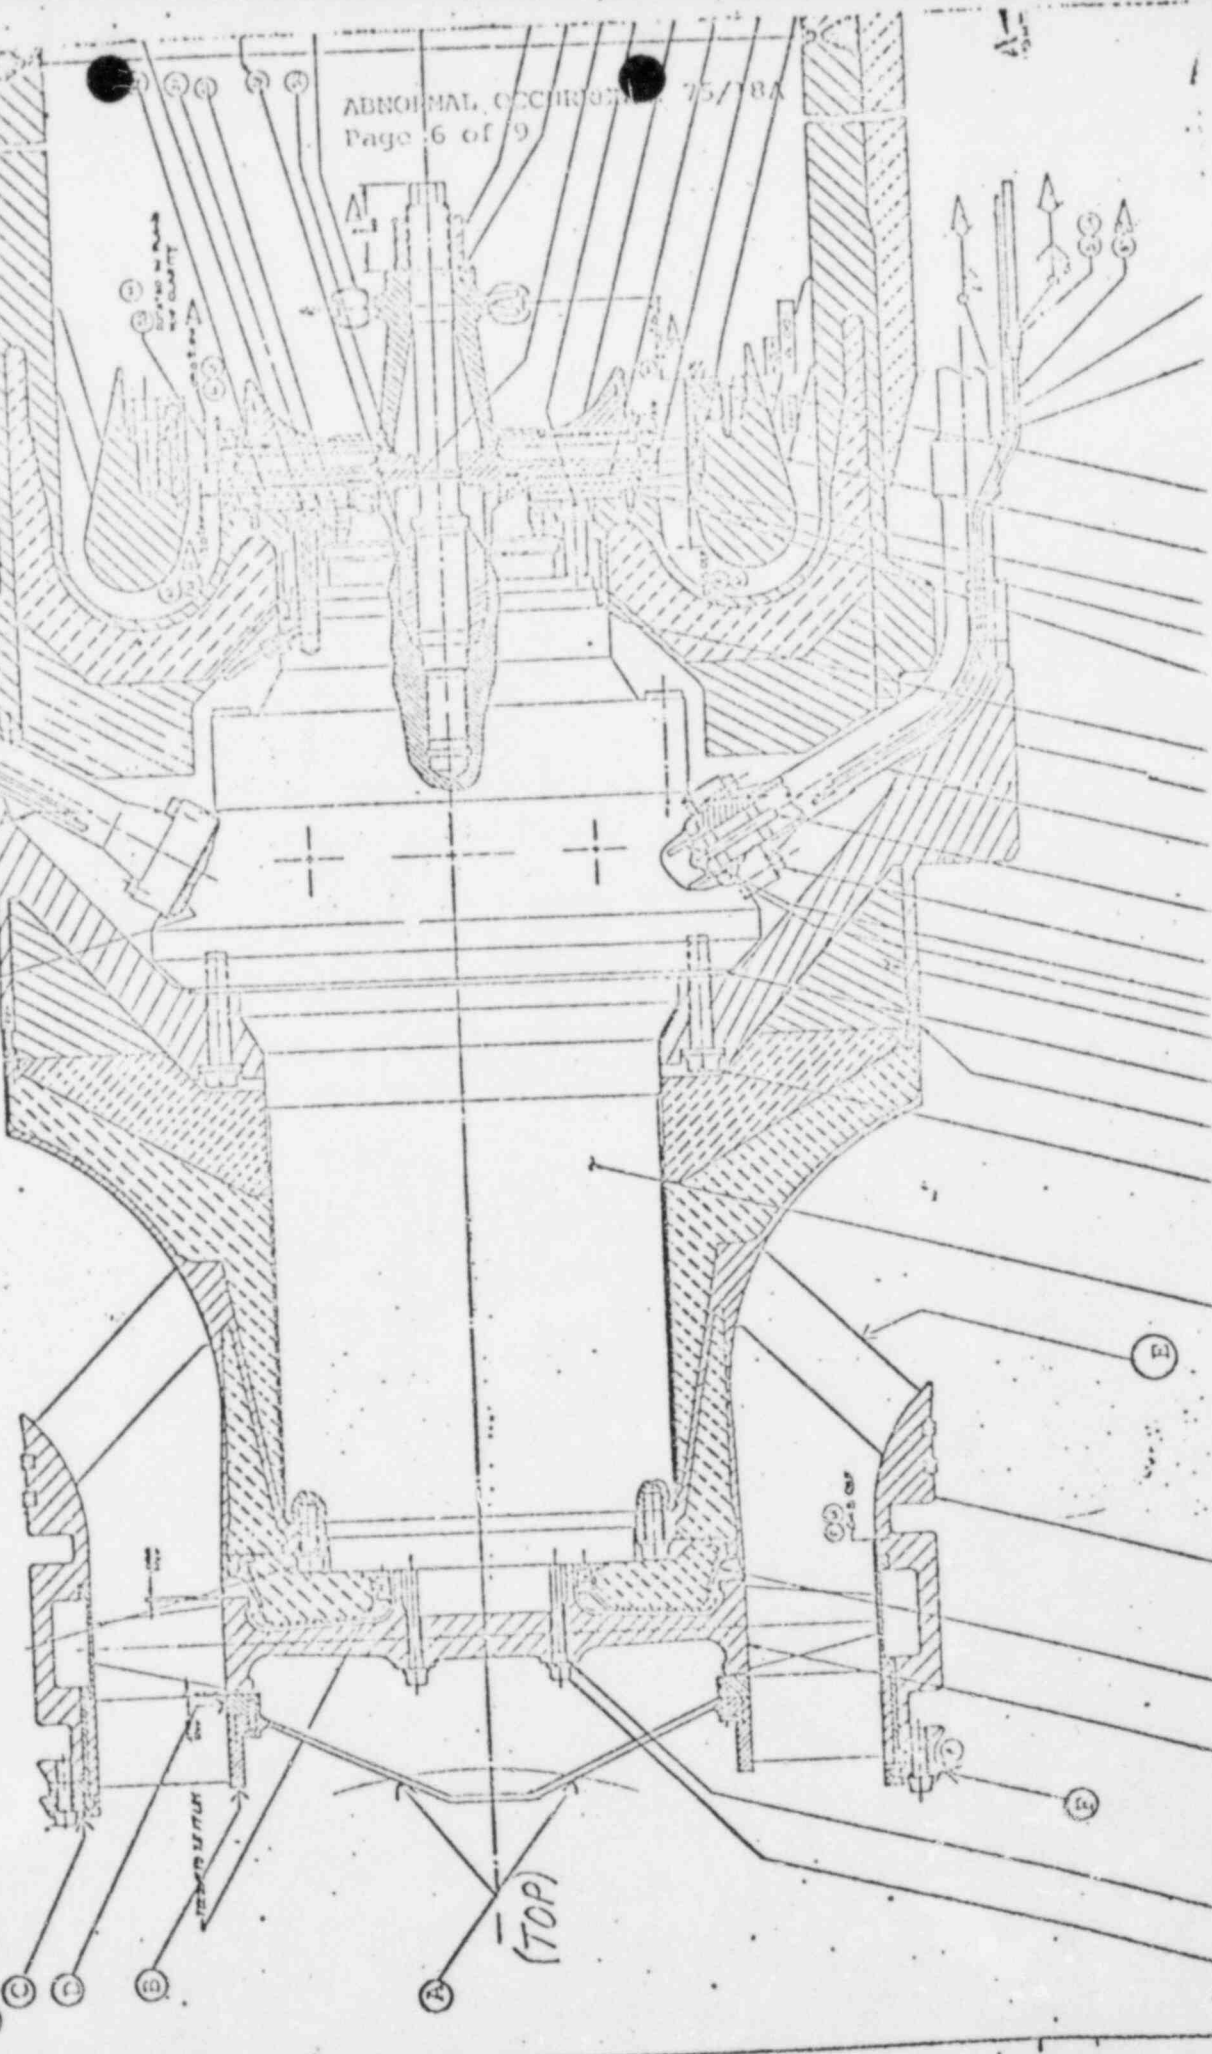
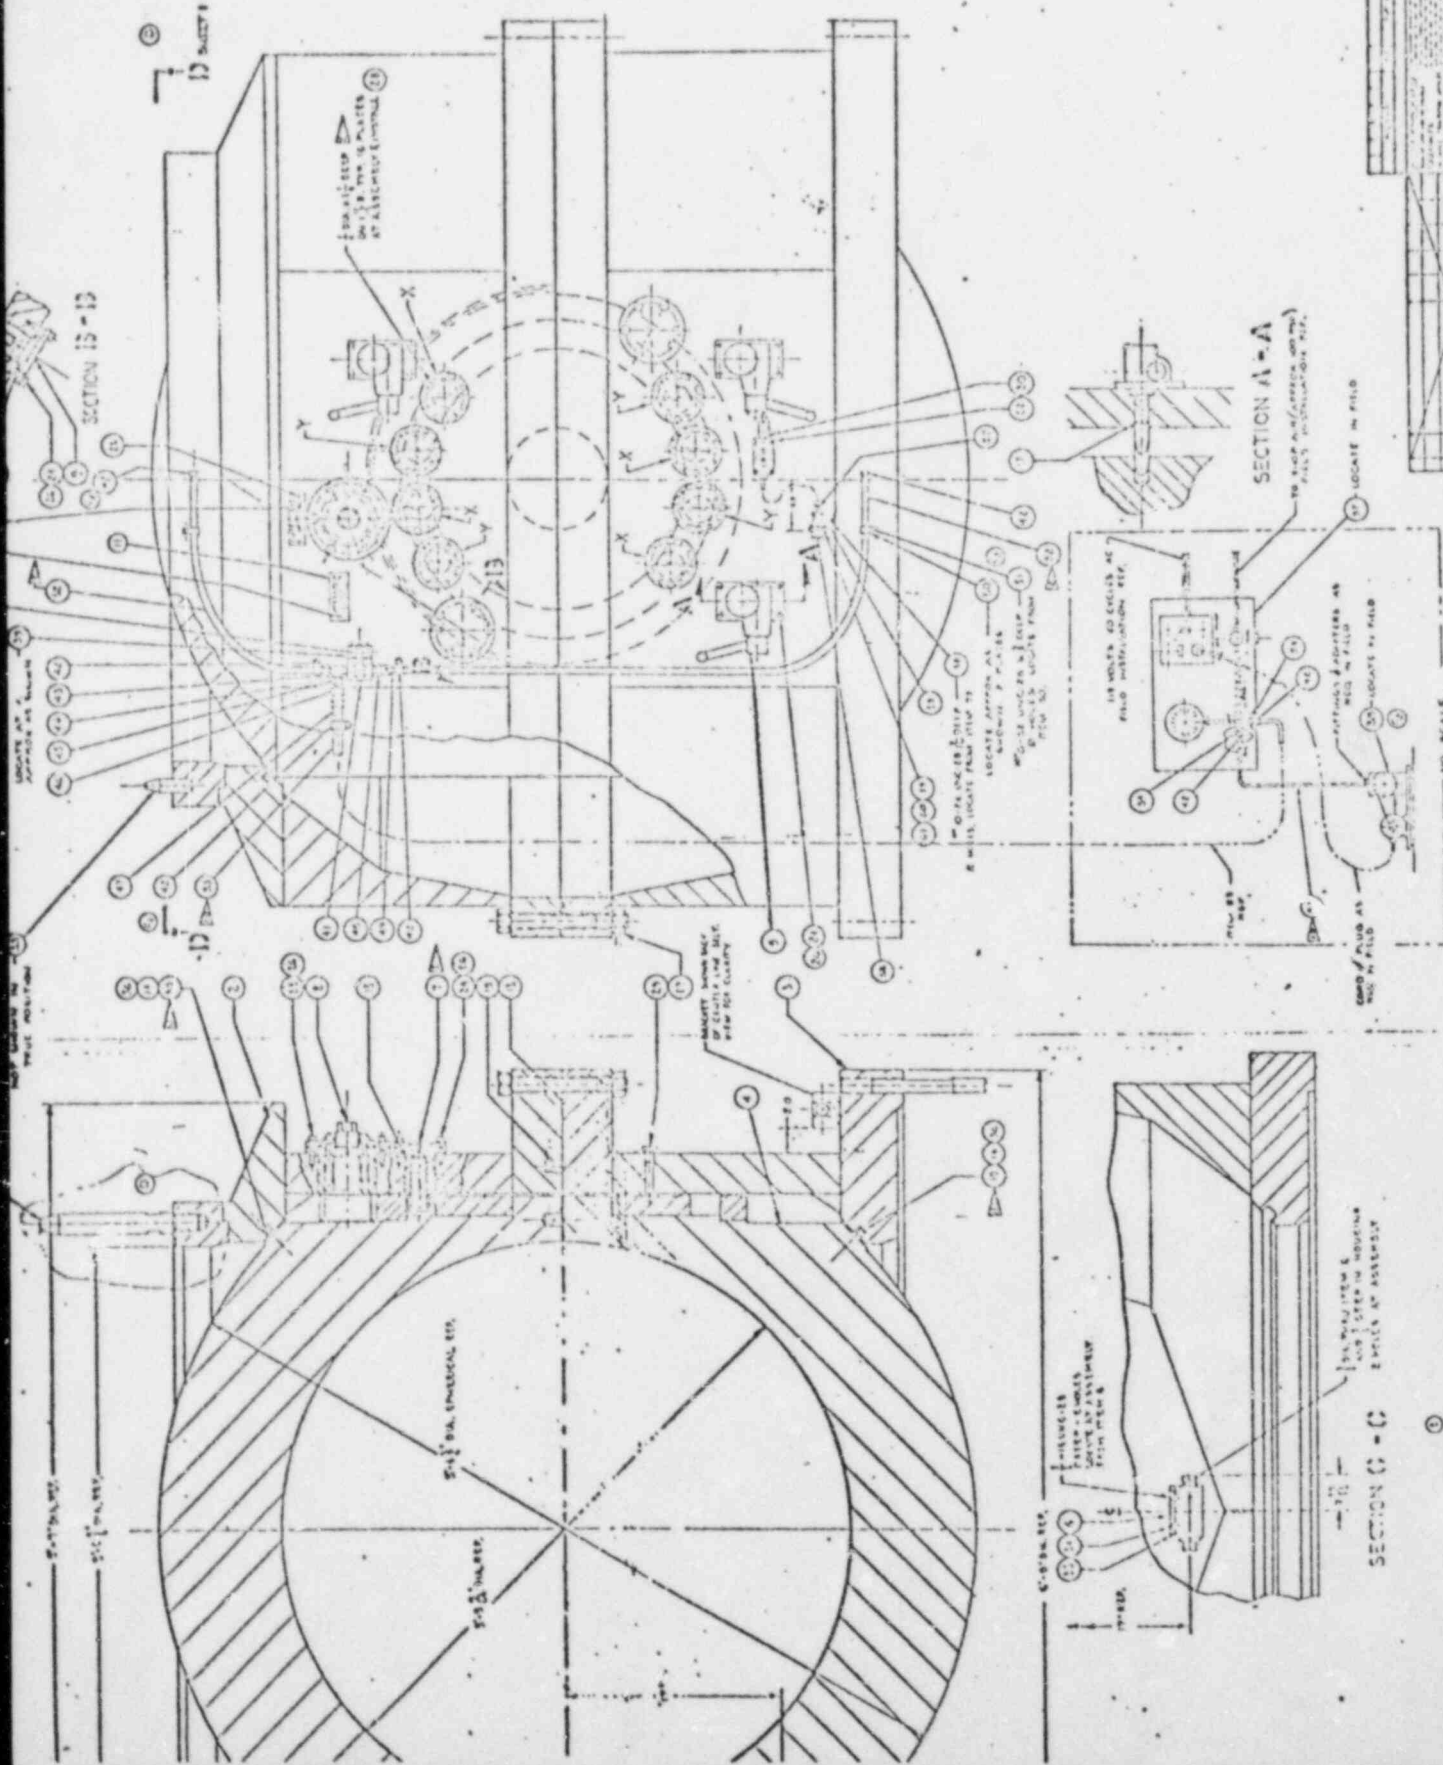
Visual inspection of the circulator showed a depression 2" - 2 1/2" deep in the stator cone (P/N C-2101-380-5) from ball valve contact. The upper rim of the cone also showed contact on its inner diameter with the ball valve as evidenced by paint transfer from the ball valve to the cone. The heaviest contact was indicated in the segment between pin (C-2101-380-7) and the circulator reference mark. The pin also showed light contact. No other damage was detected through visual inspection. Compressor clearance checks revealed an approximate .030 inch deflection of the retaining ring (C-2101-380-6) downward toward the compressor in the segment in which the heaviest contact was noted. This was determined by the compressor upper axial clearance devia-

The welds on the inlet duct struts (C-2101-341-6) which carry duct and stator loads were dye checked for evidence of failure. Four welds showed 1/32 inch linear indications on the weld to strut interface at the strut trailing edges. These indications were burnished out. A recheck with dye penetrant showed that there is no material failure. Cross sectional area reduction through burnishing at the strut to weld interface was less than .001 square inches on any one strut. (See attached drawings).

- A Progression of stator cone
- B P/N C-2101-380-5 End Cone.
- C P/N C-2101-380-7 Dowel pin. Not shown this drawing. In circumferential plane of stator assembly. Replaced with stator assembly.
- D P/N C-2101-380-6 Retraining Ring.
- E P/N C-2101-341-6 Duct Strut (Air Foil).
- F P/N C-2101-380 Compressor Stator Unit Replaced.

Notification has been given to construction management that personnel involved are not to proceed on their own. They shall have approved procedures and proper supervision present to verify adherence to such procedures. Replacement of the index plunger assembly has restored the ball valve. Replacement of the stator assembly and cone has restored S/N C-2101, "B" circulator to full operational capability. The replacement stator and cone assembly utilized were from the circulator removed (S/N C-2105) from the "B" penetration and were inspected and certified by the contractors quality assurance department.
