TENNESSEE VALLEY AUTHORITY
CHATTANOOGA, TENNESSEE
37401

BROWNS FERRY NUCLEAR PLANT UNITS 2 AND 3
HPCI AND RCIC CONTROL LOGIC PROBLEM
INTERIM REPORT

Subject: PIPE BREAK OUTSIDE CONTAINMENT: MAIN STEAMLINE BREAK, NO RCIC,
NO HPCI, NO LOSS OF OFFSITE POWER

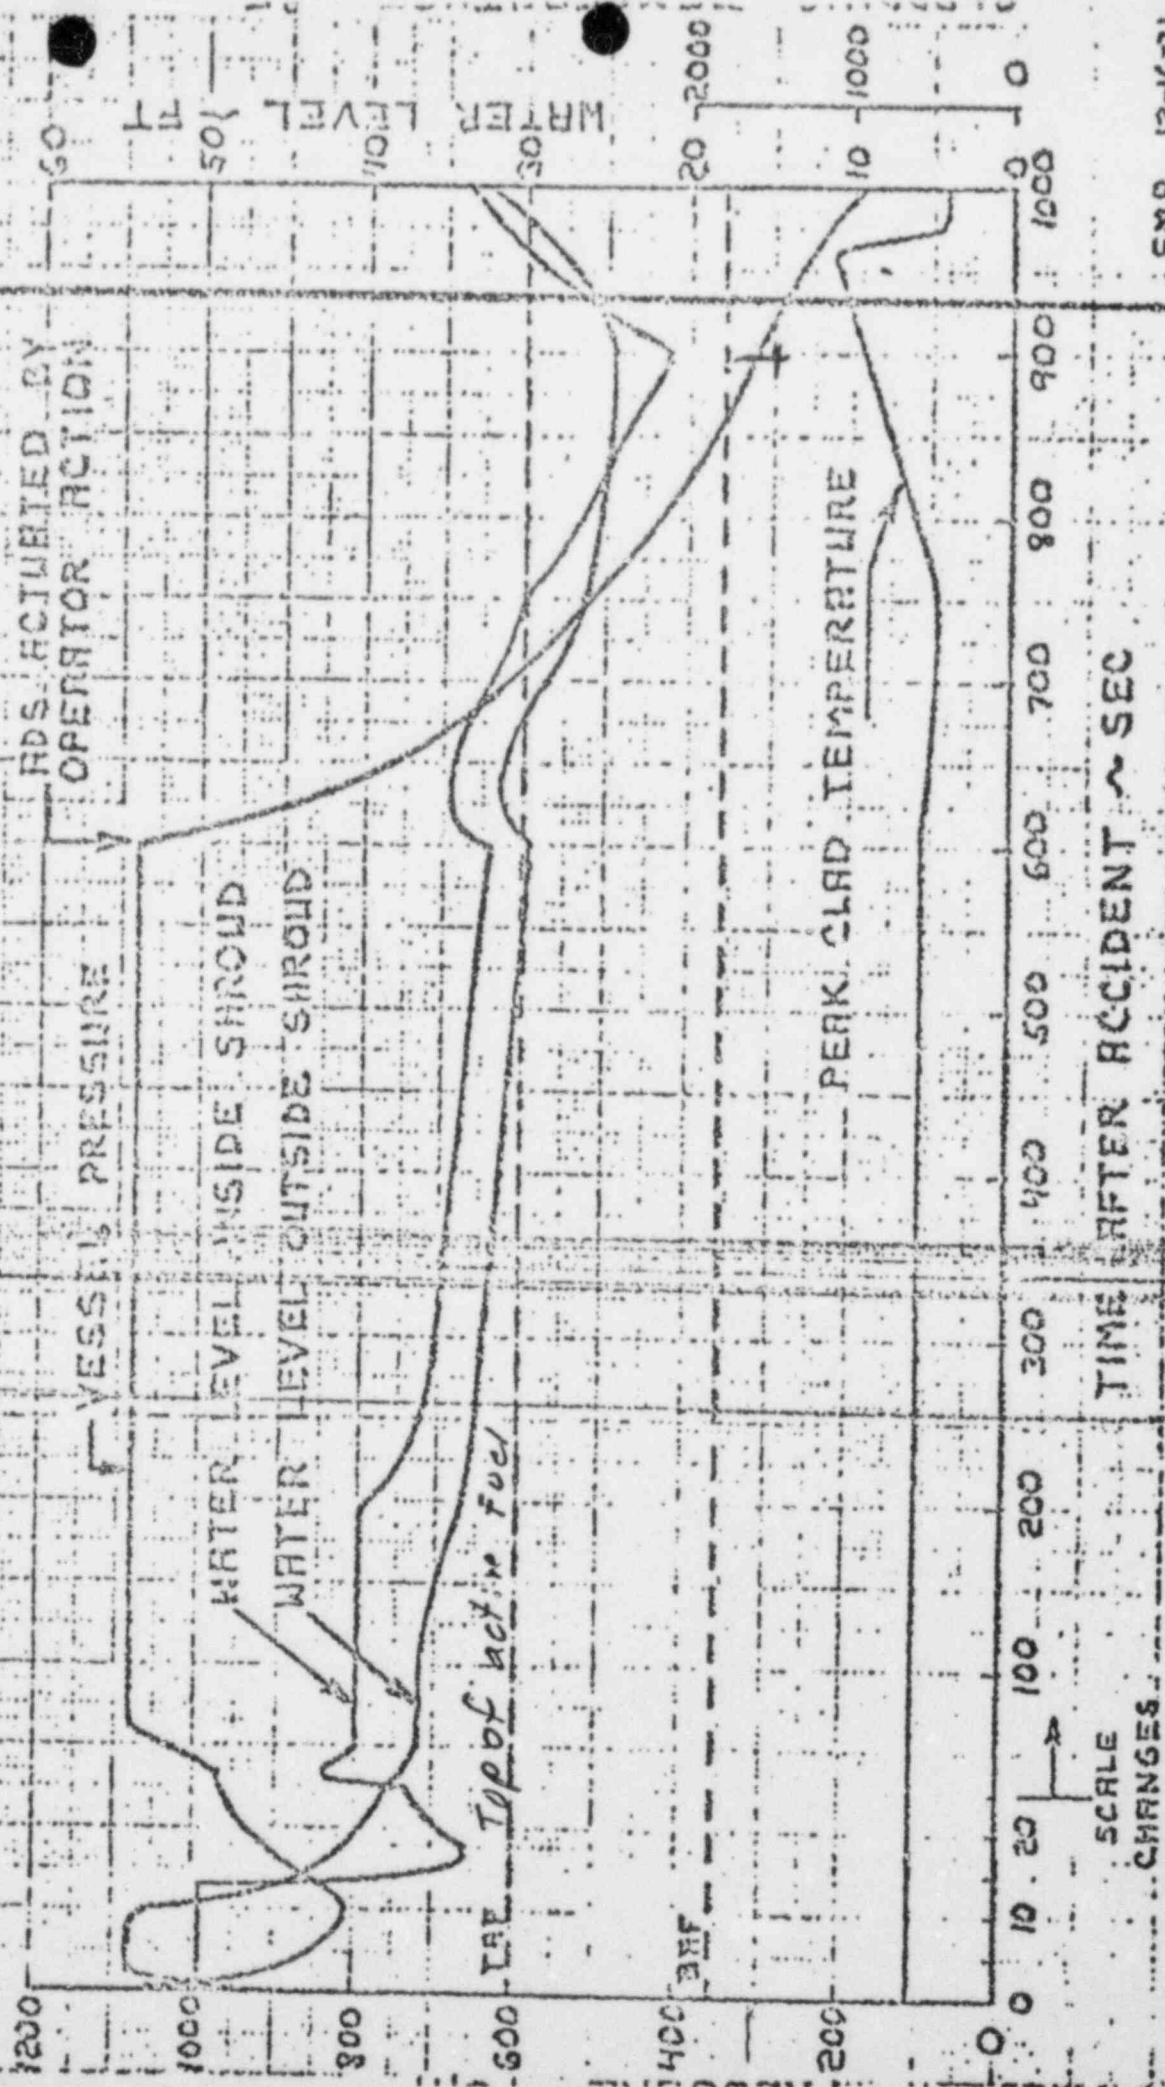
steam line break with no RCIC, no HPCI, and no loss of offsite power. A main steam line break causes closure of the main steam line isolation valves; a loss of offsite power causes isolation of the steam lines by either rapid closure of the steam turbine control valves or by closure of the turbine stop valves. There would be no steam dump with no offsite power. Thus, either situation isolates the steam lines and requires steam relief to the torus. The curves in reference 2 show that the reactor is safe for 10 minutes with no steam flow except through the relief valves and no RCIC or HPCI. The presence or lack of offsite power during this time interval would not affect the results. Note in reference 2 that after 10 minutes the Automatic Depressurization system (ADS) was actuated by operator action. It could also be assumed that, had it been necessary during the present problem, the ADS could have been manually actuated after 10 minutes. Also note in the curves in reference 2 that the vessel pressure did not exceed 1080 psia, the peak clad temperature did not exceed 1200°F, and an adequate vessel water level was maintained.

Design Engineering has reviewed the case of a steamline break outside the containment with no RCIC, no HPCI, no loss of offsite power and drywell coolers operating for a 251-764 '67 product line plant. They have concluded that the peak clad temperature is well below the perforation threshold and no fuel rod failures will occur. Adequate water level is maintained and 10 minutes following the accident the operator is assumed to take action by manually activating the ADS system.

FIGURE 2
SUBSEQUENT AT NUCLEAR POWER STATION 25
STEM LINE CRACK OUTSIDE THE PRIMARY CONTAINMENT
FAILURE OF HPCI
IC POWER AVAILABLE
HDS ACTIVATED BY
OPERATOR ACTION
