# LICENSEE EVENT REPORT

ABNORMAL OCCURRENCE 76-24A

FORT ST. VRAIN NUCLEAR GENERATING STATION  
PUBLIC SERVICE COMPANY OF COLORADO  
P. O. BOX 361  
PLATTEVILLE, COLORADO 80651

REPORT NO. 50-267/76-24A

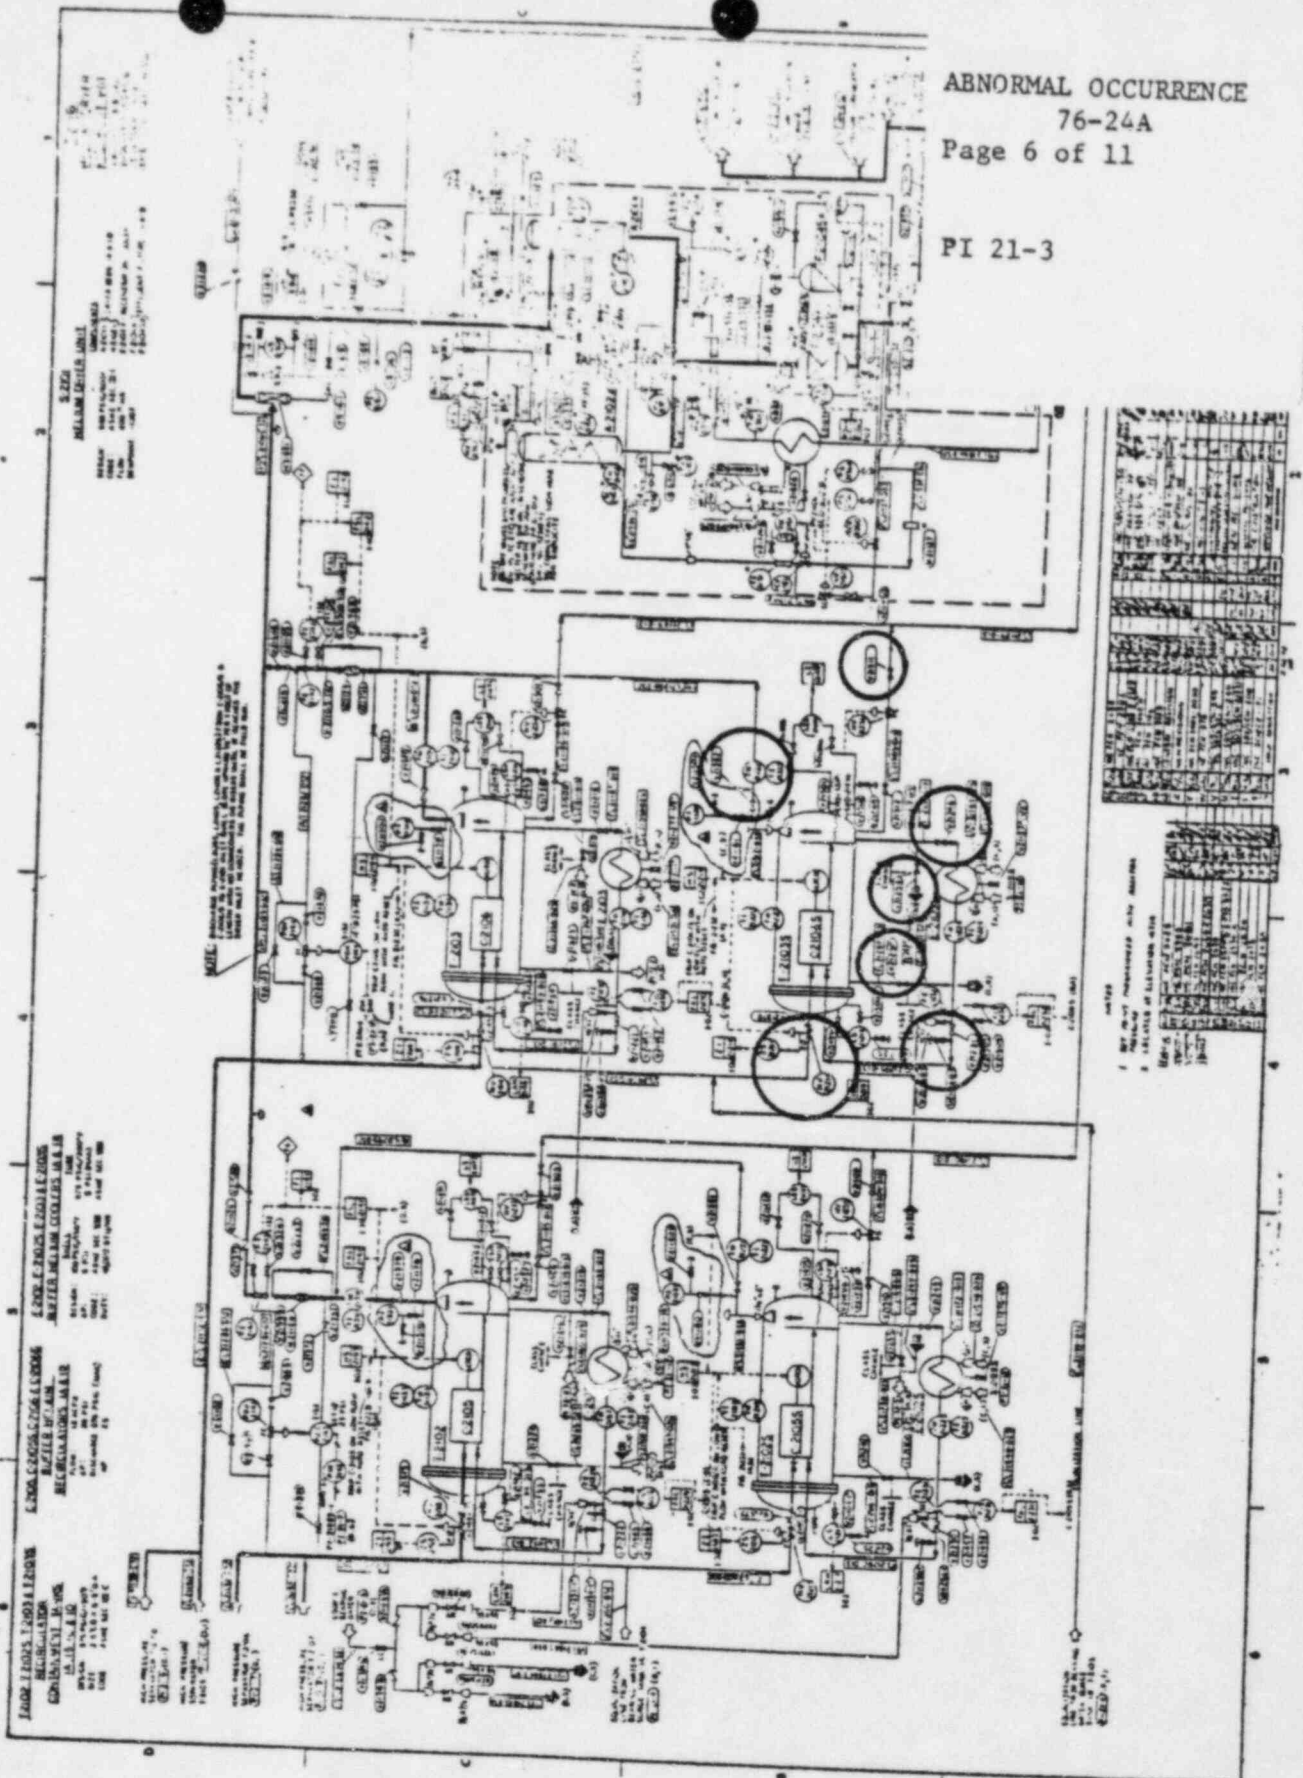
PI 21-3

An equipment operator was directed to return C-2106S, one of two Loop 2 recirculators, to service, by performing the following valve operations (see attached PI 21-3):

Plant conditions had been returned to normal following the previous circulator trip. The equipment operator was directed to isolate recirculator 1D as described by a clearance procedure, by performing the following valve operations (see attached PI-21-3):

A manual isolation valve, at the suction of each recirculator, has been added.

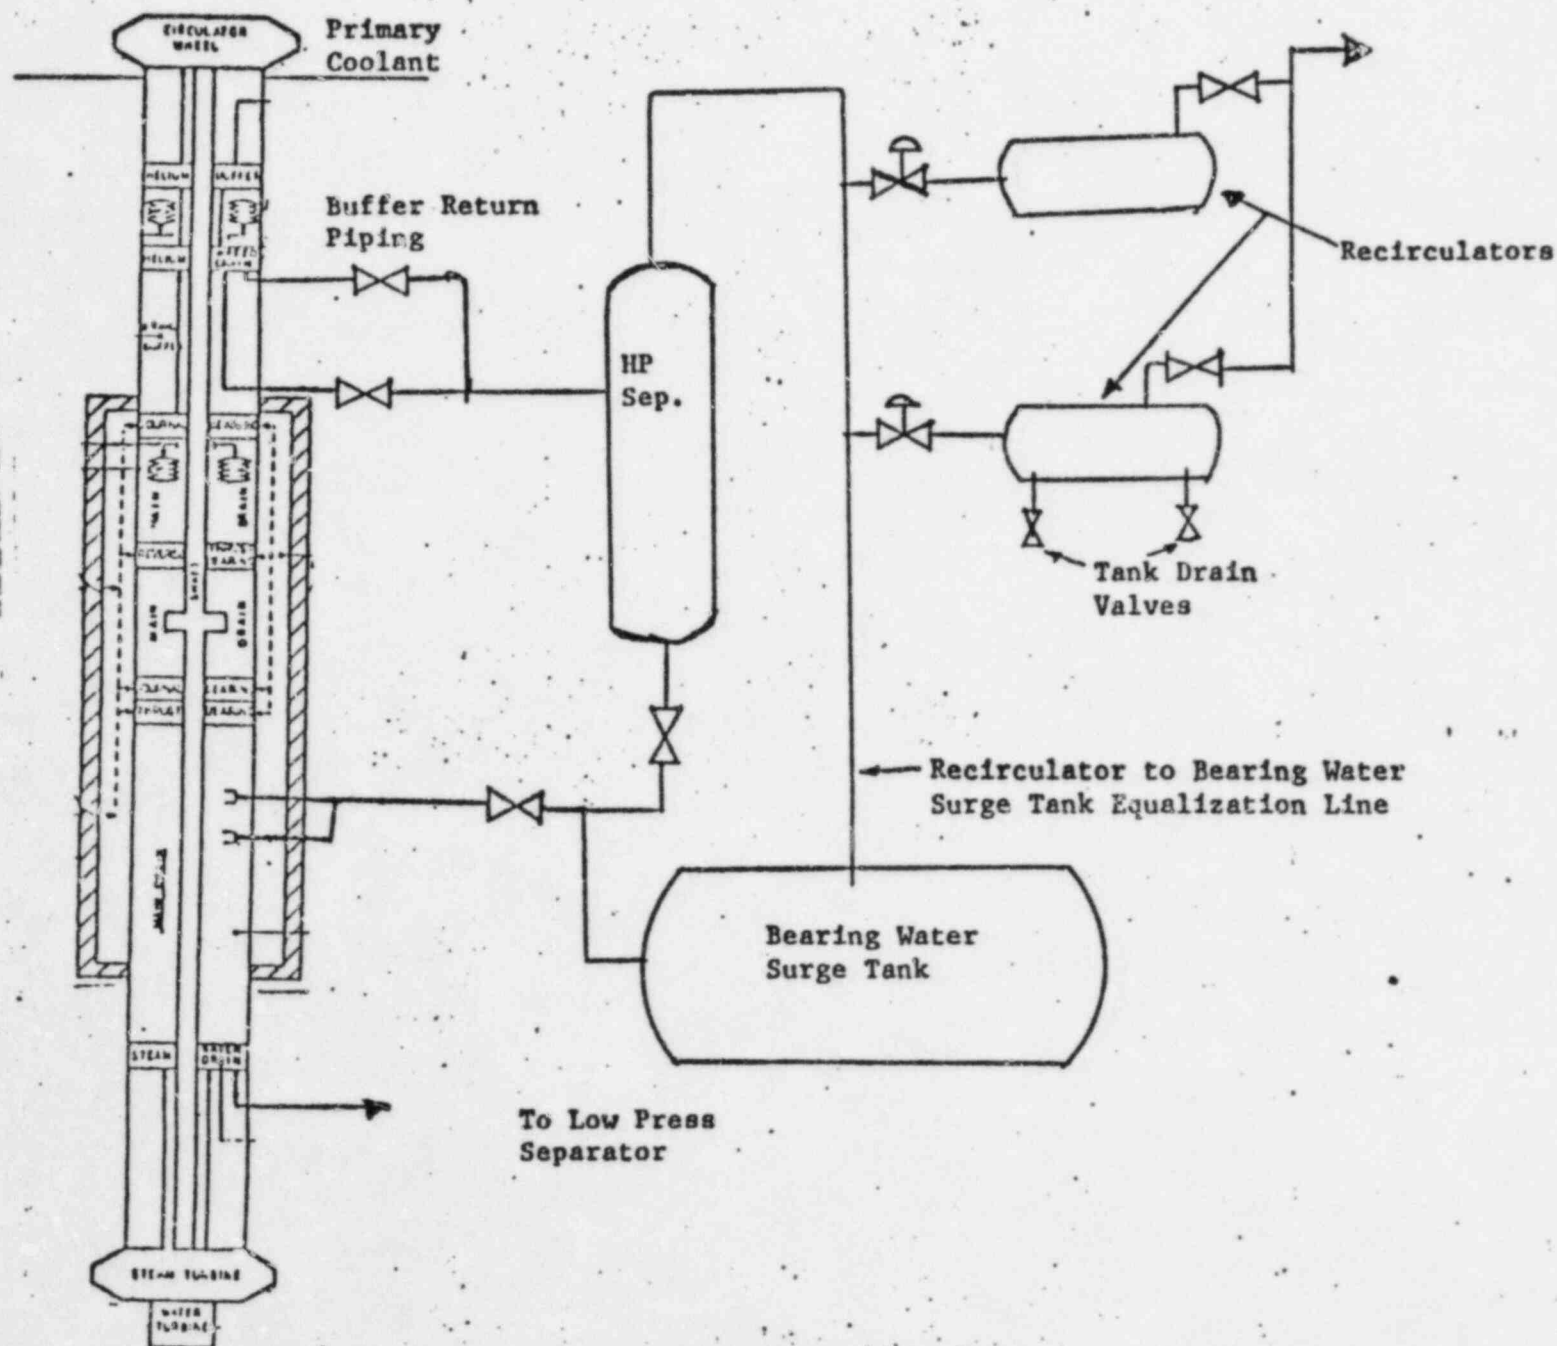
FIGURE 1

The recirculator containment tank pressures are normally between 10 and 15 psi above reactor pressure and are at 25 psi above the bearing water surge tank pressure (reference attached Figure 1). The equipment operator did not fully understand or follow the clearance procedure. When the operator removed the air from the inlet valve, it allowed the valve to open. Opening the recirculator containment tank drain valve allowed the water to drain and began venting the tank. The open suction valve, and fully opening the drain valve resulted in a high buffer helium flow rate from the buffer return piping, reducing buffer helium return pressures, the Loop 2 bearing water surge tank pressure, and increasing the circulator 1C buffer-mid-buffer differential pressure to more than +90" water. When this persisted for more than three seconds, the circulator tripped (see attached curves for 1C and 1D circulators). Circulator 1D also had high buffer-mid-buffer differential pressure but the trip of 1C circulator occurred first, which inhibited the trip of circulator 1D, a design feature of the Plant Protective System.

The lowered pressure in the buffer return line of the Loop 2 circulators was of sufficient magnitude to reduce buffer supply pressure below primary coolant pressure, allowing primary coolant to flow down both Loop 2 circulator shafts, into the bearing water and also out of the open containment tank drain valve. The radioactivity in the bearing water reached the low pressure separator and caused a high radioactivity trip of RIS-21251, which monitors the low pressure separator drain. A Health Physics technician reported the portable airborne activity monitors went off scale high at approximately the time circulator 1C tripped. Analysis of primary coolant showed an activity of  $2.3 \times 10^{-3}$   $\mu\text{Ci/cc}$ . This activity was primarily due to the presence of Kr and Xe. Reactor Building access was restricted until levels returned to normal. The Reactor Building exhaust fans operated normally and discharged to the plant stack throughout this incident. None of the four exhaust stack monitors showed any increase in radioactivity.
