Abnormal Occurrence 76/24

FORT ST. VRAIN NUCLEAR GENERATING STATION
PUBLIC SERVICE COMPANY OF COLORADO
P. O. BOX 361
PLATTEVILLE, COLORADO 80651

REPORT NO. 50-267/76/24

IDENTIFICATION OF
OCCURRENCE:

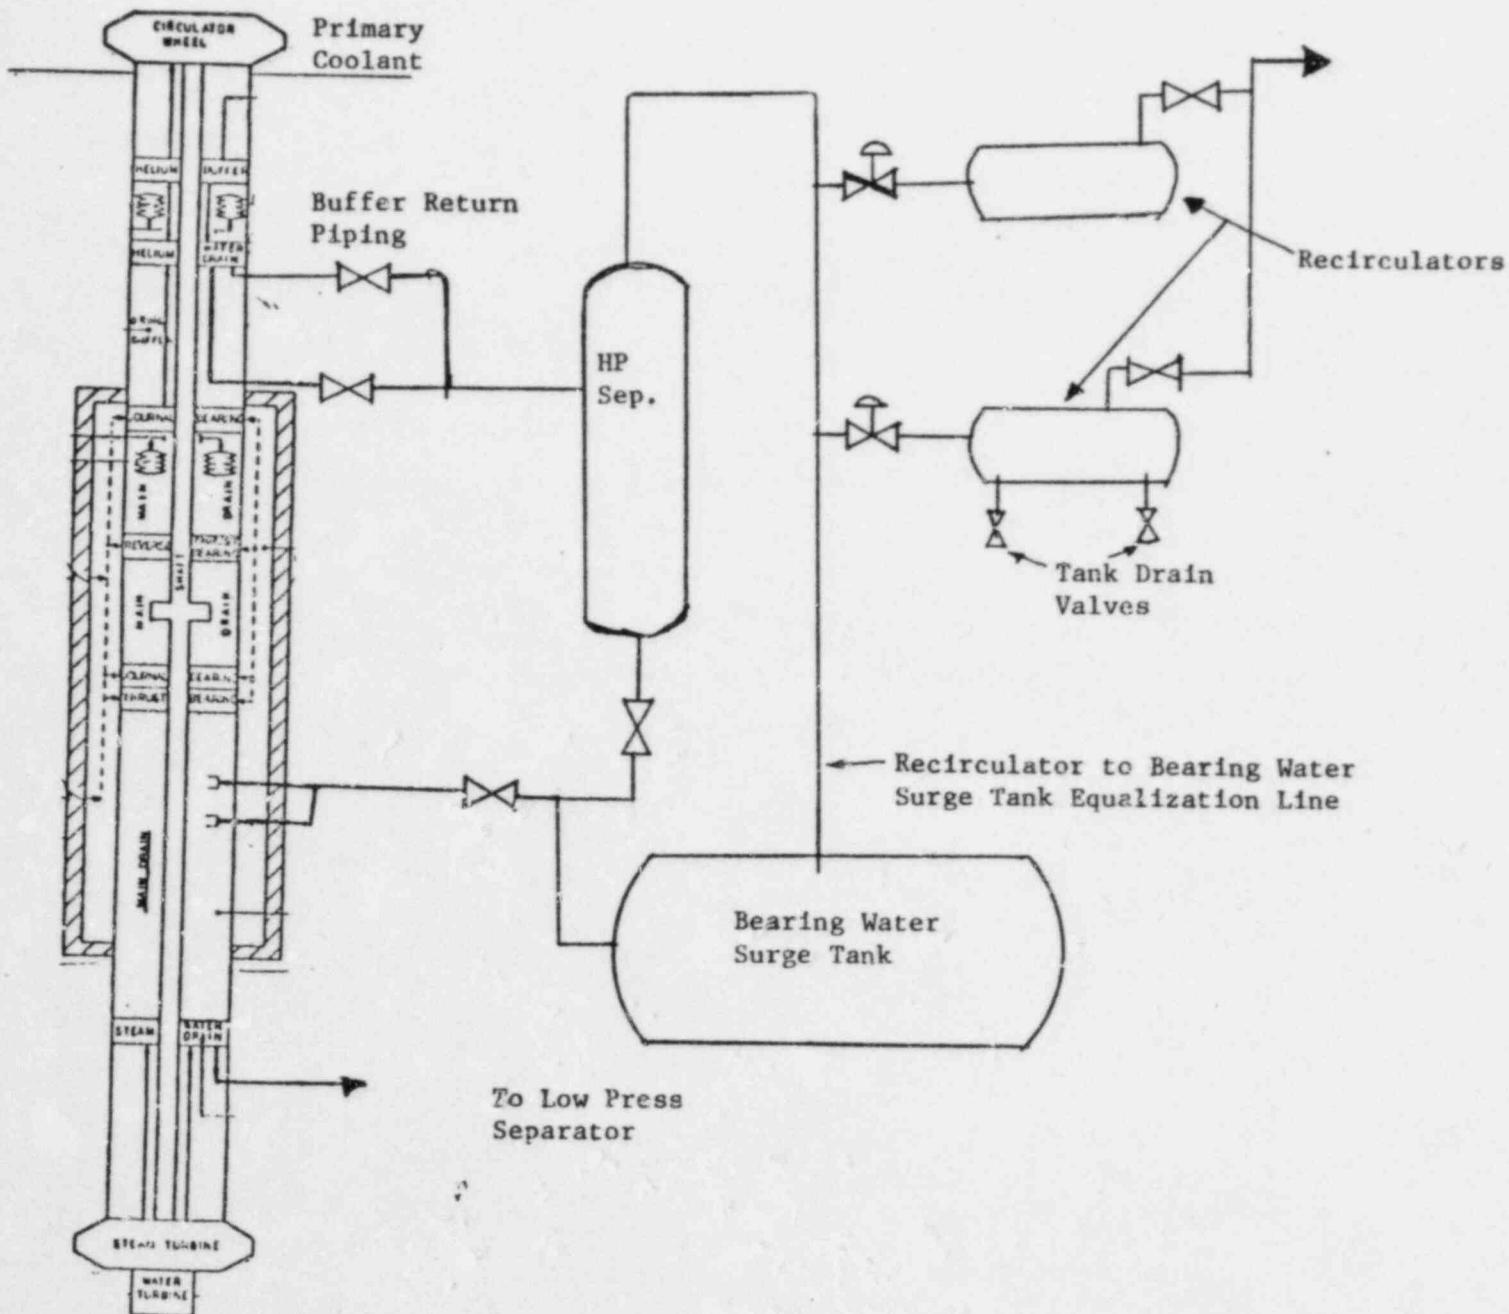
CIRCULATOR 1C PARAMETERS @ 7/26/76, 0026

The equipment operator then slowly opened V-21382, the recirculator discharge valve. This action caused high buffer-mid-buffer differential pressure on 1C circulator, which resulted in a circulator trip.

EVENT 1

Hc RETURN CIRC TRIP
