ABNORMAL OCCURRENCE 76/19

FORT ST. VRAIN NUCLEAR GENERATING STATION
PUBLIC SERVICE COMPANY OF COLORADO
P. O. BOX 361
PLATTEVILLE, COLORADO 80651

REPORT NO. 50-267/76/19

Preliminary

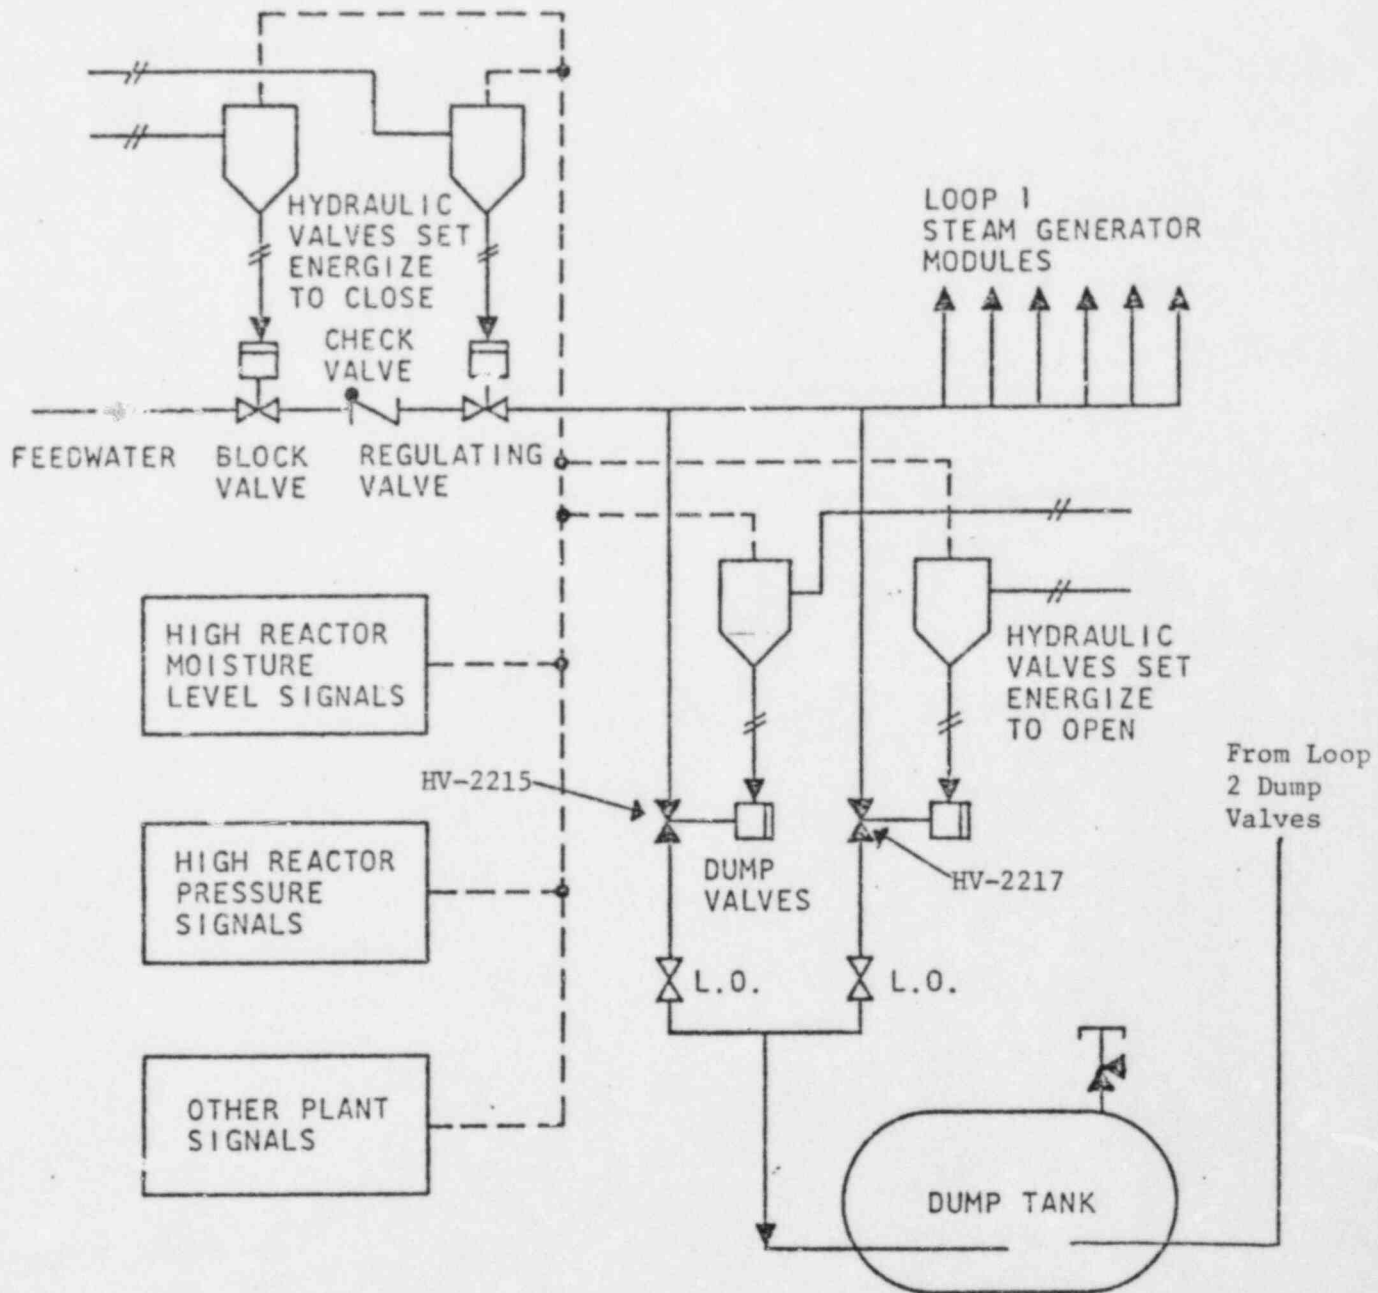
FIGURE 1

Reference attached Figure 1 which shows two parallel dump valves in a loop and the trip signals which will open a dump valve. Loop 1 and Loop 2 dump valves discharge to a common steam/water dump tank. The attached Figure 2 shows the interlocks which must be closed to open a steam/water dump valve. If a loop steam/water dump valve is open, its relay must be energized. The energized relay and position switches on the open valve interlock and should prevent automatic opening of either steam/water dump valve in the other loop.

Steam/water dump system (Loop 1)

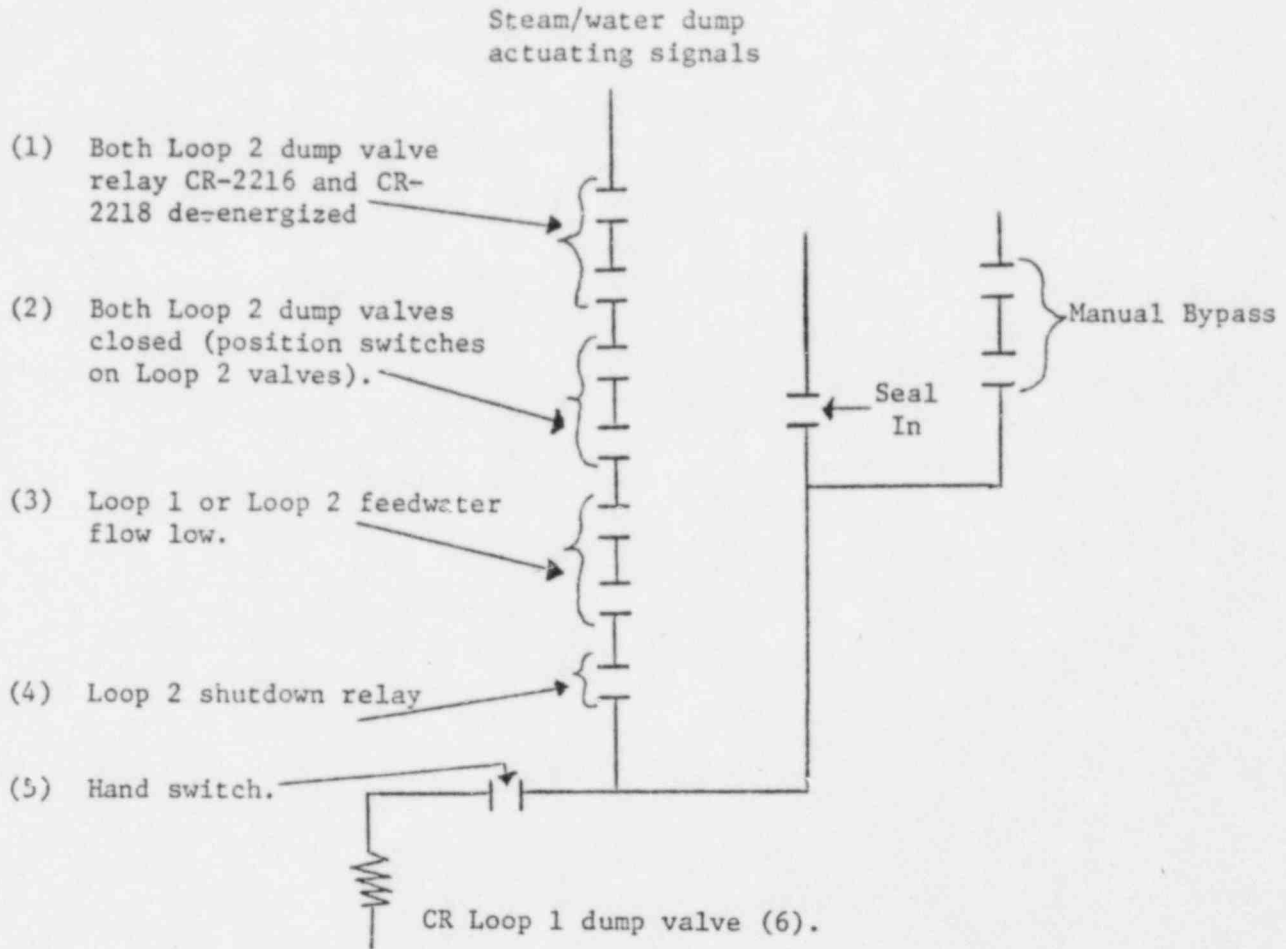
FIGURE 2

- (1) Relay contacts are open if the Loop 2 dump relay is energized; closed if de-energized.
- (2) Valve position switches are on each Loop 2 dump valve. Contacts open if valve is open, closed if valve is closed.
- (3) Contacts open if Loop 1 or Loop 2 feedwater flow is low.
- (4) Open if Loop 2 is shutdown.
- (5) Hand switch utilized to close a dump valve as required normally closes.
- (6) Relay controlling one Loop 1 dump valve relay must energize to open a Loop 1 dump valve.
