SUBJECT: COMANCHE PEAK STEAM ELECTRIC STATION (CPSES)
DUCKET NO. 50-445
CONDITION PROHIBITED BY TECHNICAL SPECIFICATIONS
LICENSEE EVENT REPORT 91-030-00

Enclosed is Licensee Event Report 91-030-00 for Comanche Peak Steam Electric Station Unit 1, "Personnel Error Leading to Mispositioned Residual Heat Removal System Cross Tie Valves".

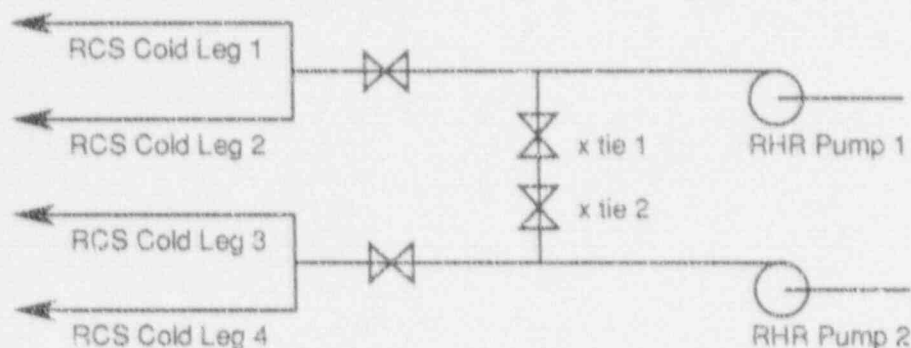
Figure 1

In preparation for testing of several check valves, Train B of the RHR system was secured. Difficulties encountered during check valve testing necessitated realignment of the system to allow the discharge header to be filled. During this activity, crosstie valve 1 was closed. Following completion of check valve testing, the RHR pumps and system were vented to satisfy the related surveillance requirement.

The Reactor Operator (utility, licensed) was directed by the Unit Supervisor (utility, licensed) to place the RHR system in standby readiness in accordance with the system operating procedure. While performing the alignment, the Reactor Operator failed to complete all steps necessary to place the RHR system in the required alignment, and inadvertently left the RHR crosstie valves closed. At 1333 the plant was declared to be in Mode 3.

Upon notification and completion of research to determine the correct valve position, the Unit Supervisor directed that the RHR crosstie valves be opened and that the appropriate surveillance test be performed to verify the correct position of other valves in the system. A review of the surveillance database was performed to identify the potential for similar problems. Additional alignment verifications were performed to ensure that no other system configuration problems existed. No valve misalignments were found.
