Carolina Power and Light Company
Docket No. 50-261
License No. DPR-23
H. B. Robinson No. 2

CLADDING SEPARATION IN STEAM GENERATOR NOS. 1 AND 3 (SUPPLEMENTAL INFORMATION TO INQUIRY REPORT NOS. 71-11, 71-12 AND 71-13)

Report on
Inspection of Leaks and Cracks in the
(A) Steam Generator at H. B. Robinson II

Report No. DC 89

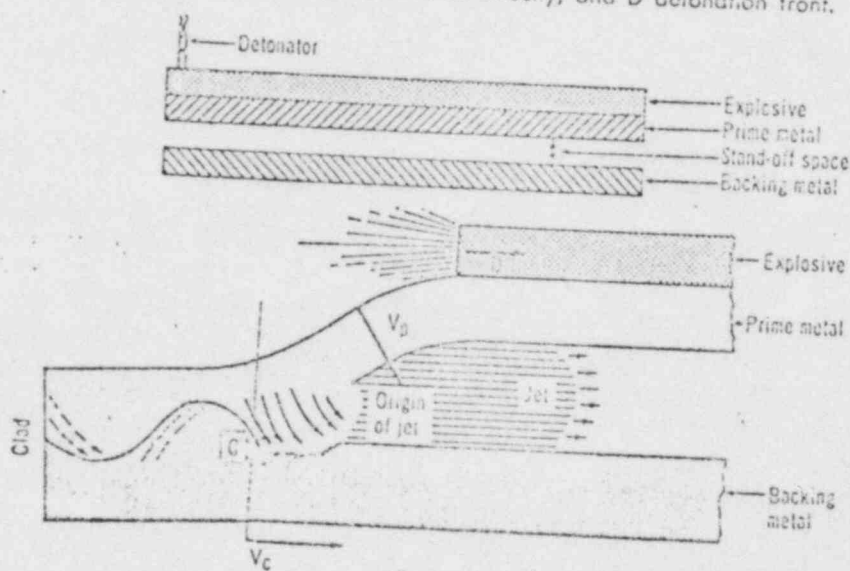
Fig. 1—In bonding, the explosive and prime metal are placed together and spaced slightly away from the backing metal. When the explosive is detonated, the prime metal collides with the backer. Jetting, which takes place ahead of the collision, acts to clean the joint zone. V_p indicates prime metal velocity, V_c collision velocity, and D detonation front.

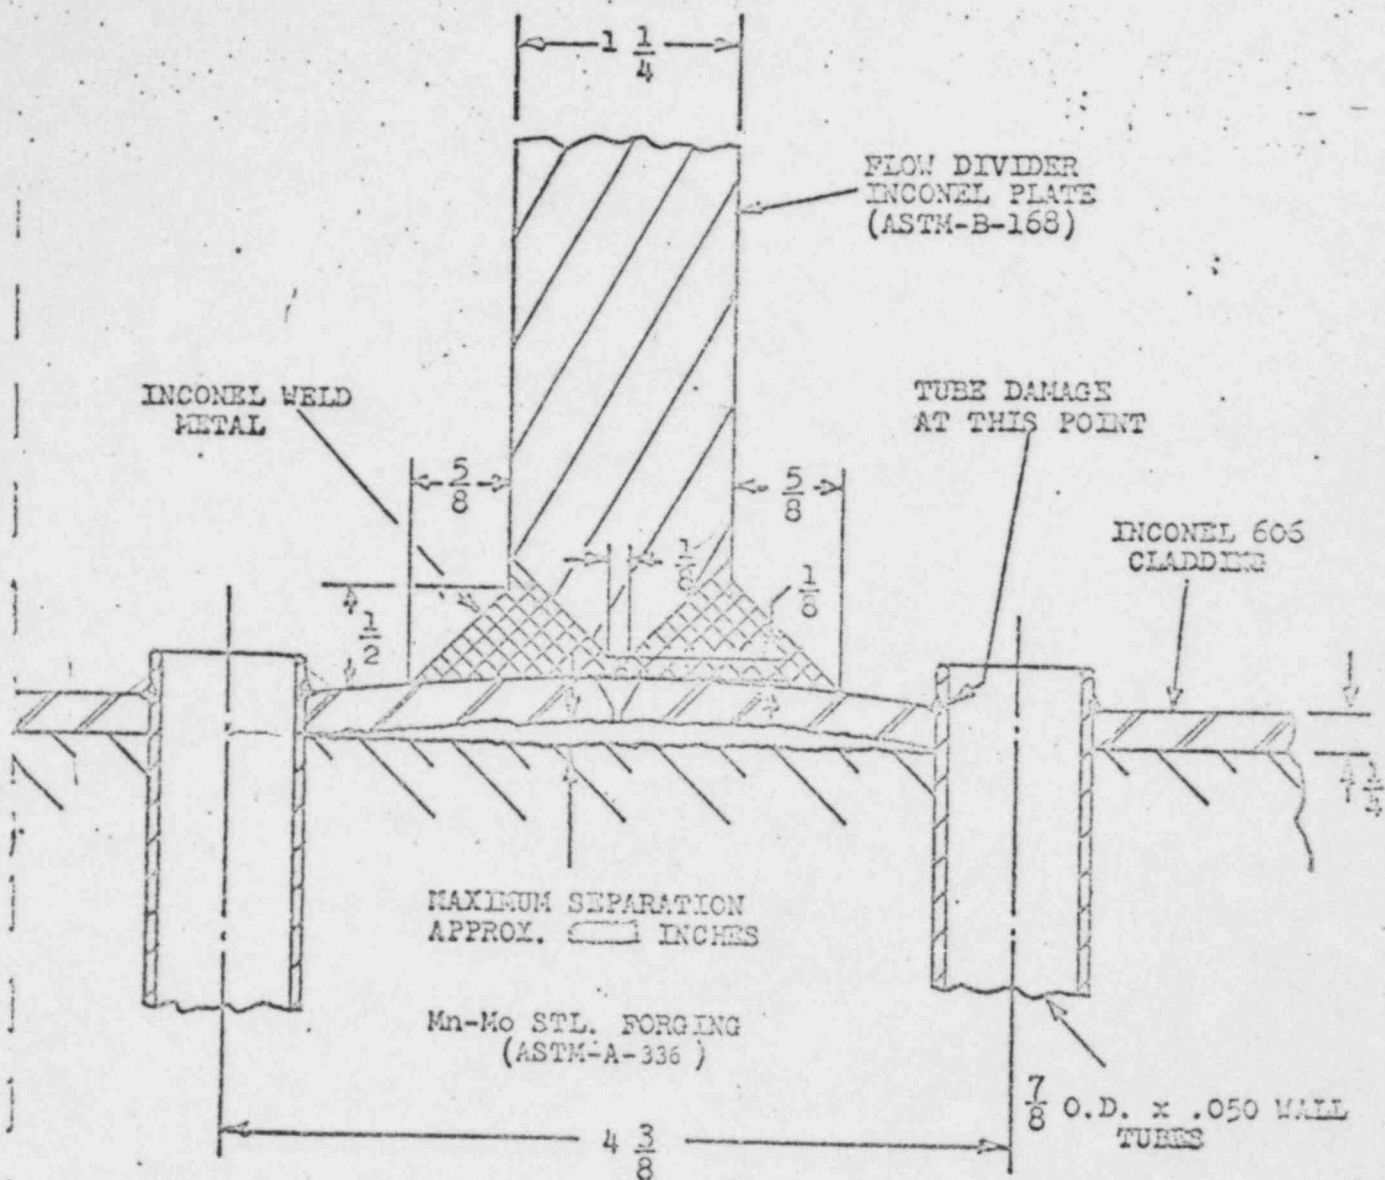
FIG. 1

In both the No. 1 and No. 3 steam generators, the one-fourth-inch inconel tube sheet cladding has been pulled loose from its base metal in the area over the divider which separates the two halves of the lower dome. The separations extend laterally from both sides of the divider to the adjacent rows of seven-eighths-inch O.D. inconel tubes. A sectional view of the failure is shown in Exhibit A (provided by Westinghouse). The separation extends along the top of the divider to within six inches of each end of the divider. The separation area is shown in Exhibit B.

The cladding is cracked along the edge of the separation area. This crack extends to the bottom surface of the cladding in the cold leg sides of both steam generators. The cladding is also broken away from the tubes which are next to the divider so that the crack is continuous, proceeding across the web between two tubes, around the tube fillet weld, across the next web, around the next fillet and so on for 25 to 30 tubes. (See Exhibit B.) In

CP & L CLAD SEPARATION

1. Removing the cladding over the divider, out to a line between the first and second rows of tubes on either side of the divider. (See Exhibit B.)
2. Removing enough of the top of the divider to provide access to the space above the divider for rewelding the cladding.
3. Grinding off the first row of tubes on each side of the divider flush with the tube sheet and plugging these tubes.
4. Replacing the cladding by weld overlay which will also cover over the ends of the plugged tubes.

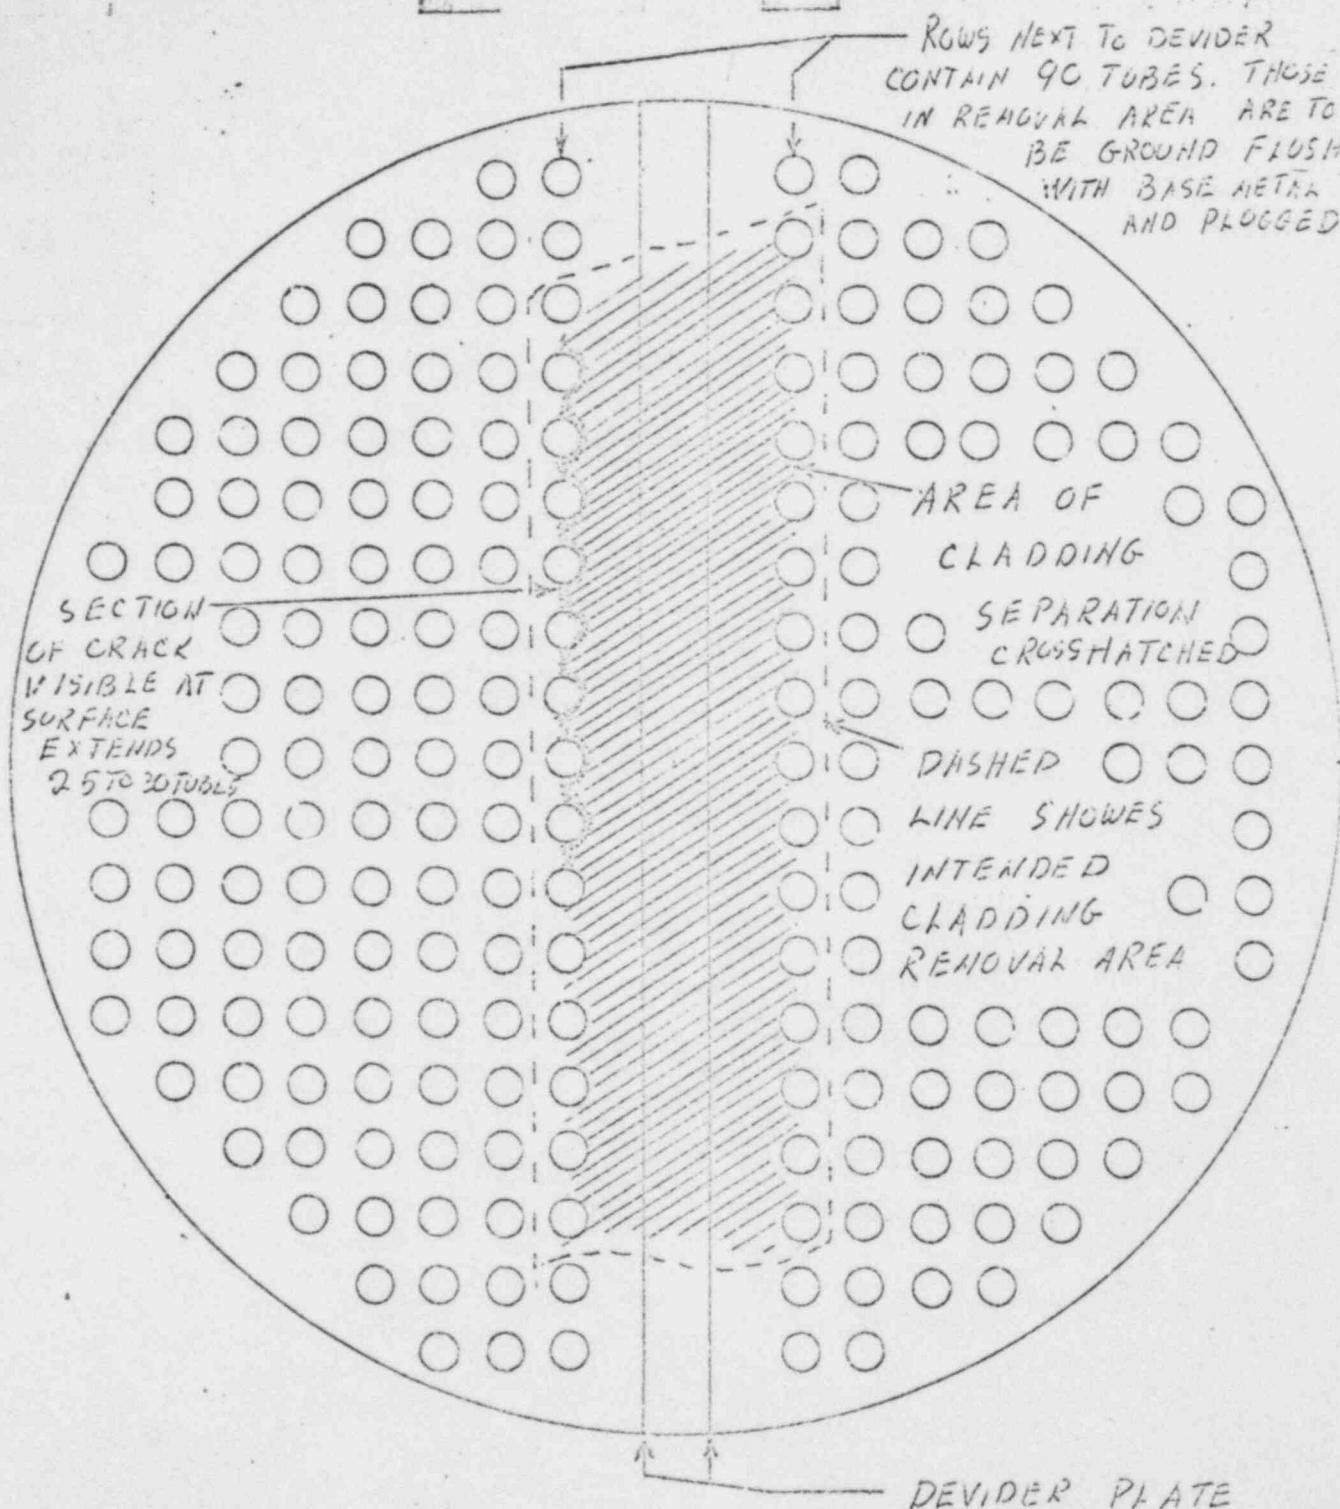
FIG 2.

DIAGRAM OF TUBE SHEET. TUBE HOLES
ARE ENLARGED FOR CLARITY. STEAM GENERATOR
ACTUALLY HAS 3260 TUBES

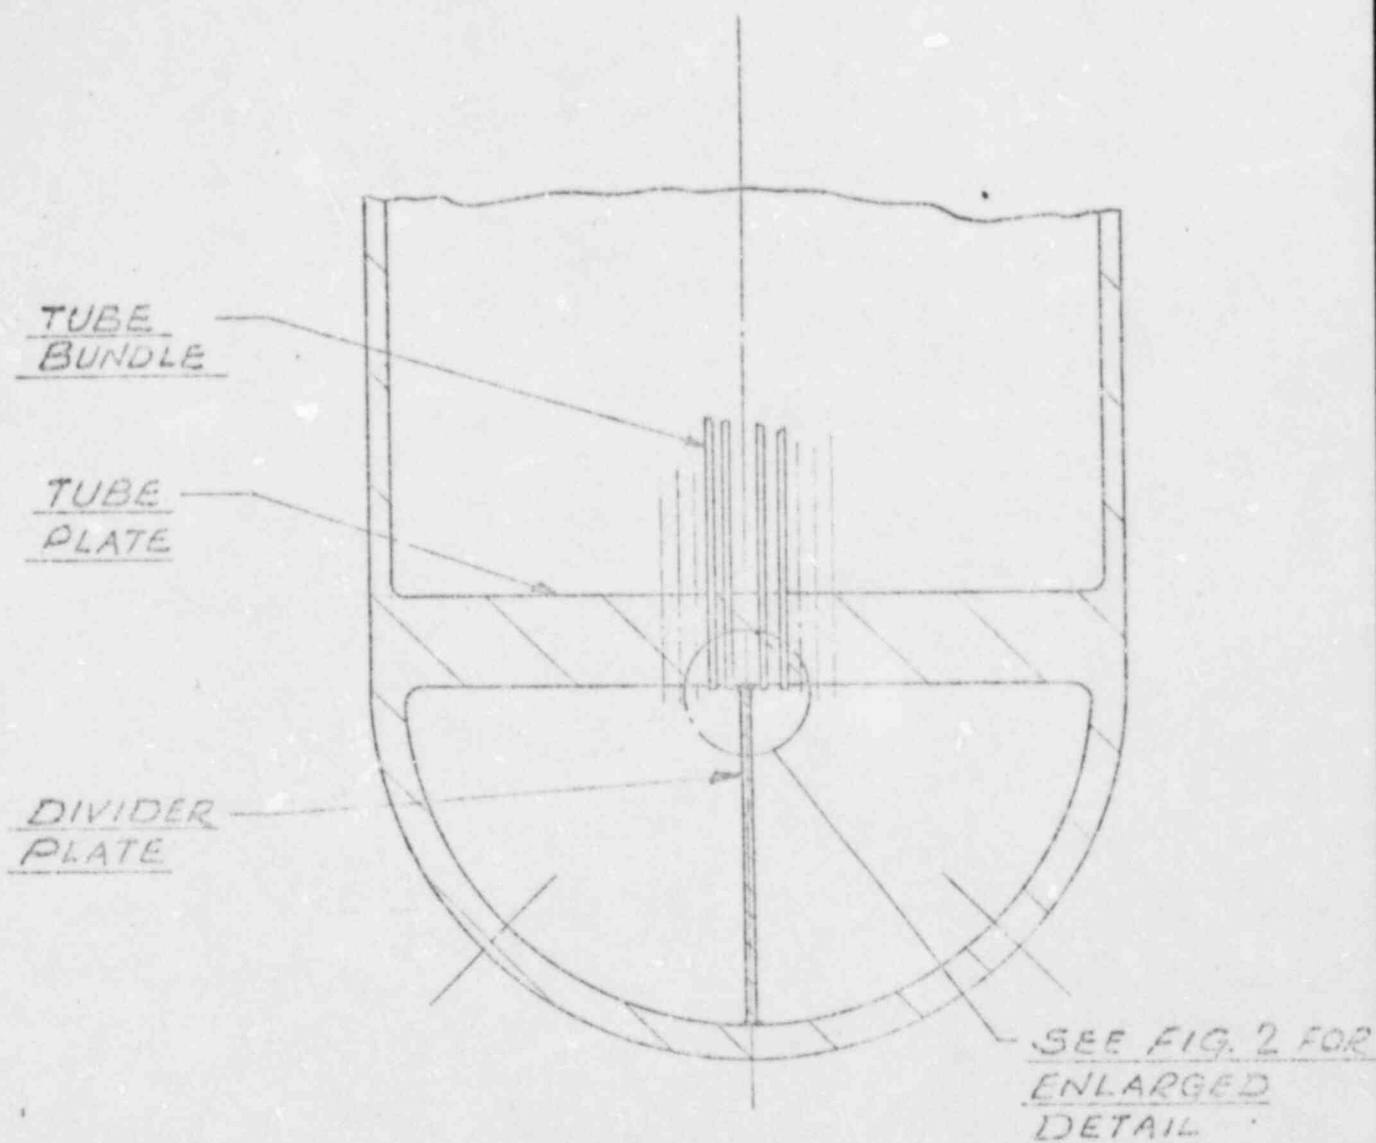
FIG. 1
"A" STEAM GENERATOR

Mr. Kirkpatrick and the writer were "suited-up" and proceeded to enter individually and inspect the cold leg of the A steam generator. The inspection was performed visually using a low power magnifying lens. Mr. Kirkpatrick attempted to photograph the conditions we observed with a 35 mm. camera using a close-up lens. The following conditions were observed during this inspection: (See Figs. 1, 2 & 3)

- (1) Severe cracks were present in the fillet welds of approximately 30 tubes. The highest intensity of fillet cracking was apparent in the region included in and surrounding the 35th

- (2) Cracking in the 1/4 inch thick cladding was extensive in the region described above. These cracks were linear in the north-south direction (parallel to the divider plate) and were located approximately in line with the center of the first row of tubes. These cracks were tighter than those observed in the fillets and appeared to range in the vicinity of .005 to .010 inches wide and extended the entire length of the cladding between the cracked tubes.

- (3) Rusting and corrosion products were observed in the immediate vicinity of the fillet weld cracks progressing into the cladding cracks. This evidence shows that galvanic action and electrochemical corrosion has already occurred between the tube sheet material and the austenitic materials involved, through the borated solution which acted as an electrolyte.

- (4) The writer visually observed a contoured region of the cladding, adjacent to the divider plate and in the vicinity of the 40th to 50th tubes that showed definite signs of having been separated from the tube sheet.

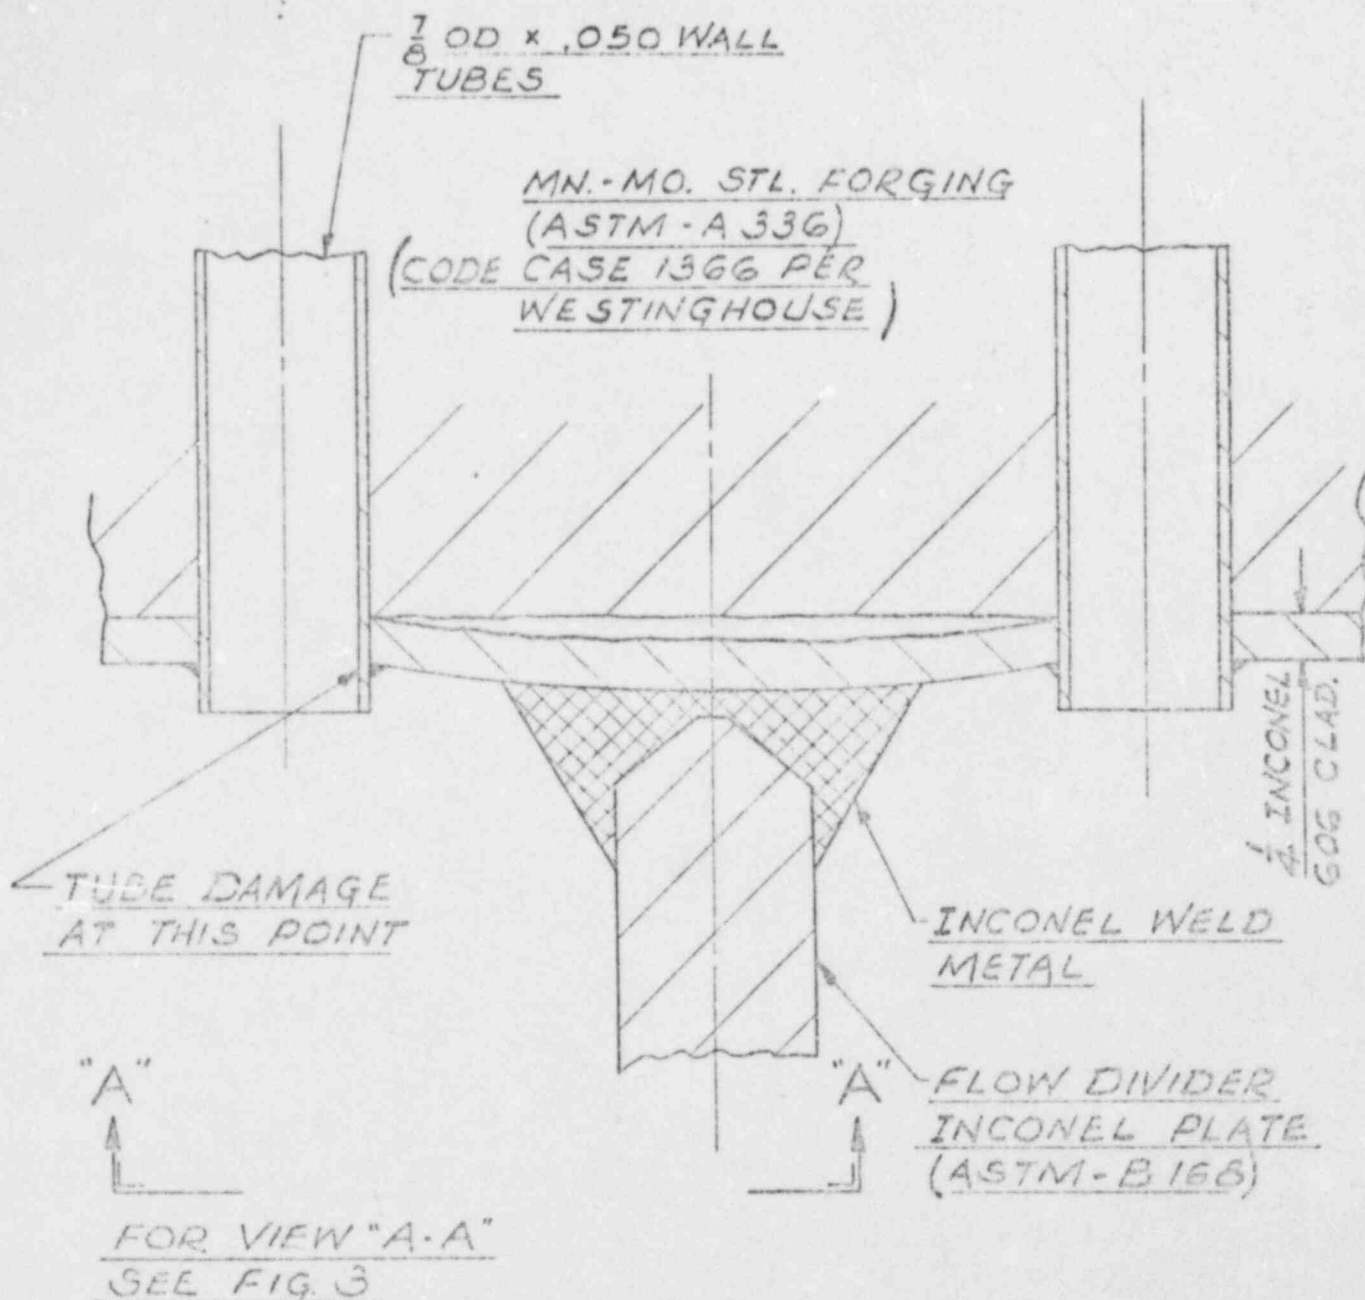
FIG. 2
ENLARGED VIEW OF
CLAD SEPARATION

to 45th tubes (accounted from the north toward the south). These cracks were opened approximately .030 to .050 inches and were approximately semi-circular on the side of the fillet welds facing the flow divider plate.

APPROX. .030 TO .050
WIDE CRACKS IN
FILLET WELDS APPROX.
SEMI-CIRCULAR ON THE
SIDE OF WELDS FACING
THE FLOW DIVIDER
PLATE.

APPROX. .005 TO .010
WIDE CRACKS IN
CLADDING APPROX.
ON ϕ OF TUBES
EXTENDING THE
ENTIRE LGTH.
BETWEEN TUBES.
