DUE TO THE CURRENT WESTERN UNION  
STRIKE WE ARE UNABLE TO SEND A  
TELEGRAM TO COMPLY WITH DPR-23  
TECHNICAL SPECIFICATION 6.6.1.C. WE  
HOPE YOU ACCEPT THIS HANDWRITTEN LETTER  
AS A SUBSTITUTE.

A LEAK HAS BEEN DETECTED IN A  
STEAM GENERATOR. THIS FALLS UNDER  
ABNORMAL OCCURRENCE DEFINITION  
1.8.2. THE PROBLEM IS BEING INVESTIGATED  
BY OUR CONTRACTORS & IT HAS BEEN FOUND  
THAT THE LEAK IS DUE TO CRACKING  
OF THE TUBE SEAL WELDS AT THE TUBE  
SHEET DUE TO A SEPARATION OF THE INCLAD  
CLADDING FROM THE TUBE SHEET. THIS  
SEPARATION HAS BEEN FOUND IN TWO

In reference to Report No. DC 89, "Inspection of Leaks and Cracks in the (A) Steam Generator at H. B. Robinson II," June 23, 1971, I would like to offer the following opinions and recommendations:

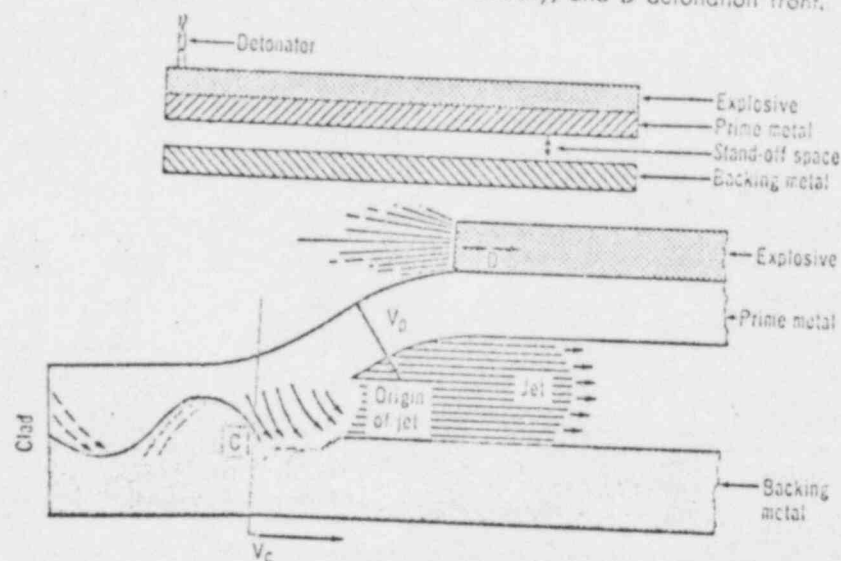
The process dates back to the late 1950's and early 1960's and, is generally based on the Cowan, G. R., Douglass, J. J., and Holtzman, A. H., U. S. Patent No. 3,137,937 issued June 3, 1964 and assigned to E. I. du Pont de Nemours and Co. A typical cladding arrangement, as well as the basic operating principles are illustrated in Figure 1. After the explosive is detonated, the prime metal is accelerated very rapidly to a high velocity ( $V_p$ ) by the detonation pressure. As the detonation front (D) moves across the plate, an angle is established between its undeflected and deflected portions. When the deflected portion of the prime metal collides with the backer plate, the region of high-pressure collision moves across the plates at high speed. This velocity ( $V_c$ ) equals the detonation

velocity for the illustrated situation. Ahead of the collision region in each plate, high pressures cause surfaces of both metals to flow plastically into the space between the plates.

The jet which forms acts to remove surface films of oxides and of other materials normally detrimental to bonding. At the same time, the clean metal surfaces are subjected to high pressures in the collision region causing plastic deformation. The metals supposedly come into interatomic contact with each other, establishing a metallurgical bond.

Fig. 1—In bonding, the explosive and prime metal are placed together and spaced slightly away from the backing metal. When the explosive is detonated, the prime metal collides with the backer. Jetting, which takes place ahead of the collision, acts to clean the joint zone.  $V_p$  indicates prime metal velocity,  $V_c$  collision velocity, and  $D$  detonation front.
