Report on  
Inspection of Leaks and Cracks in the  
(A) Steam Generator at H. B. Robinson II

Report No. DC 89

June 23, 1971

Prepared for: U. S. Atomic Energy Commission  
Division of Compliance  
AEC Contract AT (11-1)-1658  
Subcontract No. 10

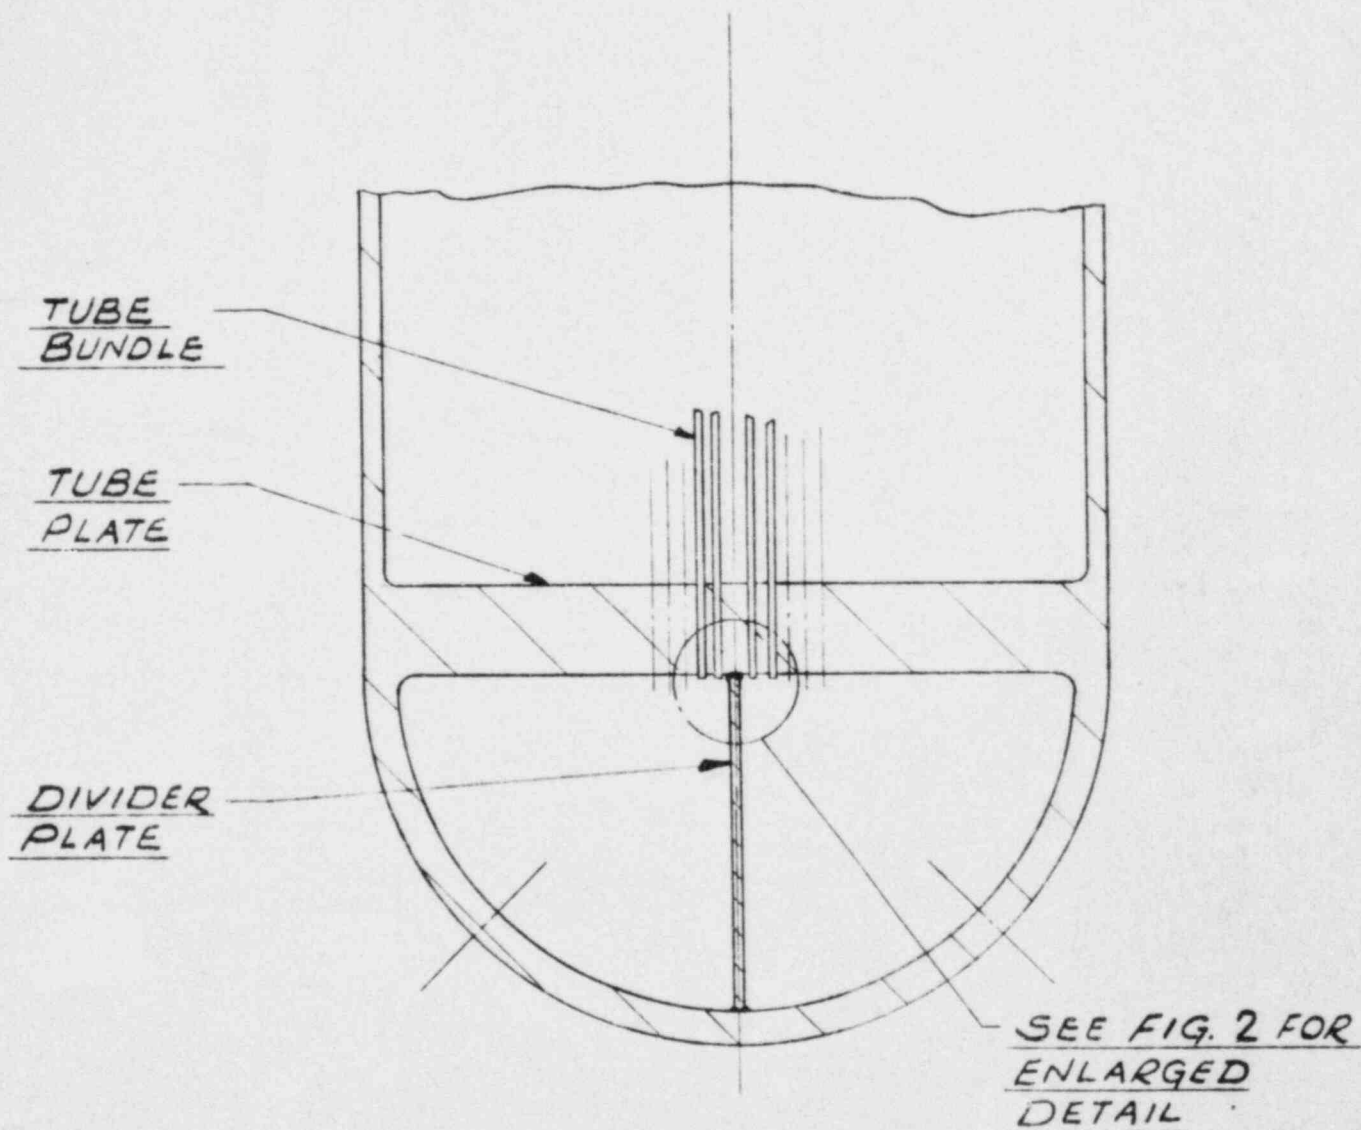
FIG. 1  
"A" STEAM GENERATOR

- (1) Severe cracks were present in the fillet welds of approximately 30 tubes. The highest intensity of fillet cracking was apparent in the region included in and surrounding the 35th

These cracks were opened approximately .030 to .050 inches and were approximately semi-circular on the side of the fillet welds facing the flow divider plate.

- (2) Cracking in the 1/4 inch thick cladding was extensive in the region described above. These cracks were linear in the north-south direction (parallel to the divider plate) and were located approximately in line with the center of the first row of tubes. These cracks were tighter than those observed in the fillets and appeared to range in the vicinity of .005 to .010 inches wide and extended the entire length of the cladding between the cracked tubes.

- (4) The writer visually observed a contoured region of the cladding, adjacent to the divider plate and in the vicinity of the 40th to 50th tubes that showed definite signs of having been separated from the tube sheet.

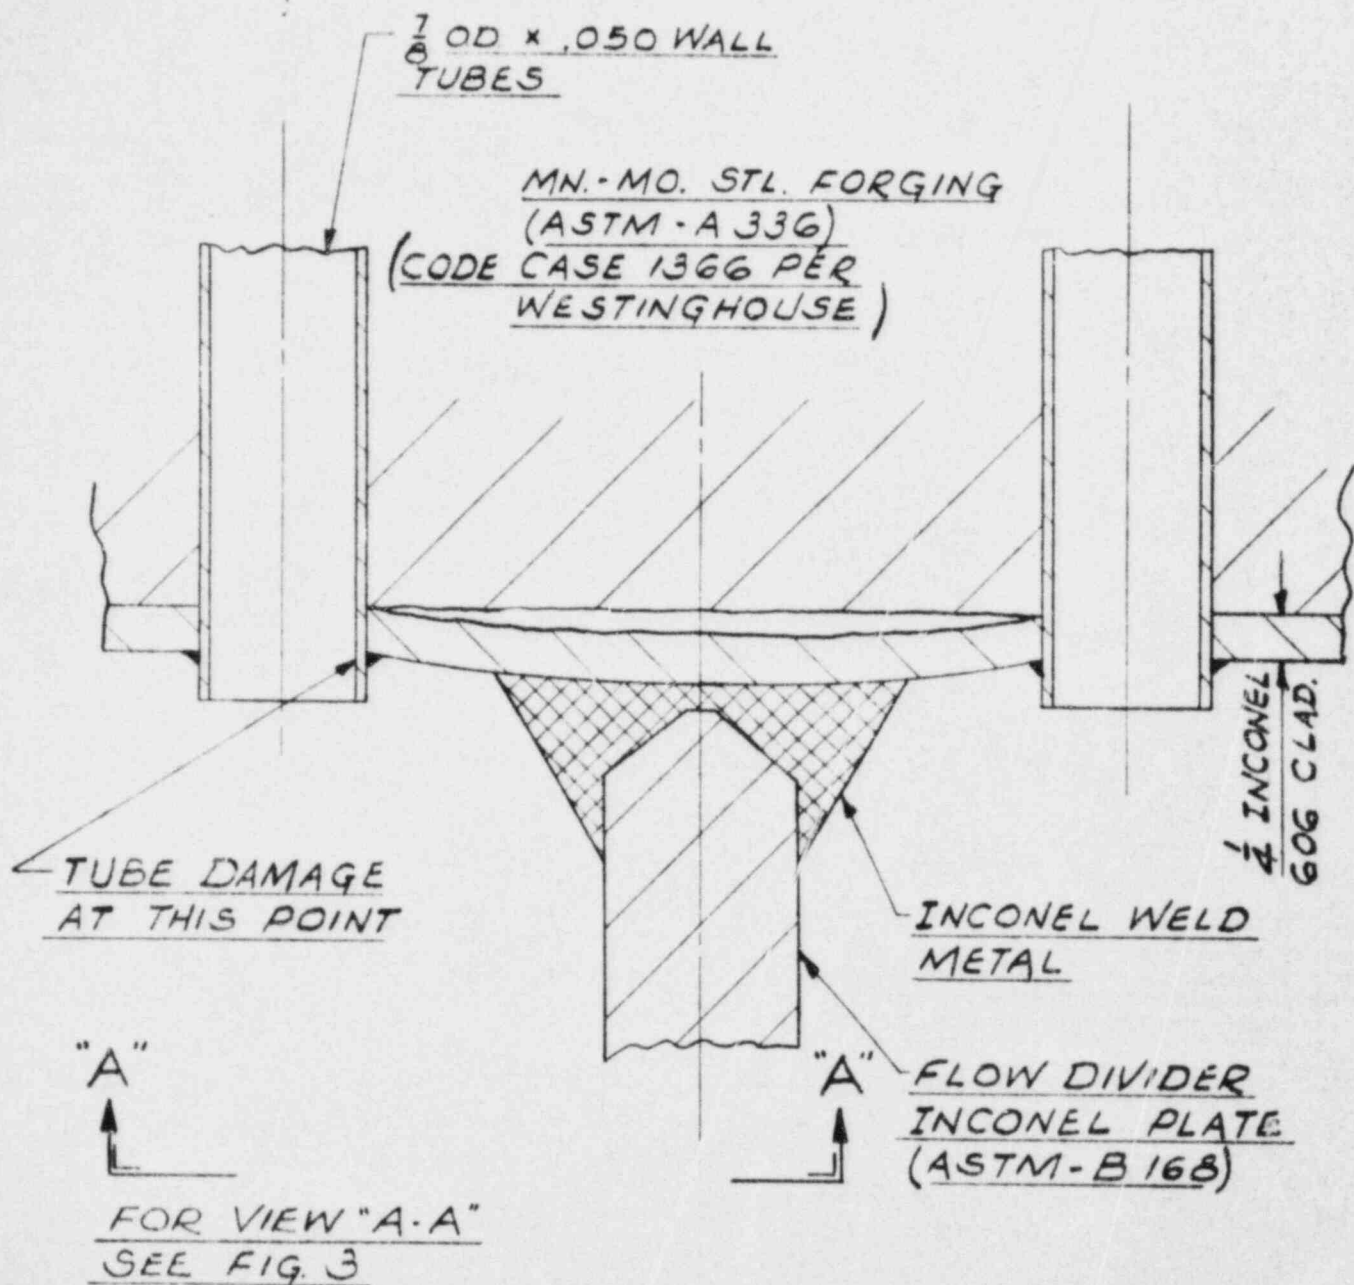
FIG. 2  
ENLARGED VIEW OF  
CLAD SEPARATION

- (3) Rusting and corrosion products were observed in the immediate vicinity of the fillet weld cracks progressing into the cladding cracks. This evidence shows that galvanic action and electrochemical corrosion has already occurred between the tube sheet material and the austenitic materials involved, through the borated solution which acted as an electrolyte.

APPROX. .030 TO .050  
WIDE CRACKS IN  
FILLET WELDS APPROX.  
SEMI-CIRCULAR ON THE  
SIDE OF WELDS FACING  
THE FLOW DIVIDER  
PLATE.

APPROX. .005 TO .010  
WIDE CRACKS IN  
CLADDING APPROX.  
ON  $\frac{1}{2}$  OF TUBES  
EXTENDING THE  
ENTIRE LGTH.  
BETWEEN TUBES.

- (a) A minimum amount of material, including the fillet welds, be removed from the divider plate.
- (b) Defectively bonded cladding will be removed by arc and grinding methods.

- (d) The tube sheet will be re-clad using shielded metal arc (coated electrodes) techniques and the cracked tubes will be ground back and permanently blocked off by seal-welding.
