Crystal River Unit 3  
Docket No. 50-302

Subject: Licensee Event Report (LER) 95-011-00

Personnel Error Leads to Incorrect Orientation of Door Seals Resulting in Operation Outside the Design Basis

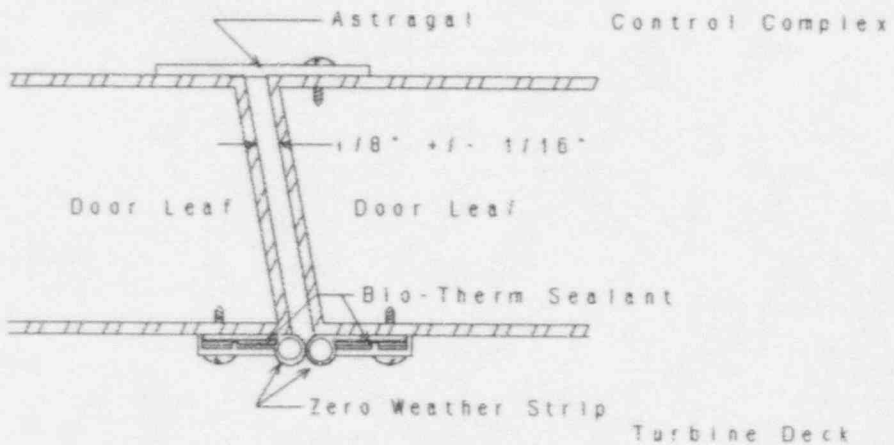
Fig 1-A Door Sealing Detail

Figure 1A illustrates the door sealing detail including weather stripping on the positive (higher) pressure side of the doors and the astragal on the negative (lower) pressure side of the doors as tested by the door assembly vendor. Figure 1B is a plan view of the ingress and egress doors as installed with the incorrect door seal orientation. Figure 1C illustrates the doors properly installed in the tested configuration.

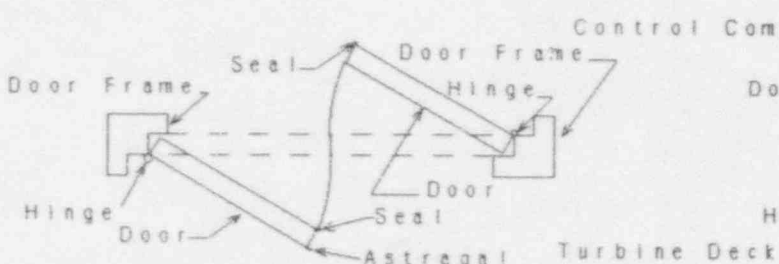
Fig 1-B As Installed

As the doors were re-installed following frame installation, FPC maintenance personnel performing the work failed to install the doors in conformance with the work package drawings illustrating the door seal orientation. Since these doors are identical, except for the seal configuration, either door could be installed on either side of the door frame. The only difference would be the door seal orientation. During the re-installation of the doors, they were inadvertently reversed, resulting in the condition placing the plant outside the design basis, relative to the HE.

The cause of this event was personnel error by FPC maintenance personnel. During installation of the door, the drawings associated with the work package were not consulted for proper door orientation.

By July 19, 1995, the astragal and door seals were removed and replaced in their as tested configuration, thereby returning the plant to within its design basis.
