# LICENSEE EVENT REPORT (LER)

FACILITY NAME (1) **Wolf Creek Generating Station** DOCKET NUMBER (2) **050004821** OF **06** PAGE (3)

TITLE (4) **Containment Isolation Valves Failed Local Leak Rate Test Causing Total Path Leakage And Overall Integrated Leakage To Be Above 0.6 La And 0.75 La Respectively**

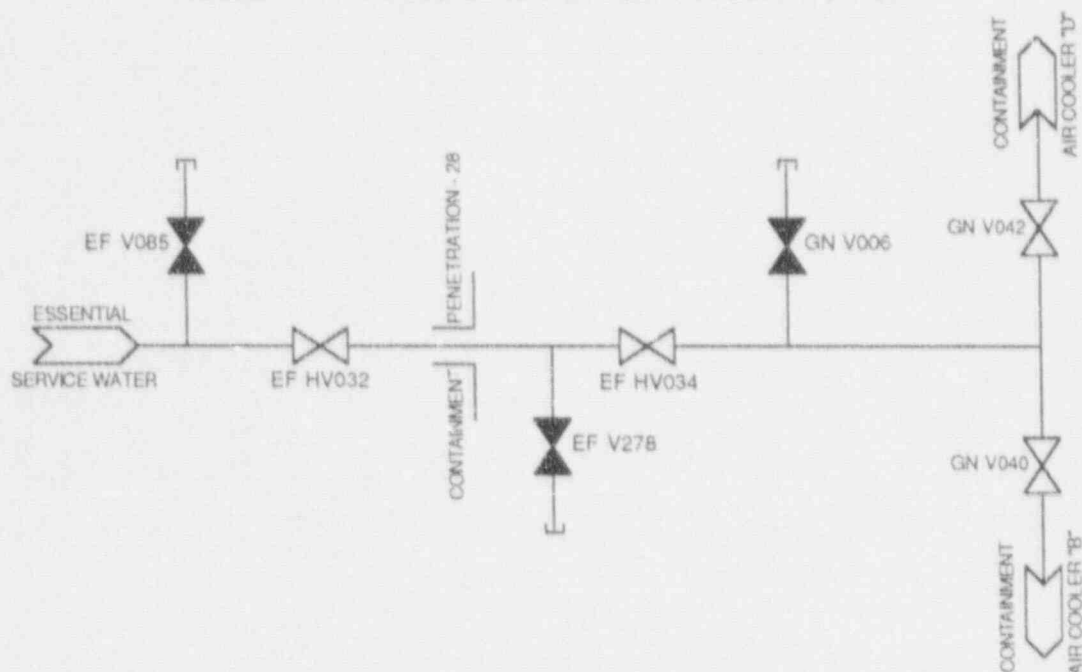
**FIGURE 1 - PIPING DIAGRAM FOR PENETRATION 28**

Appendix J of 10 CFR Part 50 requires that the combined leakage rate for all penetrations and valves subject to Type B and C tests shall be less than  $0.60 I_a$ . This equates to a leakage rate of 252,028 standard cubic centimeters per minute (scm). Containment Isolation Valves EF HV032 and EF HV034 are required to have a Type C leak test performed at least once per 24 months or prior to conducting any maintenance that can affect valve leakage characteristics. These valves are normally open and receive an open signal in the event a Safety Injection Signal is generated.

On October 22, 1991, during the performance of surveillance procedure STS PE-017-028, "Local Leak Rate Test for Containment Penetration 28", the test volume contained by valves EF HV032 and EF HV034 could not be pressurized to the required 48 pounds per square inch gauge (psig). This procedure is performed to determine the Containment Local Leakage Rates for Type B and C tests.

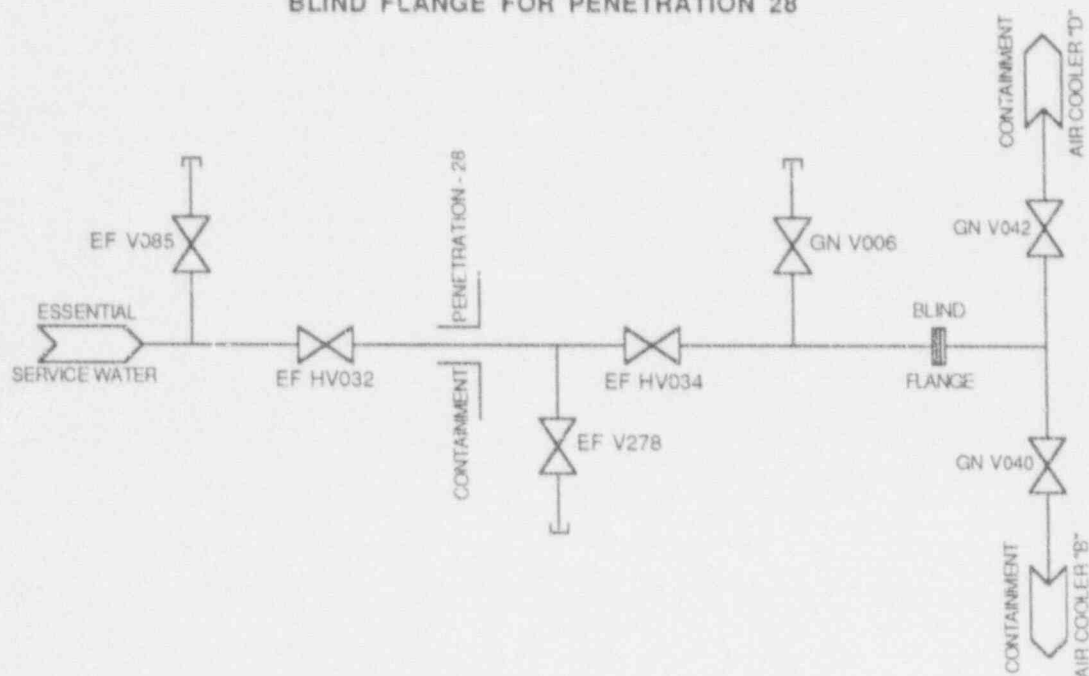
**FIGURE 2 - LOCAL LEAK RATE TEST WITH  
BLIND FLANGE FOR PENETRATION 28**

Since the required pressure could not be obtained, a blind flange was installed downstream of EF HV032 and EF HV034 but upstream of GN V040 and GN V042 [Figure 2]. This would allow the individual testing of the valves without the use of GN V040 and GN V042 as a test boundary. Although the required pressure could still not be obtained, a leak rate was obtained for each valve using a pressure decay method of calculating leakage. This method estimated the leakage for valve EF HV032 to be approximately 281,857  $\pm$  28,186 sccm. Valve EF HV034 had approximately 265,310  $\pm$  26,531 sccm leakage. This increased the total path leakage to 404,418 sccm which is above the the Technical Specification limit of 252,028 sccm. The failure to meet the Technical Specification LLRT limit is considered a degradation of a principal safety barrier.
