REPORT NO.: 10CFR21-0059
November 8, 1991

10CFR21 REPORTING OF DEFECTS
AND NON-COMPLIANCE

COMPONENT: Stud - EMD #80346..
Camshaft Locating Stud

SYSTEM: All Diesel Generators with EMD 645 Series Engines

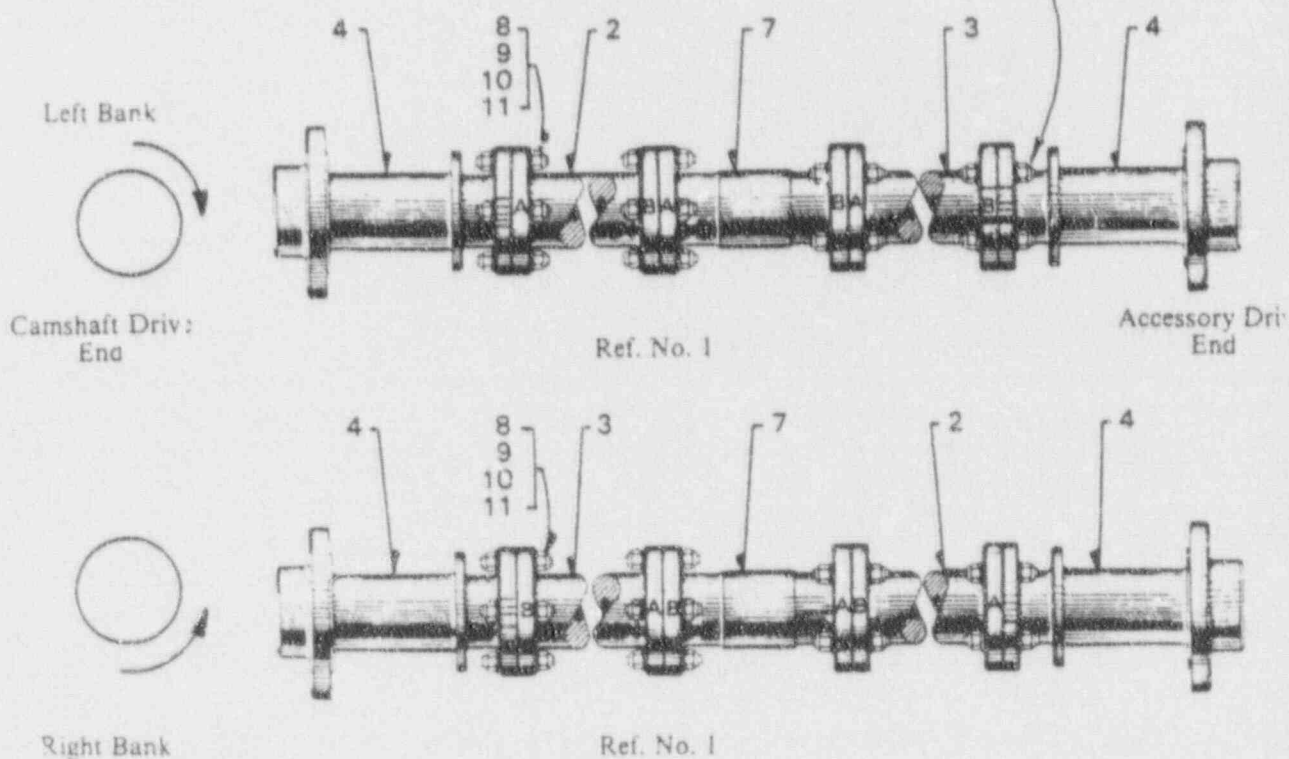
PLATE B28-4

MKW Power Systems received notification on 10/10/91 that, upon inspection of San Onofre Unit #3B diesel engine, one (1) camshaft locating stud (EMD #8034672) was found broken. Three (3) other studs were found cracked. The camshaft flange which contains the broken/cracked studs is located at the drivegear end of the left bank camshaft (see Attachment 2).

8	8034672	8 8 8	STUD .. Locating 3/8-24 x 2-3/8 .4370 shoulder
9	8034673	24 24 24	STUD .. Segment 3/8-24 x 2-3/8 .5000 shoulder
10	8035950	64 64 64	WASHER .. Special
11	8032717	64 64 64	NUT .. Lock 3/8-24 hex.
