LICENSEE EVENT REPORT (LER)

FACILITY NAME (1) <div style="text-align: center;">Surry Unit 1</div>										DOCKET NUMBER (2) <div style="text-align: center;">0 5 0 0 0 2 8 0</div>				PAGE (3) <div style="text-align: center;">1 OF 0 4</div>							
TITLE (4) <div style="text-align: center;">Reactor Trip: Low Steam Generator Level with Steam Flow / Feed Flow Mismatch</div>																					
EVENT DATE (5)			LER NUMBER (6)				REPORT DATE (7)			OTHER FACILITIES INVOLVED (8)											
MONTH	DAY	YEAR	YEAR	SEQUENTIAL NUMBER	REVISION NUMBER	MONTH	DAY	YEAR	FACILITY NAMES				DOCKET NUMBER(S)								
0	2	0	6	8	4	8	4	0	0	3	0	0	3	0	6	8	4				
			THIS REPORT IS SUBMITTED PURSUANT TO THE REQUIREMENTS OF 10 CFR §: (Check one or more of the following) (11)																		
OPERATING MODE (9)			20.402(b)				20.406(e)				50.73(a)(2)(iv)				73.71(b)						
POWER LEVEL (10)			20.406(a)(1)(i)				50.73(a)(1)				50.73(a)(2)(v)				73.71(e)

FACILITY NAME (1) Surry Unit 1	DOCKET NUMBER (2) 0 5 0 0 0 2 8 0	LER NUMBER (6)			PAGE (3)		
		YEAR	SEQUENTIAL NUMBER	REVISION NUMBER			
		8 4	0 0 3	0 0	0 2	OF	0 4

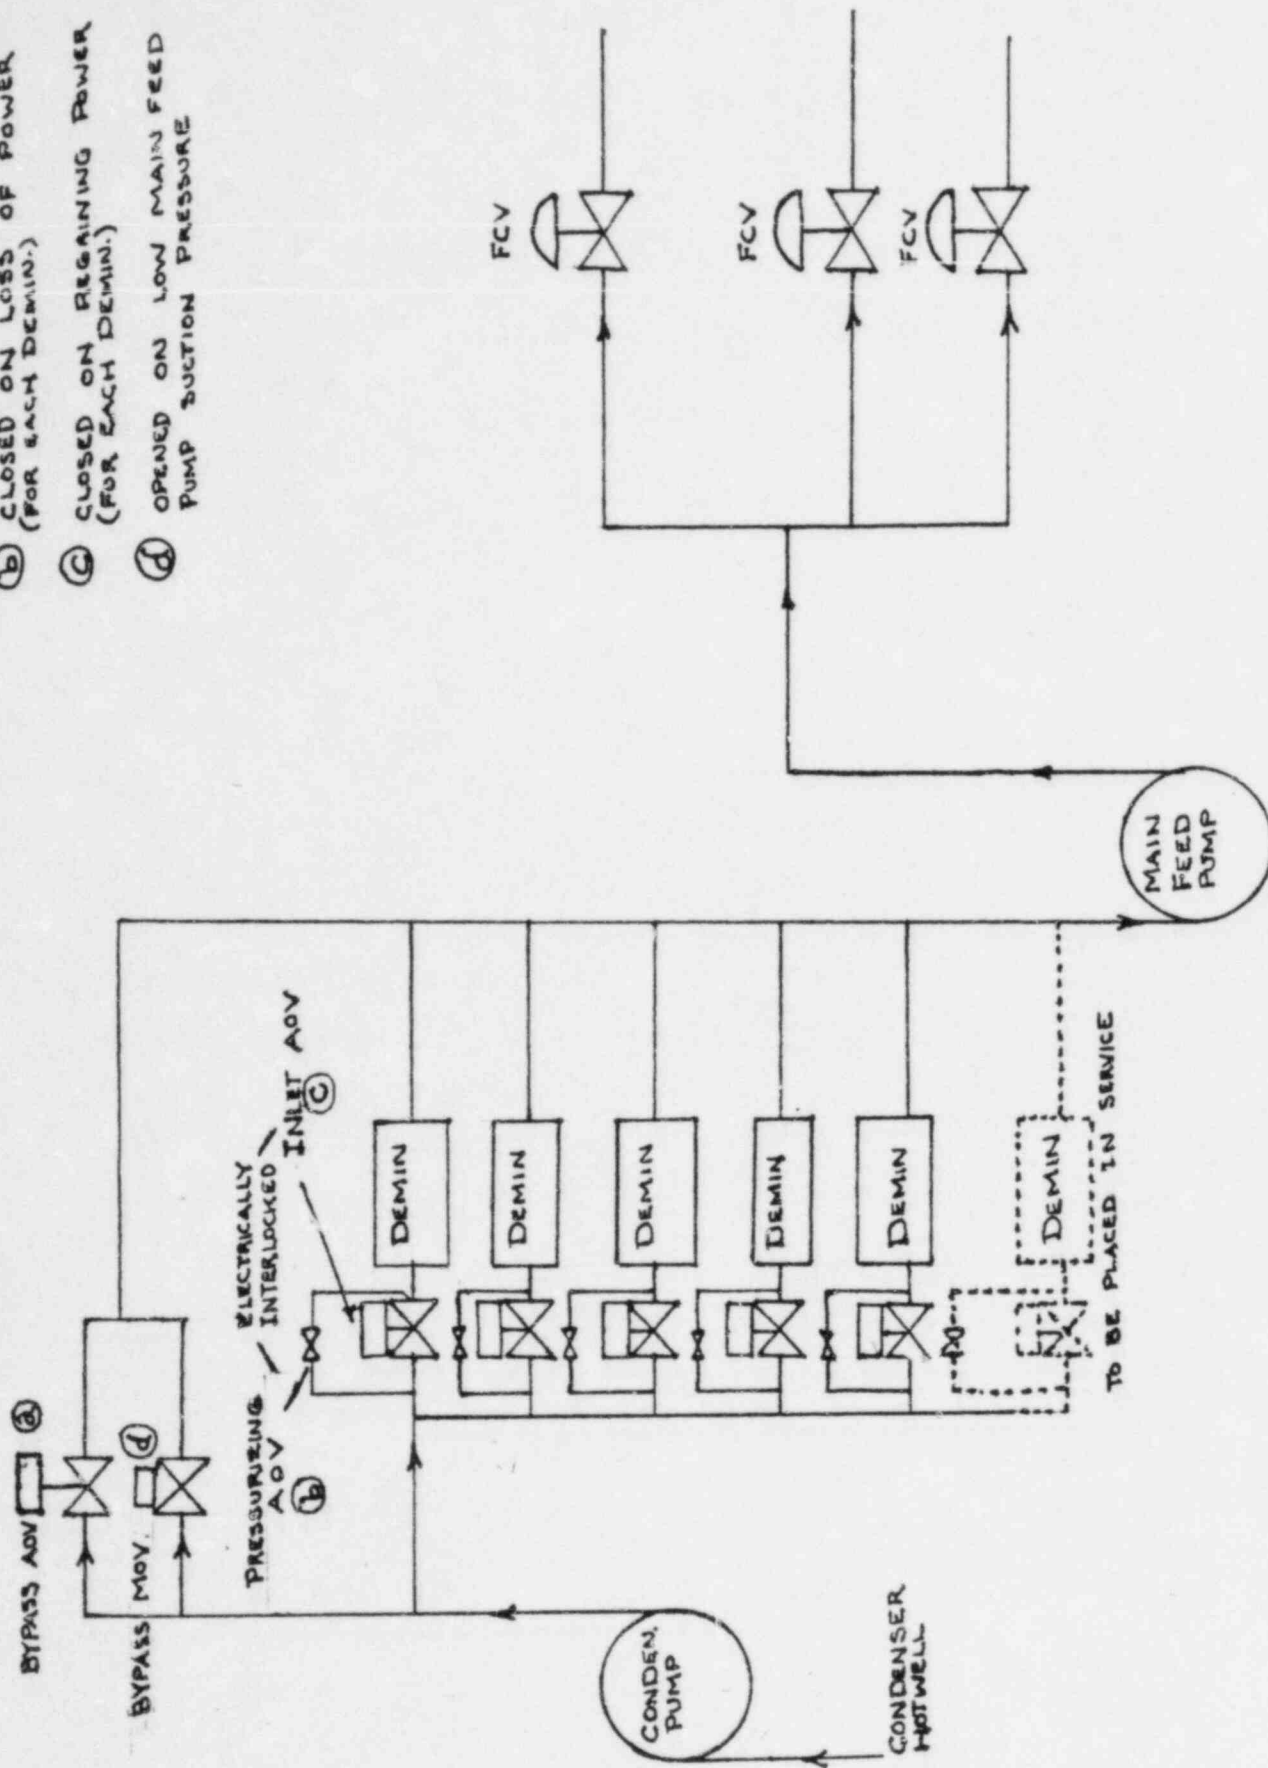
FIGURE I

- 1) The normally open "Pressurizing Valves" to the individual condensate polishing demineralizers beds (EIIS No. FDM) closed and signaled the demineralizers 10 inch "Inlet Valves" (EIIS No. PDCV) to close. However, the demineralizer Inlet Valves did not close because of the loss of control power. (See Figure 1).
- 2) The polishing building bypass AOV fully opened.

Re-energizing the control panel (1-CP-PNL-1) caused the Inlet Valves to the individual demineralizer beds to close. These valves are electrically interlocked with the demineralizer bed pressurizing valves.

The closure of the inlet valve to the demineralizer beds caused low suction pressure to the main feed pumps (EIIS No. P) which resulted in the automatic opening of the condensate polishing building bypass MOV (Motor Operated Valve). The decrease in condensate supply to the main feed pumps resulted in a decreased main feedwater flow and steam generator level. As a result, the reactor tripped on feed flow/steam flow mismatch with low level in "A" steam generator.

- ② OPENED ON LOSS OF POWER
- ③ CLOSED ON LOSS OF POWER (FOR EACH DEMIN.)
- ④ CLOSED ON REGAINING POWER (FOR EACH DEMIN.)
- ⑤ OPENED ON LOW MAIN FEED PUMP SUCTION PRESSURE

- 1) A label will be installed on the feeder breakers to provide a caution that the polisher must be bypassed prior to reclosing the breaker.
- 2) An Engineering Study will be performed to review the control logic of the polishing building bypass.
