ABNORMAL OCCURRENCE REPORT

REPORT NO. AO-S1-74-09

VIOLATION OF LIMITING CONDITION
OF OPERATION
EMERGENCY DIESEL GENERATOR FUEL OIL SUPPLY

SURRY POWER STATION
VIRGINIA ELECTRIC AND POWER COMPANY

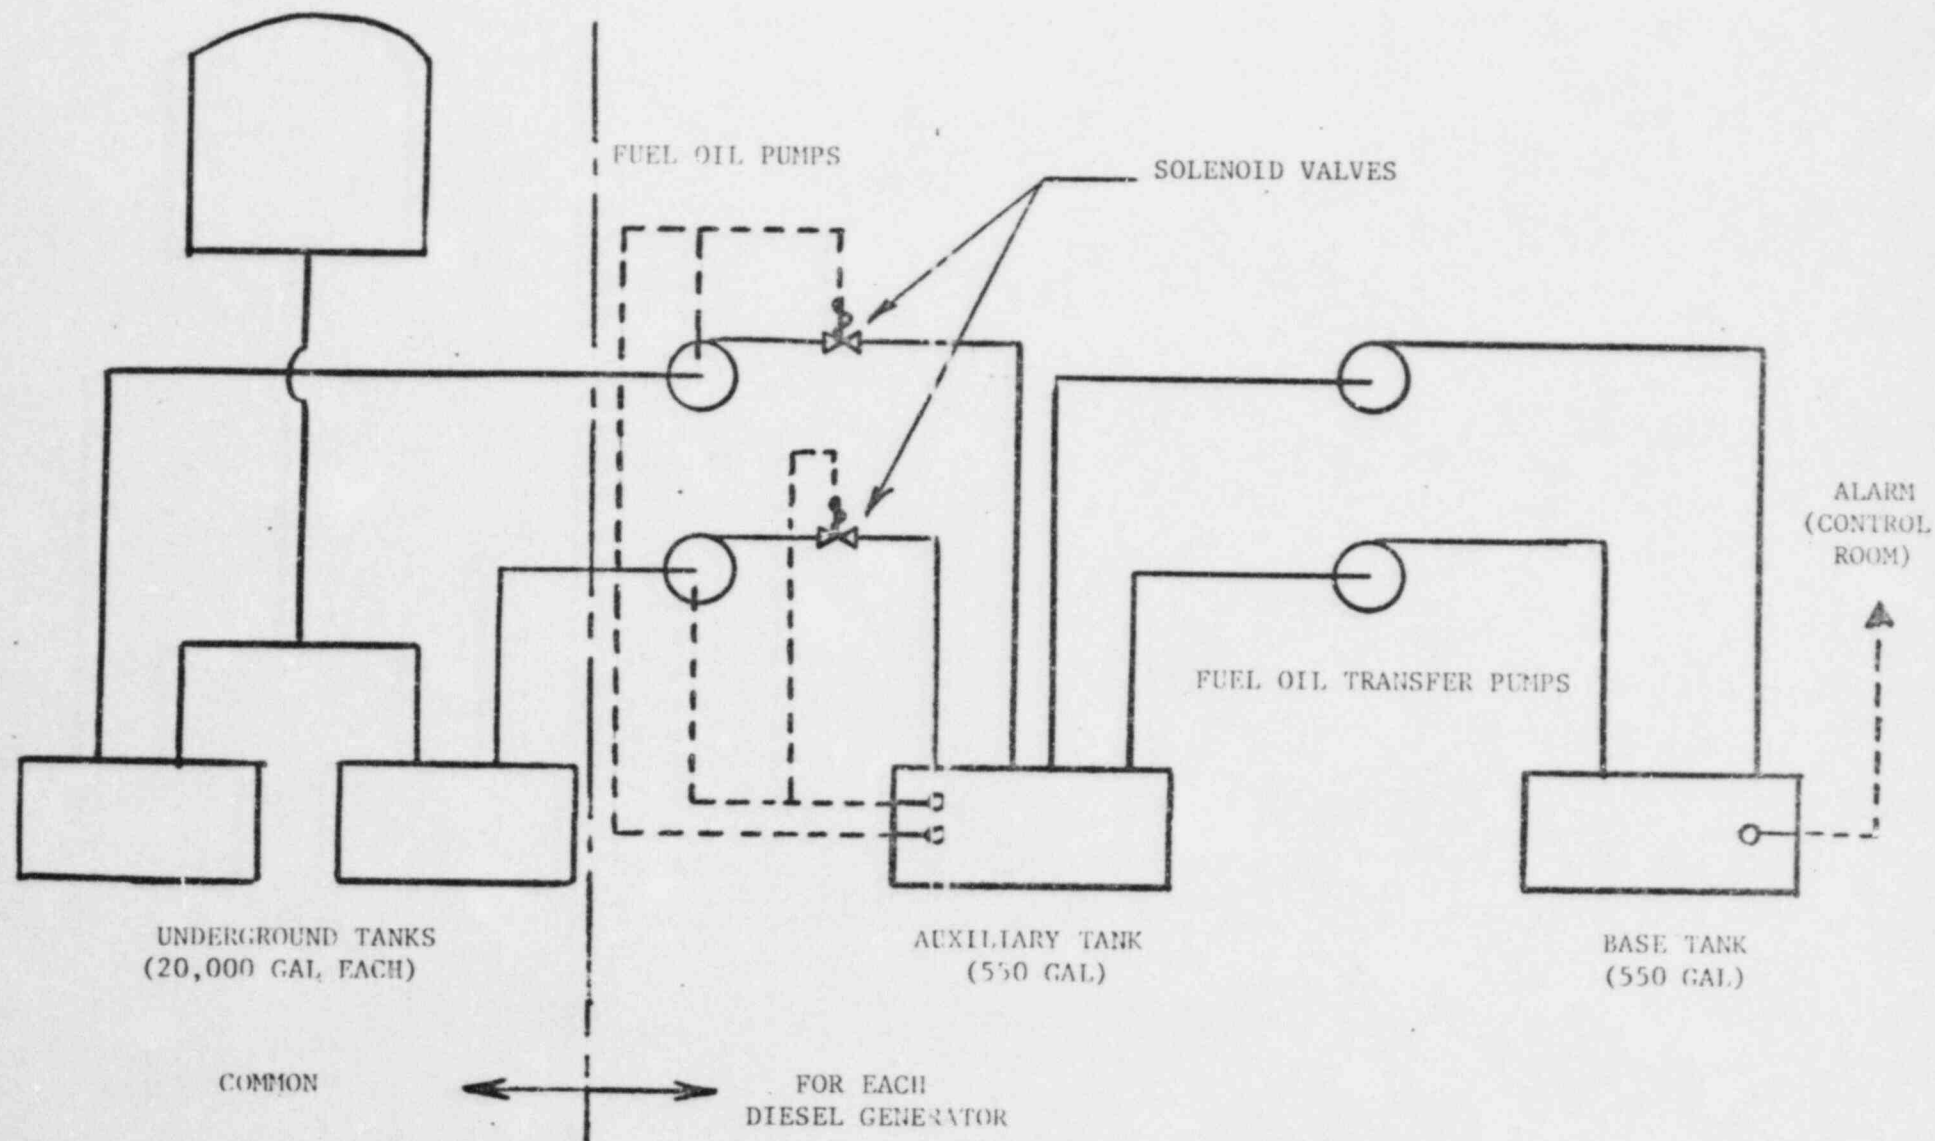
EMERGENCY DIESEL GENERATOR FUEL OIL SYSTEM

The diesel generator fuel oil supply system is schematically shown in the attached figure. The system consists of a 550 gallon capacity base tank on the diesel generator, two (2) fuel oil transfer pumps for each diesel generator, an auxiliary tank of 550 gallon capacity, two (2) fuel oil pumps, two (2) underground tanks (20,000 gallons each) and a 210,000 gallon aboveground storage tank. The aboveground storage tank and the underground tanks serve the three (3) diesel generators. Each of the diesel generators is equipped with redundant flow paths containing the remainder of the listed equipment.

The occurrence reported herein was caused by the inoperability of both level switches in the auxiliary tank. Investigation of the occurrence revealed that only one (1) of the two (2) level switches were in place. The in place switch had apparently been rendered inoperable as a result of a faulty spring causing the switch to hang up. The other switch had been removed from service for approximately two (2) weeks to repair a faulty mercooid switch. Since each of the level switches separately actuate one (1) fuel oil pump, both of the pumps were rendered inoperable in the automatic mode.

The immediate corrective action was to repair both defective switches and return them to service. In addition, a low level alarm will be added to the auxiliary tank to indicate when a problem occurs in the fuel transfer from the underground tank to the auxiliary tank.
