Houston Lighting & Power South Texas Project Electric Generating Station P. O. Box 289 Wadsworth, Texas 77483

South Texas Project
Units 1 & 2
Docket Nos. STN 50-498 & STN 50-499
Request for Relief from ASME Boiler and Pressure Vessel
Code, Section XI Requirements, Relief Request RR-ENG-10

REQUEST FOR RELIEF FROM ASME BOILER AND
PRESSURE VESSEL CODE, SECTION XI REQUIREMENTS
RELIEF REQUEST NO. RR-ENG-10

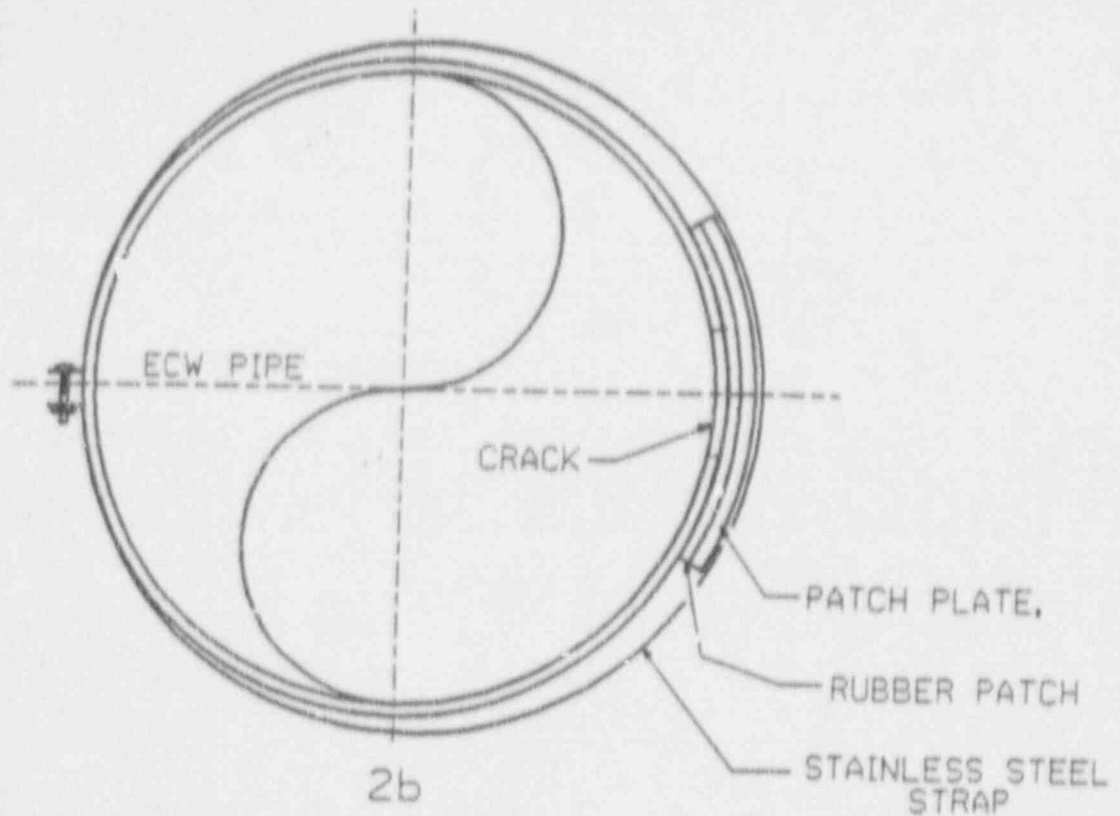
TEMPORARY REPAIRS TO STOP LEAKAGE

- (1) Leave the weld joint as is, subject to monitoring as described above, and subject to meeting the criteria for consequences and for structural integrity as described above.
- (2) Identical to option -1, except that a strap with rubber patch as shown in Attachment 2 may be used as an augmentation to stop the leakage, if deemed desirable for housekeeping reasons. Credit is not taken for such a patch for structural integrity. Daily monitoring will be conducted to assure that the patch is effective in limiting leakage, and the patch will be removed at the time of every monthly walkdown to visually monitor the crack size.
- (3) A welded patch, as shown in Attachment-2 which is used to stop leakage, with no credit for its addition to structural integrity. Monitoring of cracked weld will continue at the repair location outside the patch in the monthly walkdowns.
