Docket No. 50-346

March 6, 1984

On March 2, 1984, the Davis-Besse Nuclear Power Station, Unit 1, experienced a plant trip in which a Main Steam Safety Valve failed to fully close. The nature of the transient resulted in the activation of the Toledo Edison Emergency Plan with its classification as an Unusual Event. A limited Nuclear Regulatory Commission (NRC) Site Team was dispatched to observe Toledo Edison's actions.

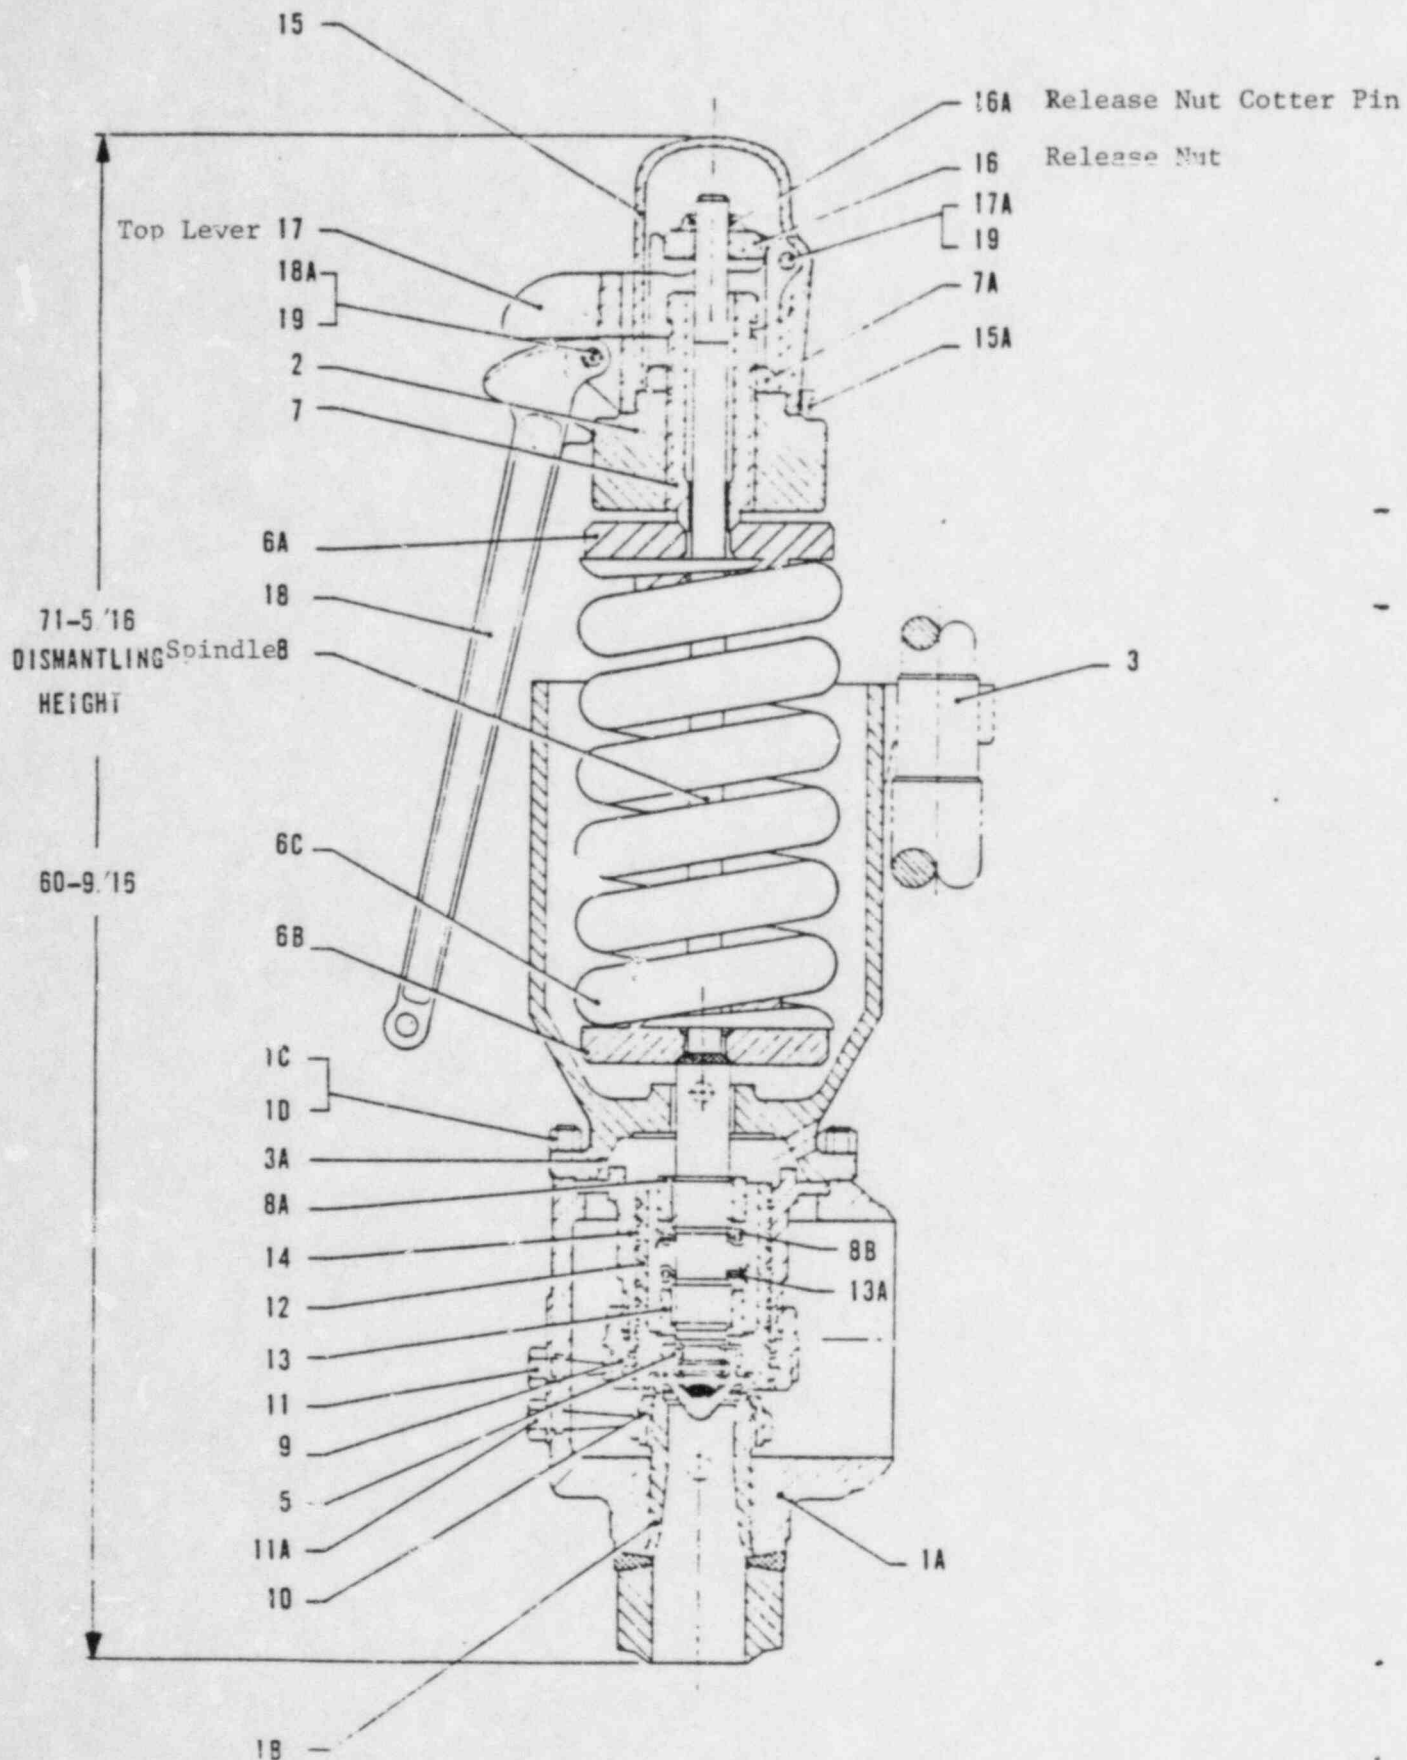
Response: Main Steam Safety Valve (MSSV), SP17A4, is a Dresser type 3707 RA-RT 21 valve. SP 17A4, having a set pressure of 1070 psig, lifted and failed to fully close.

Inspection of SP17A4 revealed the release nut cotter pin (Item 16A of Enclosure 1), which secures the release nut (Item 16) to the valve spindle (Item 8) was missing. The release nut had moved down on the spindle approximately one inch and was jammed on the top lever (Item 17). The spindle was also bent. Apparently, the release nut cotter pin was left out of the release nut or had broken during plant operation and vibrated out,

allowing the release nut to travel down the threaded end of the spindle while the valve was open. The bottom of the release nut made contact with the top lever preventing complete spindle travel for valve closure.

The existing release nut cotter pins will be replaced on all MSSV's before returning to power operation. Modifications were made to existing maintenance procedures to verify installation of new release nut cotter pins after maintenance or testing in the future.
