## LICENSEE EVENT REPORT

UPDATE REPORT

Instruction Number BF SI 4.10.A.1  
 Unit No. 1, 2, 3  
 Title REFUELING INTERLOCKS

TENNESSEE VALLEY AUTHORITY - BROWNS FERRY NUCLEAR PLANT UNIT 1 - DOCKET  
NO. 50-259 - FACILITY OPERATING LICENSE DPR-33 - REPORTABLE OCCURRENCE  
REPORT BFRO-50-259/E3C66 R1

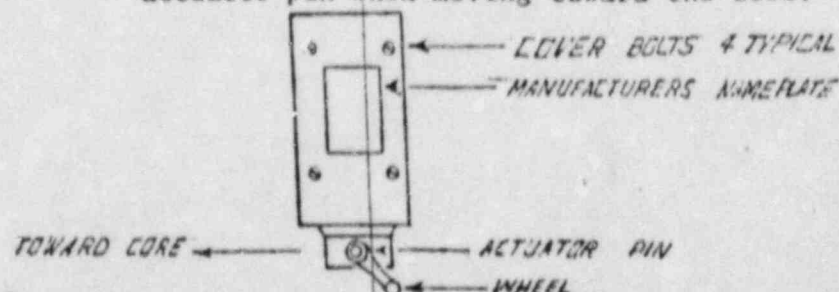
CAUTION: Verify that the refueling platform interlock limit switches actuate for both clock-wise and counter clock-wise operation. (If not, then adjust actuator to do so.)

Verify that the wheel on the actuator arm trails the actuator pin when moving toward the core.

Verify that the actuator arm is adjusted so that the contacts are in (1) the normal position when the cam is not under the limit switch and (2) the non-normal position when the cam is under the switch.
