Northern States Power Company

MONTICELLO NUCLEAR GENERATING PLANT
Docket No. 50-263 License No. DPR-22

LER 95-003

Equipment Supports Connected to Steel Shoring Plates

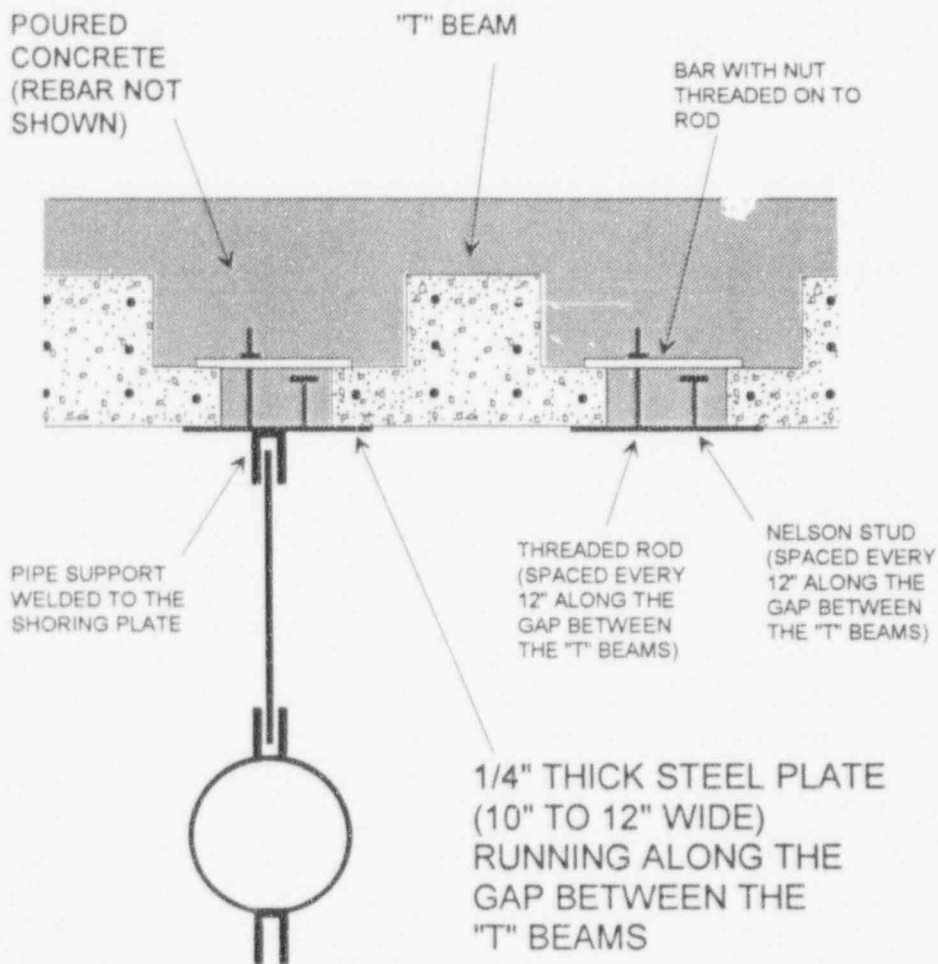
FLOOR CROSS SECTION

In 1993, during a stress re-analysis of the Scram Discharge Volume (EIS System Code: AA), a Scram Discharge Volume support (EIS Component Code: SPT)(Support number H-231) was found attached to a steel shoring plate. During a 1989 modification, the support was moved and attached to the shoring plate. The design engineers assumed the plate was an embedded plate, but the plate was actually a shoring plate¹. Shoring plates have a Nelson stud and a threaded rod attached every 12" (See Figure). The threaded rods were used to hold the shoring plates in place during the concrete pour.

All the attachments are believed to have been made during original construction except the support for the Scram Discharge Volume (H-231). The Scram Discharge Volume support was attached to what was assumed to be an embedded plate. Engineering personnel should have better identified the characteristics of the plate the support was being attached to.

¹ Shoring plates were used between concrete "T" beams in some of the reactor building floors. These floors were constructed from parallel concrete "T" beams and the shoring plates were used to contain the concrete poured between the beams to make the floor. Embedded plates are generally thicker with Nelson studs attached to provide support and flush with the concrete as the concrete was poured around them. Base plates are thicker than shoring plates also, but are attached after the concrete surface is poured. They are typically attached with concrete anchor bolts.

1. The plant was inspected to identify safety related supports attached to shoring plates (the results were discussed above).
2. The Scram Discharge Volume and Main Steam supports were modified. The rest of the pipe supports were determined to comply with the code in their existing condition. All supports comply with code requirements.
3. The cable tray support plates have been analyzed to meet all applicable code requirements.
4. This report will be discussed at Engineering Technical Staff Training.
