BRUNSWICK STEAM ELECTRIC PLANT, UNIT NO. 1
DOCKET NO. 50-325 / LICENSE NO. DPR-71
NRC GENERIC LETTER 94-03, "INTERGRANULAR STRESS CORROSION CRACKING OF
CORE SHROUDS IN BOILING WATER REACTORS"

BRUNSWICK STEAM ELECTRIC PLANT, UNIT 1 NRC DOCKET NO. 50-325 OPERATING LICENSE NO. DPR-71

REVISED UNIT 1 CORE SHROUD REINSPECTION SCOPE - WELDS H6a AND H6b B110R1 REFUELING OUTAGE

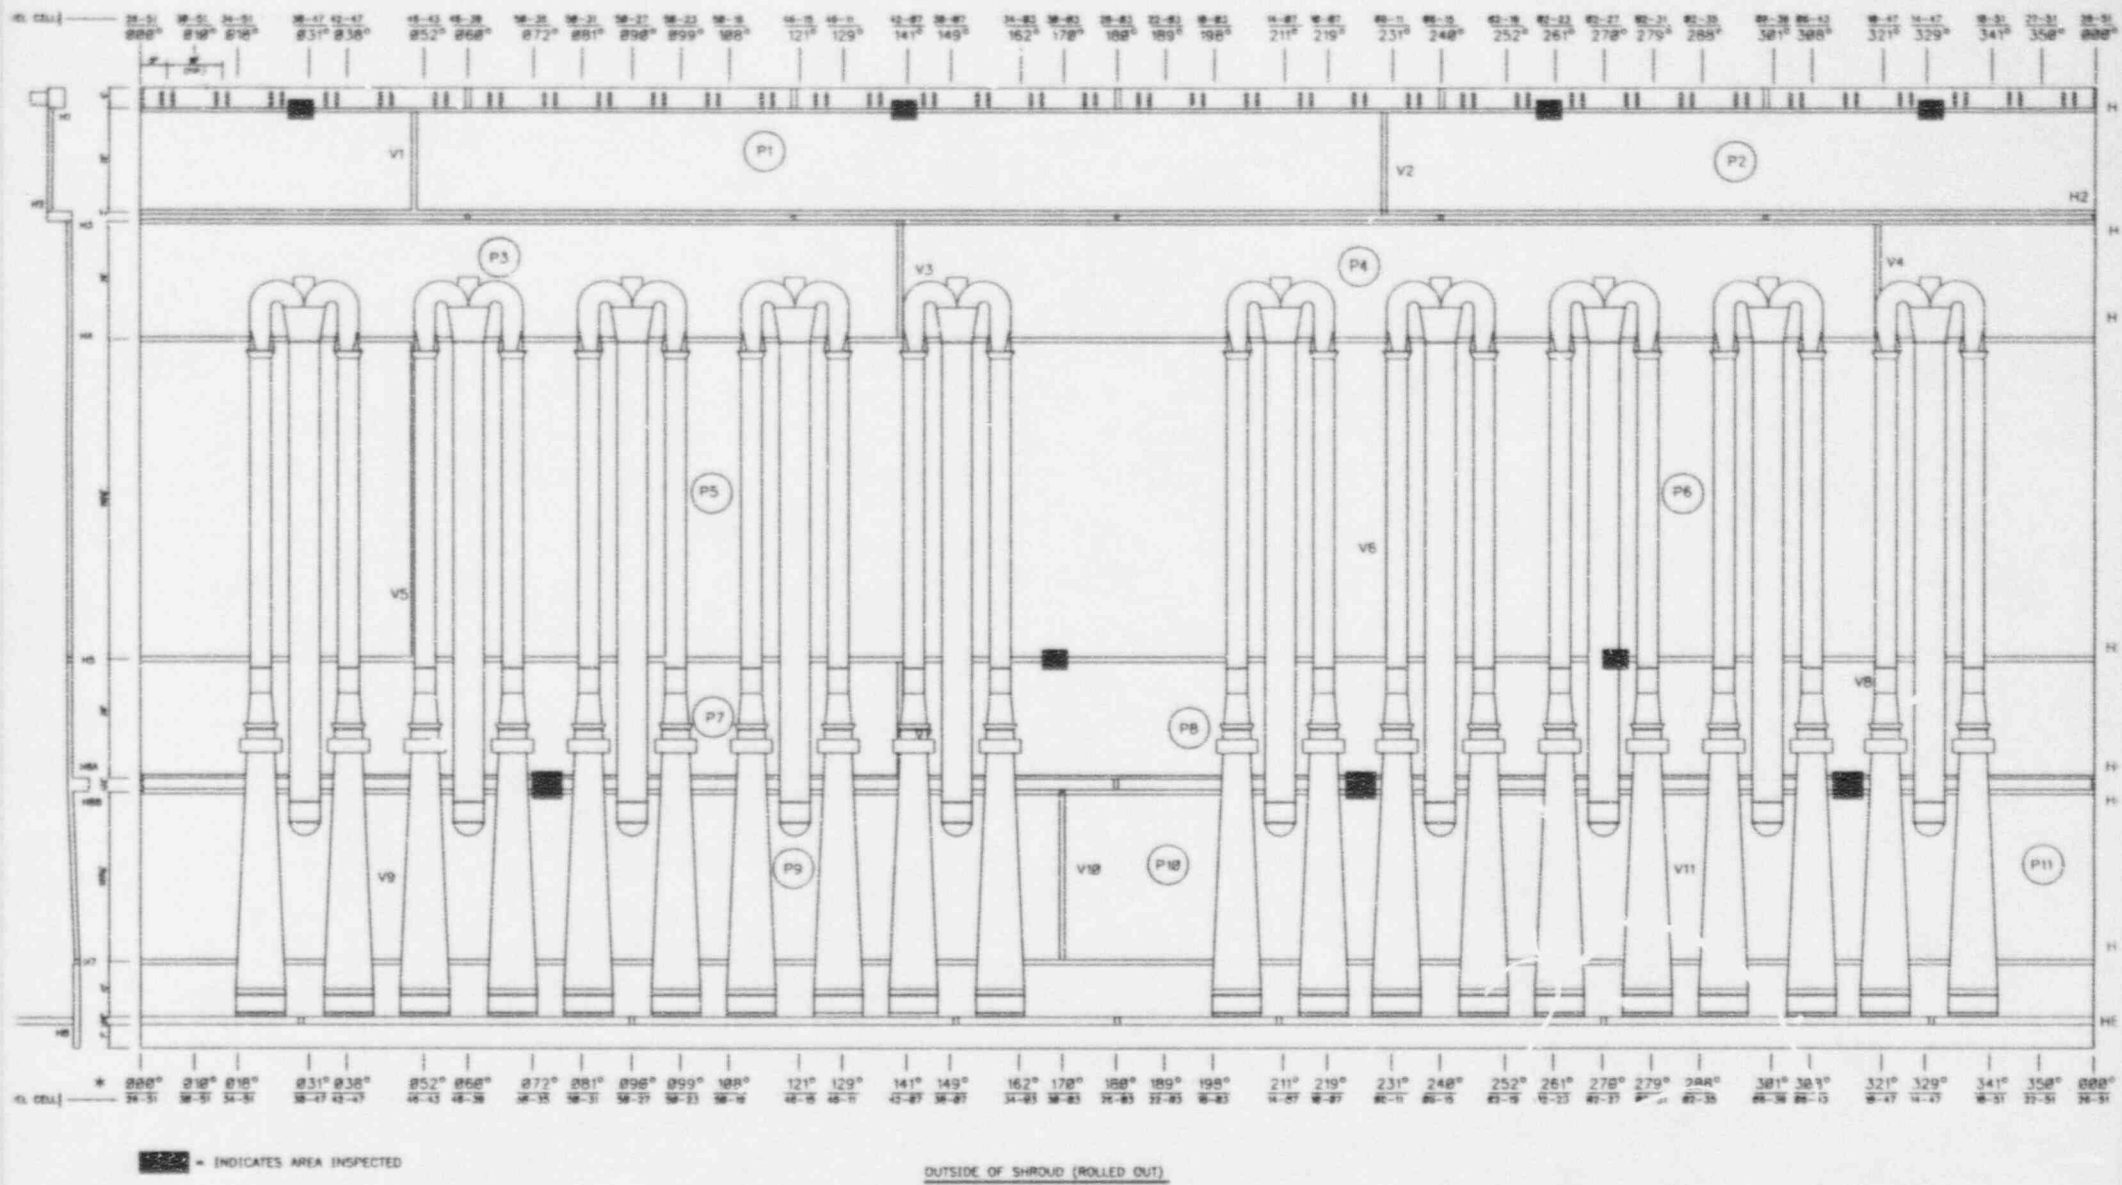
Rollout Drawing of the OD of the Core Shroud for BNP U1
Figure 1

During VT inspection of approximately 48% of the OD of the H6a/6b welds during the last outage (B109R1), 3 small axial indications were found on H6a and H6b welds. Creeping wave UT, designed to detect surface cracking on the OD of the shroud, was employed on the scanner package during inspections this outage. No additional OD cracks were found in the three areas inspected this outage.

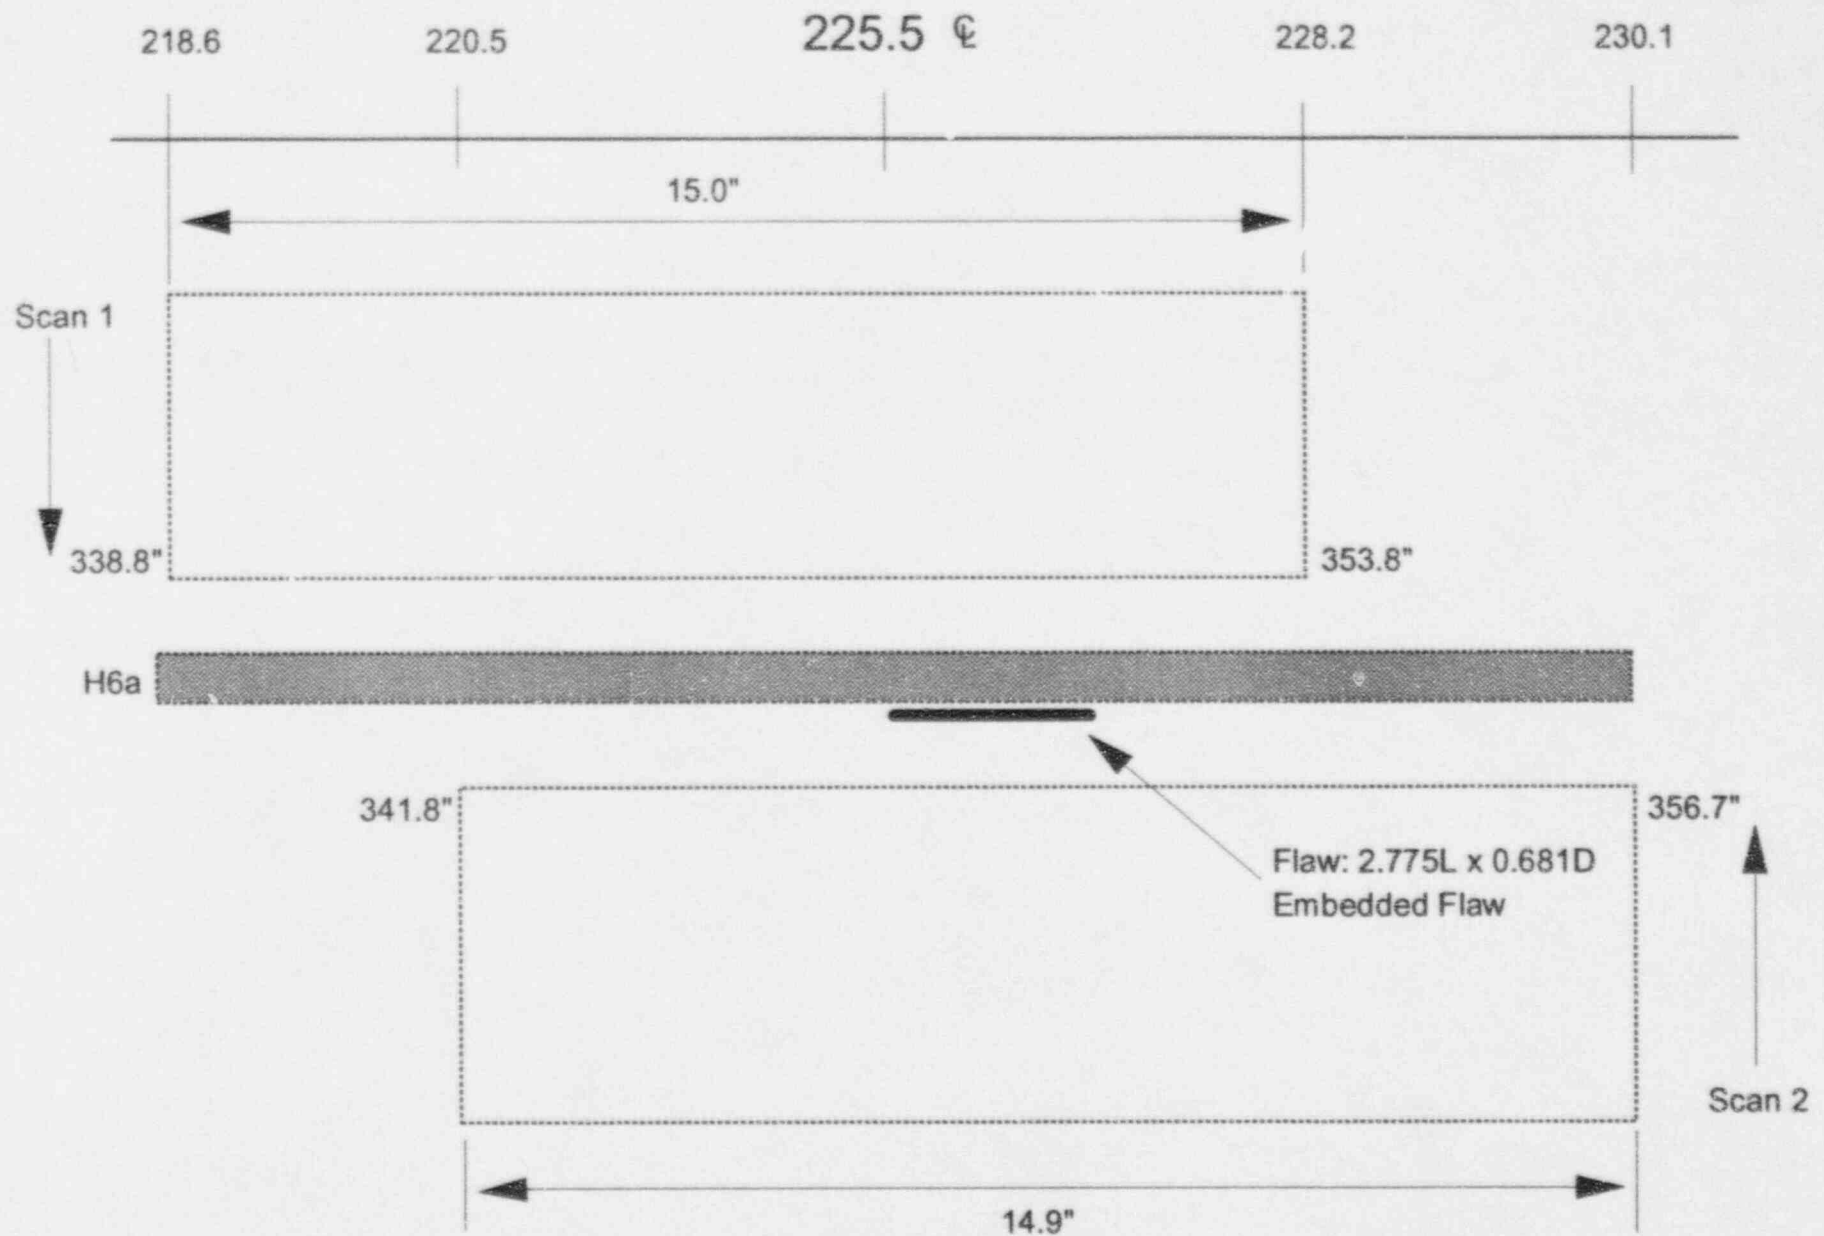
Core Shroud H6a Weld @ 225 Deg

UT examinations of the three H6a/H6b weld areas scanned this outage total approximately 53 inches, 88% of the planned inspection area (60 inches). Five (5) indications were recorded in these areas. Two indications, H6a at 225.5 degrees and H6b at 75.5 degrees, are imbedded flaws that were not connected to either the ID or OD surface. These flaws are considered original fabrication flaws and are not IGSCC-related.

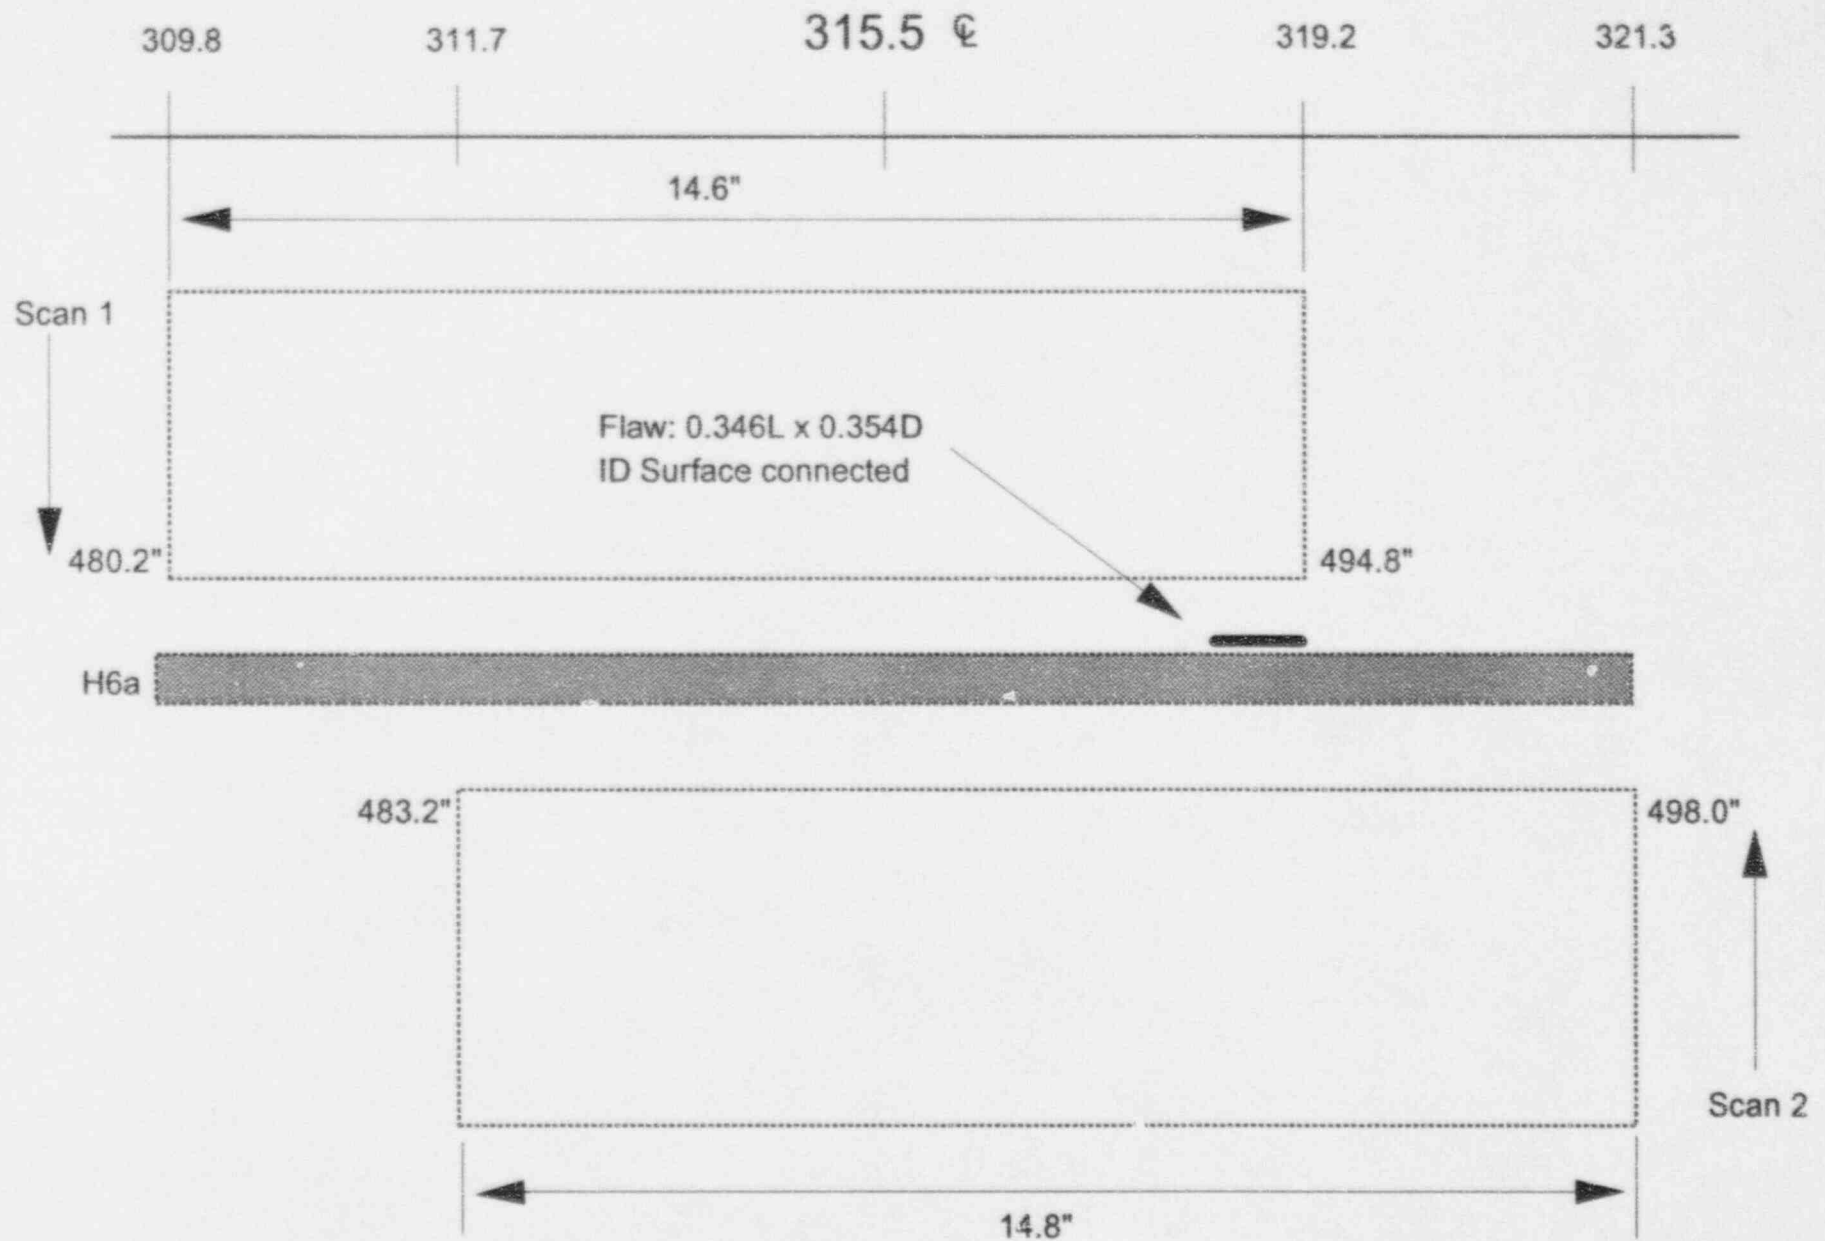
Core Shroud H6a Weld @ 315 Deg

Three indications were observed which contained ID surface-connected flaws, totaling approximately 7.3% of the 53 inches of total area scanned (see Table 1). One indication was observed in the H6a weld area at the 315° azimuth. This indication has been preliminarily sized as 0.346" long by 0.354" deep. The actual length of the indication could not be determined since the indication continued out of the scan window; however, the indication is bounded by the V8 vertical weld and would be limited to about 3" in length. Rollout drawings of the core shroud and detailed scan area drawings for the H6a/H6b weld locations inspected during this outage are provided as Figures 1 through 8.

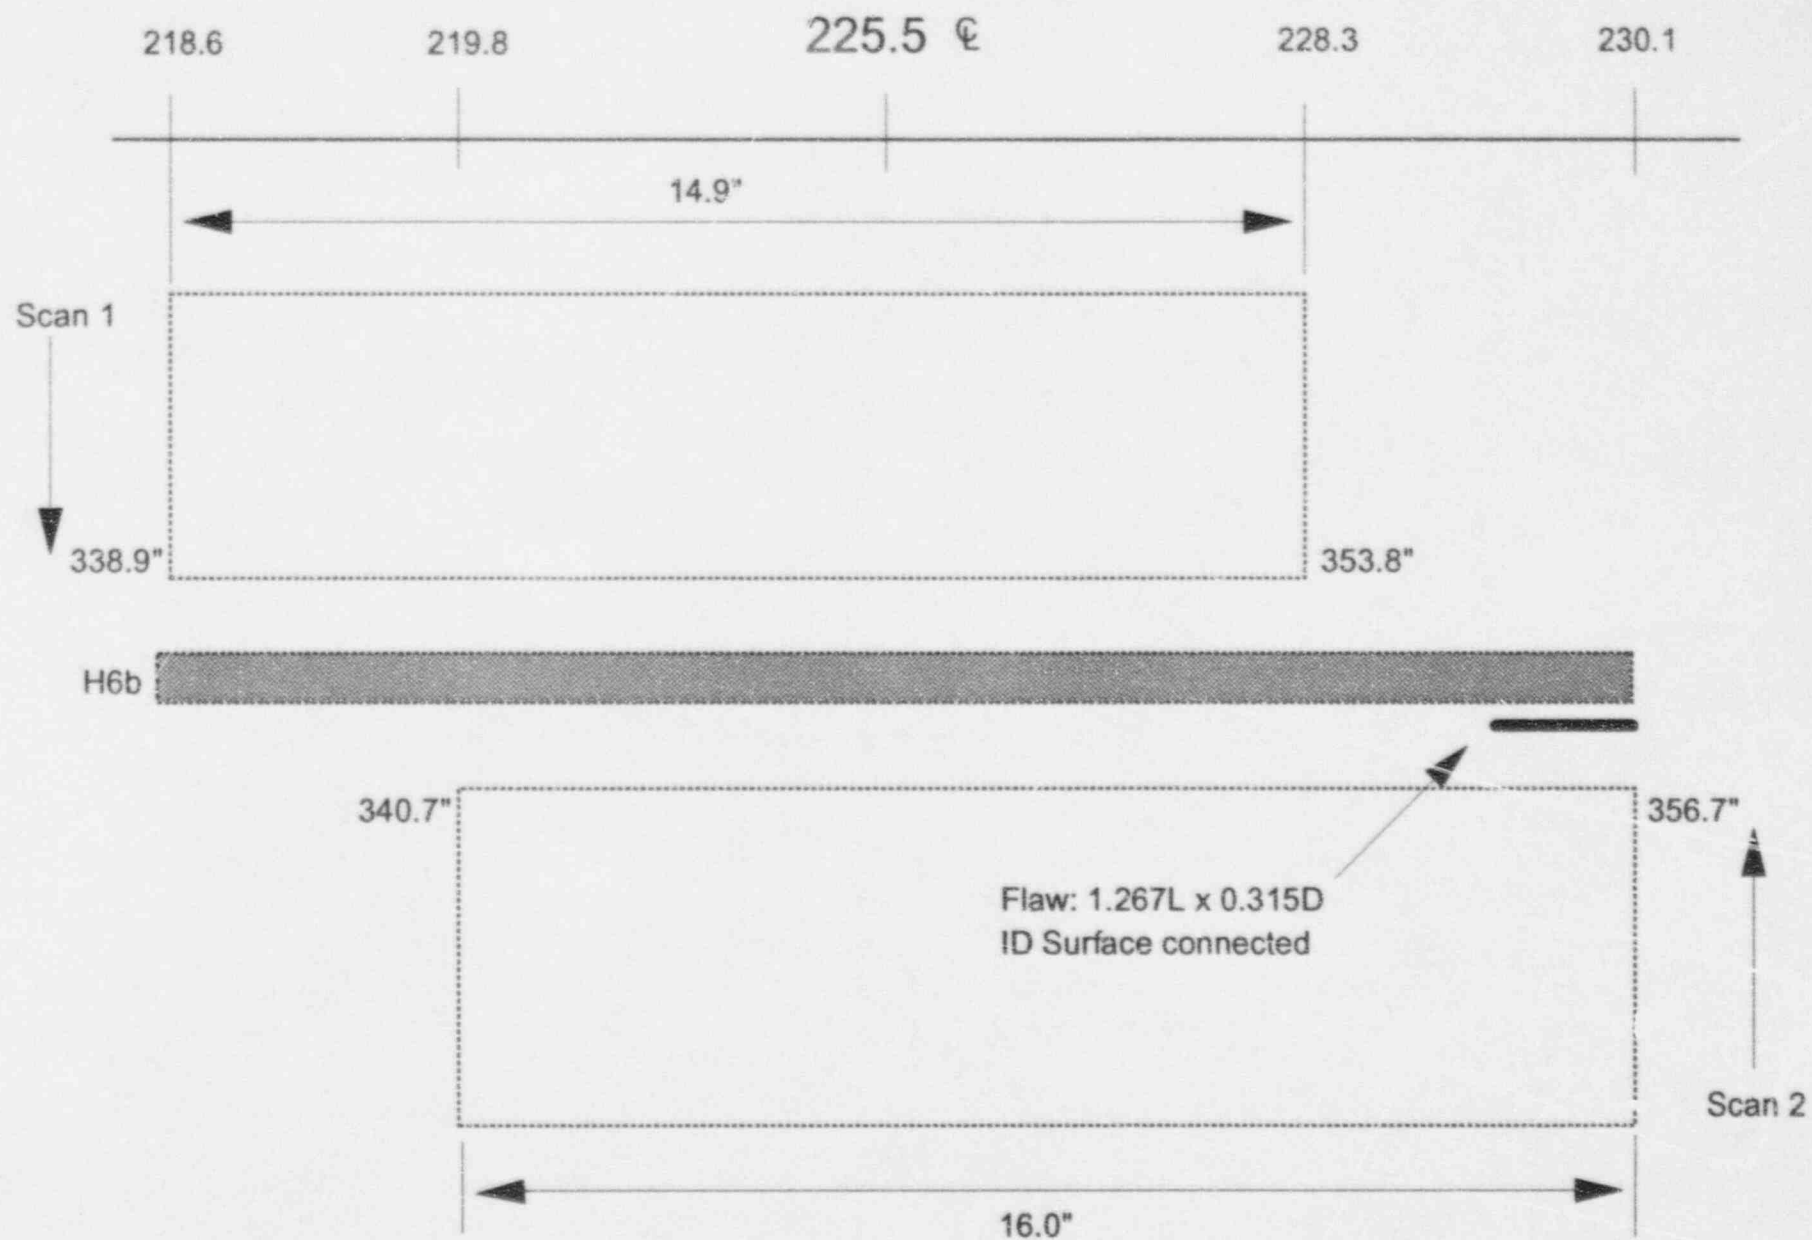
Core Shroud H6b Weld @ 225 Deg

Two indications were observed in the H6b scan areas; one at 225° azimuth and the other at the 315° azimuth. The indications were 1.3" long by 0.276" deep (225°) and 2.3" long by 0.551" deep (315°), respectively. Actual length for the indication at the 225° azimuth could not be determined because the indication continued out of the scan window.

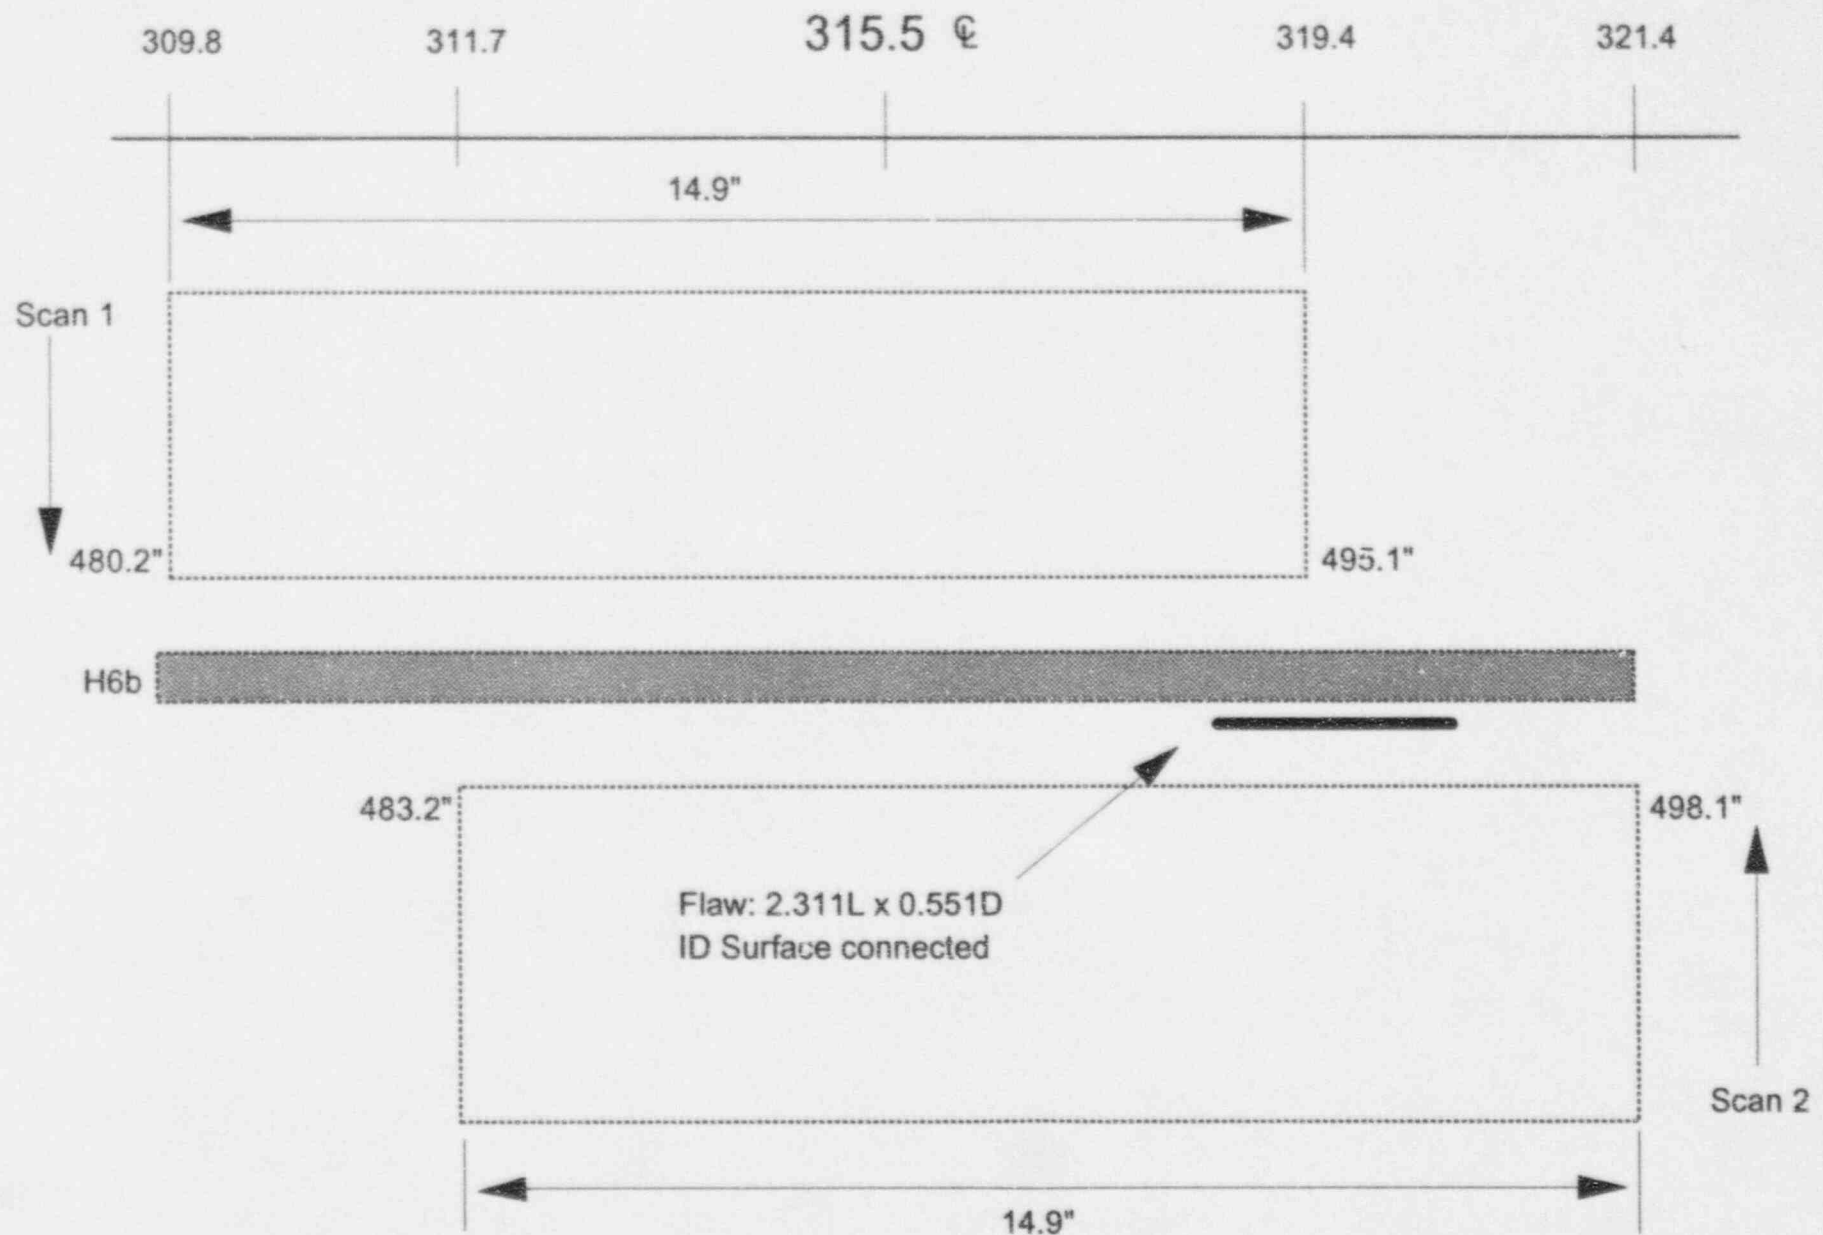
Core Shroud H6b Weld @ 315 Deg

Applied stresses are higher at H6b than at H6a; therefore, the H6b weld was analyzed as the limiting case. Load cases were analyzed using the deepest reported indication (0.551"). This indication was conservatively assumed to be 360°, even though UT results clearly show that the welds are not cracked 360°.
