SUBJECT: Information Pertaining to the Effects of Chemical Cleaning on
Byron Unit 1 Steam Generators

Byron Nuclear Power Station Unit 1
NRC Docket Number 50-454

ATTACHMENT A

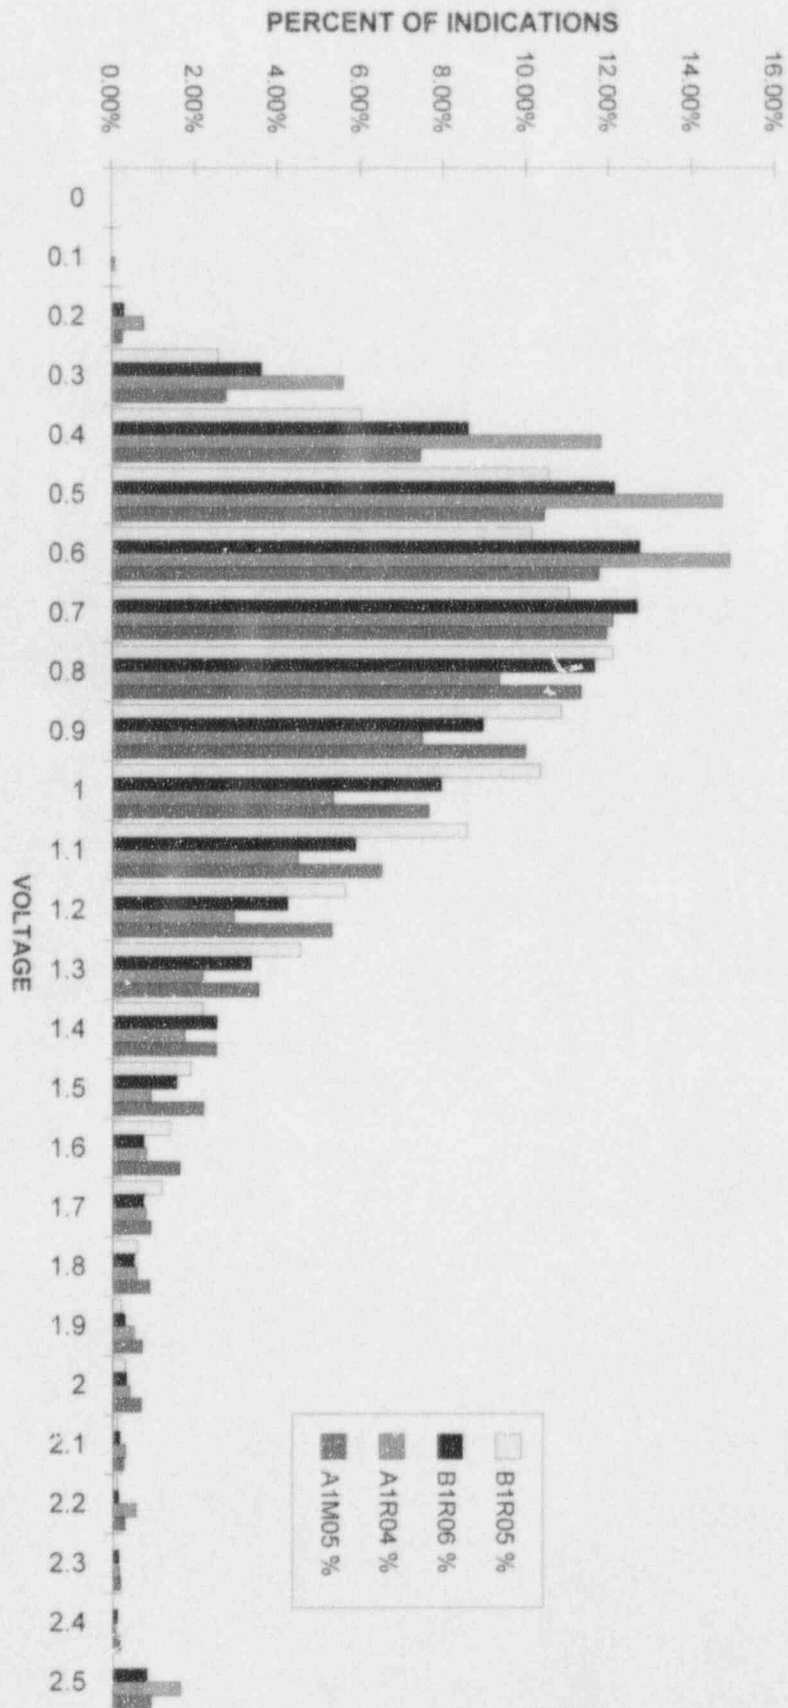
FIGURE 1
BYRON/BRAIDWOOD VOLTAGE DISTRIBUTION

Figures 1 and 2 show the total as-found voltage distributions from B1R05, B1R06, A1R04 and A1M05. These figures indicate that the voltage distributions are very similar. The B1R06 post-cleaning voltage distribution on a percentage basis is bounded by the no-cleaning distributions. The variations of voltage distributions between steam generators during a single inspection are nearly identical to the variations between inspections, as shown in Figure 3. The voltage distributions continue to be similar between Byron following chemical cleaning and Braidwood, indicating that the cleaning process did not affect the as-found voltage amplitudes. Consequently, the voltage growth rates determined by the post-cleaning inspection would also not be affected by the cleaning process. This conclusion is supported by Figures 4 and 5, which show the respective voltage progression scatter plots for B1R06 and A1R04 normalized to a per EFPY progression for a direct comparison. These two voltage progressions are nearly identical. In terms of negative growth rates, the scatter plots show that there is virtually no difference between the Byron (post-cleaning) and the Braidwood (no-cleaning) results. Since the inspections employed the same inspection guidelines and techniques, it can then be concluded that normal eddy current variability was experienced at Byron following the chemical cleaning.

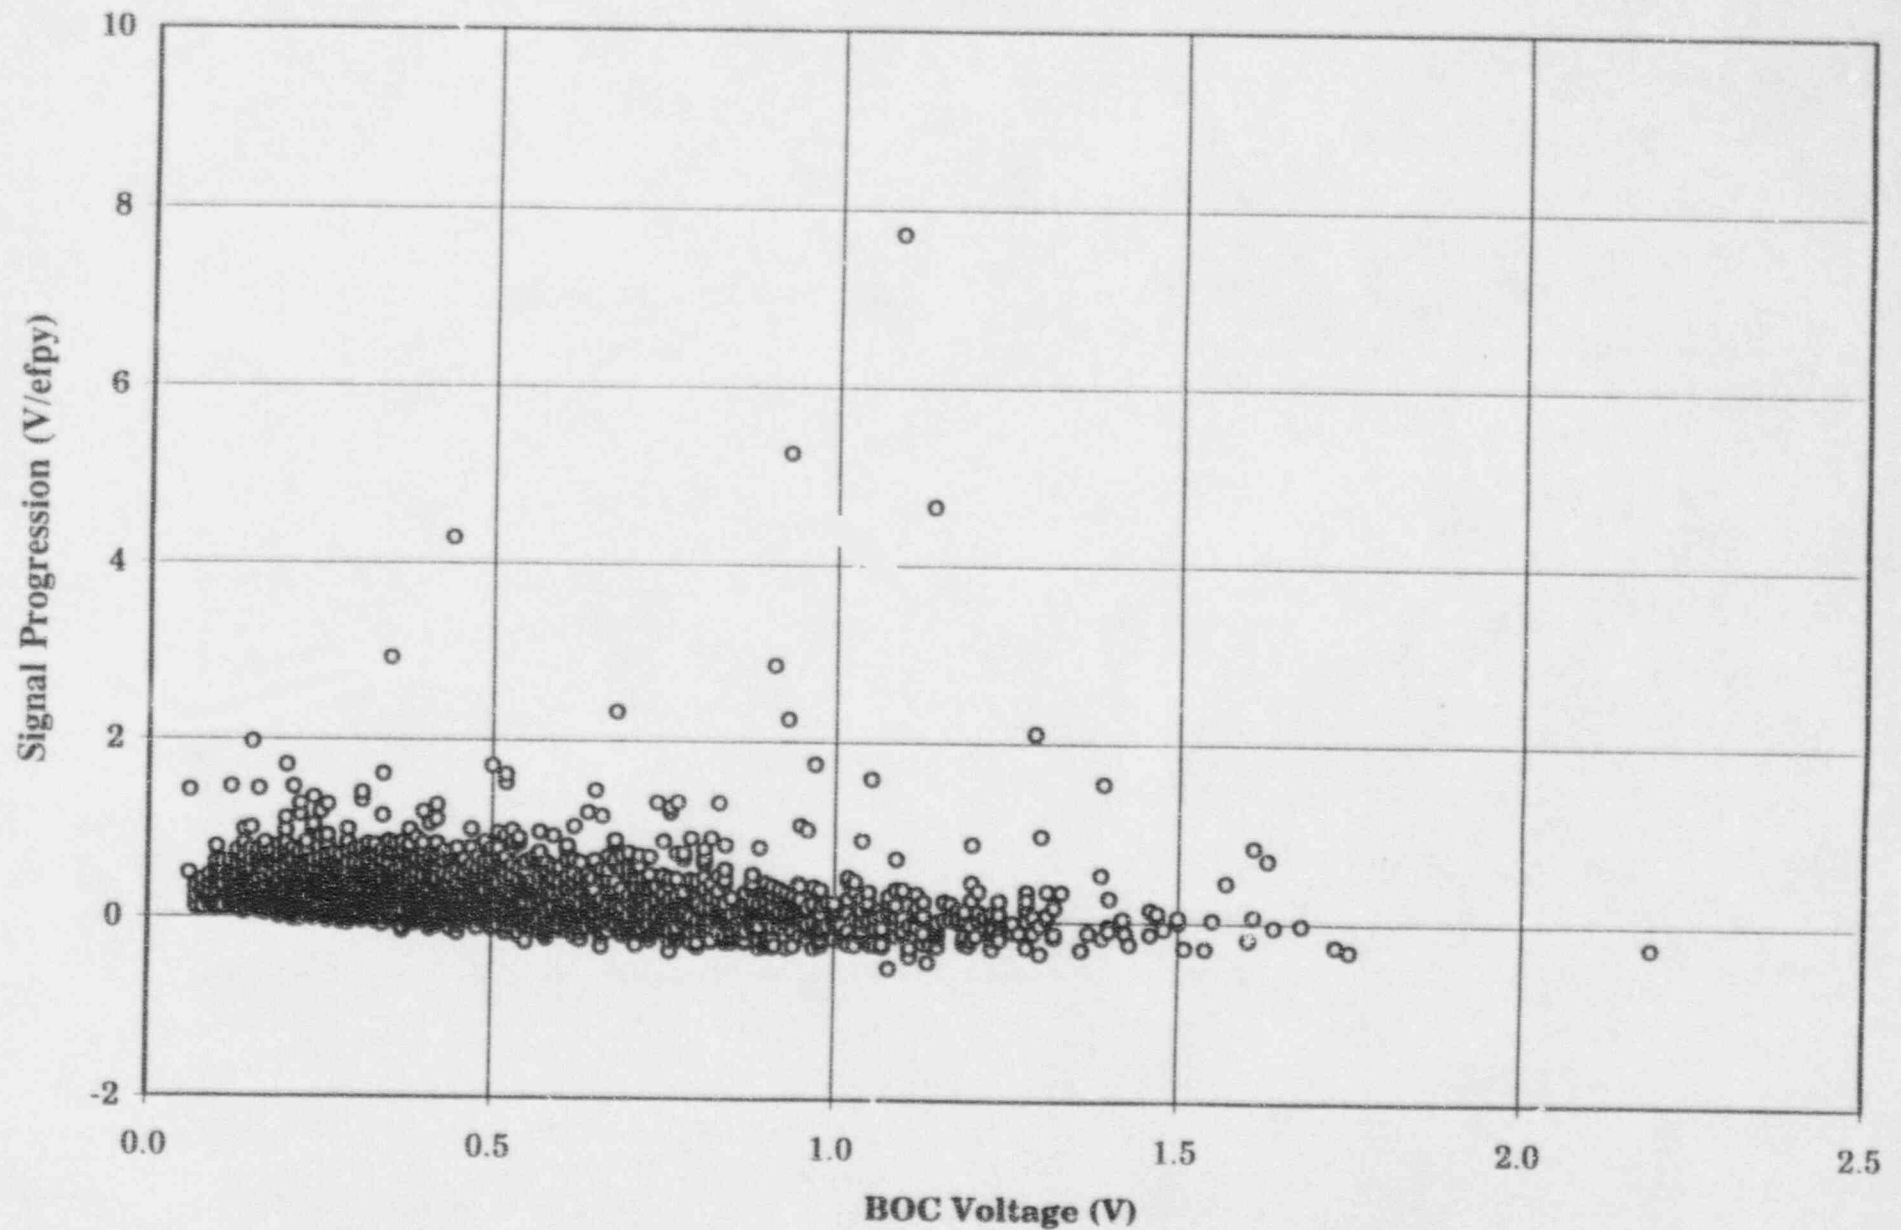
FIGURE 5

Braidwood Unit 1 1994 Inspection, Support Plate ODS/SCC Signal Progression

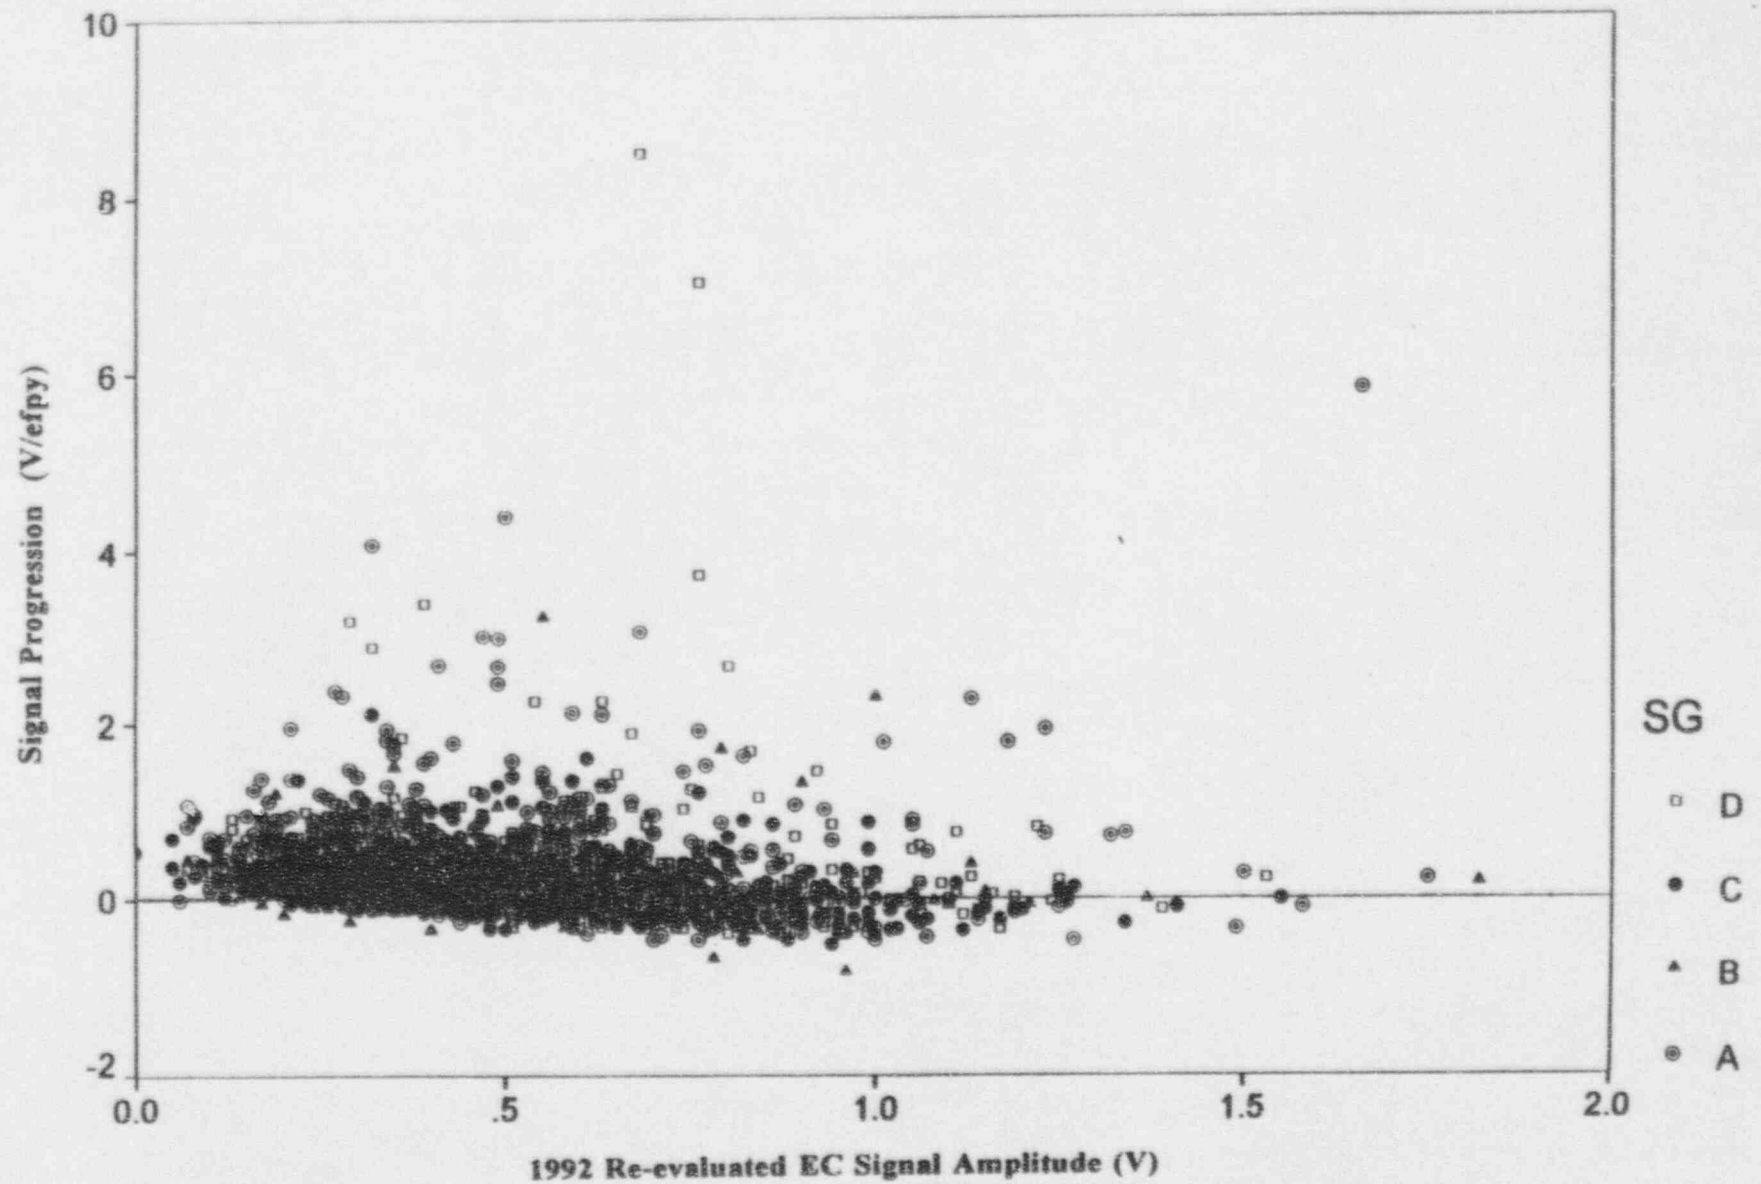
FIGURE 6
BYRON/BRAIDWOOD GROWTH RATE DISTRIBUTION

Figures 6 and 7, show the growth rate distributions for B1R06, A1R04 and A1M05 in cumulative percentage and bar chart formats. These distributions indicate similar voltage growth patterns with B1R06 experiencing a slightly lower incidence of zero to negative growth than Braidwood. This could possibly be due to less distortion in the signals as a result of the cleaning. Lower signal distortion increases the signal-to-noise ratio, thus reducing the variability of detection and sizing. This results in an increased detection sensitivity to lower voltage indications, but also reduces the number of false indications due to signal distortion. This is demonstrated by Figure 8, which shows that the RPC confirmation rate of B1R06 (post-cleaning) is significantly higher for lower amplitude indications than the B1R05 (pre-cleaning) confirmation rates. The increased detection sensitivity and reduction of false calls result in a net cancellation effect of the number of indications detected. The total number of indications detected following chemical cleaning continued to follow the pre-cleaning degradation curve with no unexpected increases or decreases in the number of indications detected, as shown in Figure 9. As previously discussed, the post-cleaning voltage distributions were consistent with the pre-cleaning or no-cleaning distributions, which indicates that chemical cleaning did not globally affect defect sizing.

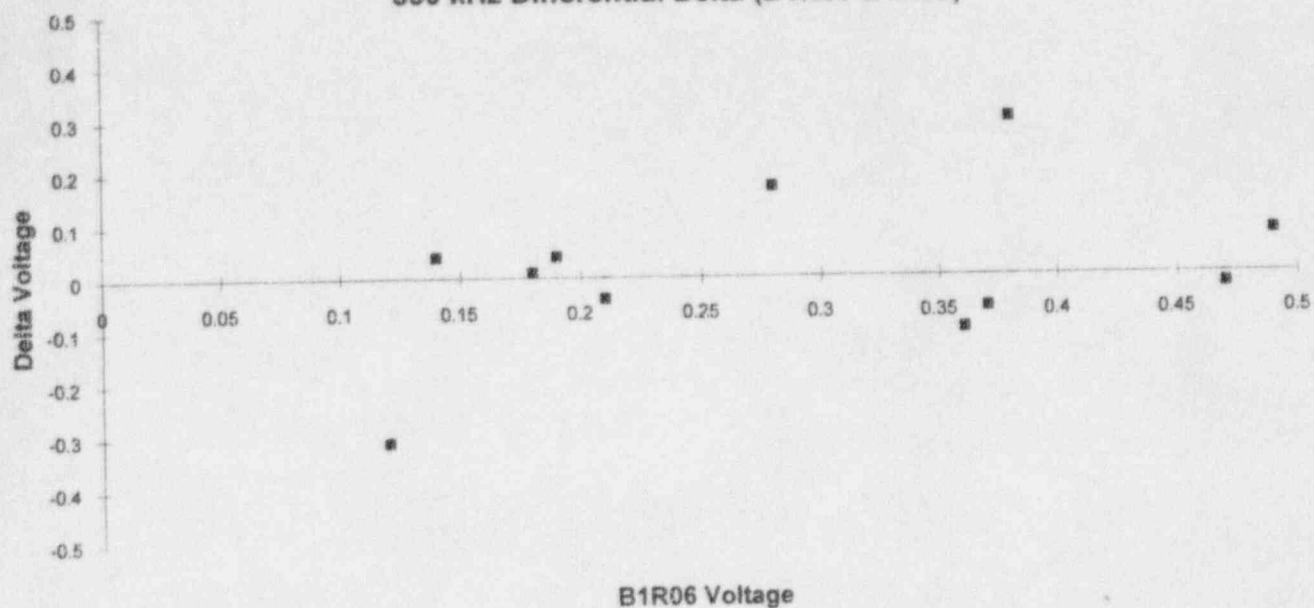
FIGURE 10
BYRON PRE/POST CHEMICAL CLEANING MBM COMPARISON
550 kHz Differential Delta (B1R06-B1R05)

A study was performed by ComEd in conjunction with BWNT to determine the effects of the Byron chemical cleaning on eddy current bobbin coil voltage signals by comparison of manufacturing burnish marks (MBMs) found during B1R05 and the same MBMs in B1R06. Direct comparison of ODSCC indications before and after the cleaning was not possible since the only pre-cleaning data is from the previous refueling outage inspection and the indications would have grown over the operating cycle. MBMs were chosen because these indications typically do not change over time and therefore, any changes would be due to the chemical cleaning and eddy current variability. Table 1 and Figures 10 through 12 show the change in voltage amplitude in the MBMs from B1R05 to B1R06 versus Cycle 5 voltage for the 550 kHz differential, 130 kHz differential, and 550/130 kHz mix frequencies. These frequencies are the frequencies used for sizing ODSCC at support plates. The 550 kHz and 130 kHz frequency plots indicate a scatter centered at nearly zero growth. The 550/130 kHz mix indicates a slight (-0.05 volt average with a 0.08 standard deviation) skew towards a negative growth. However, a 0.05 volt difference in eddy current sizing is considered insignificant and well within eddy current variability. It can be concluded that the chemical cleaning had insignificant impact on eddy current sizing.

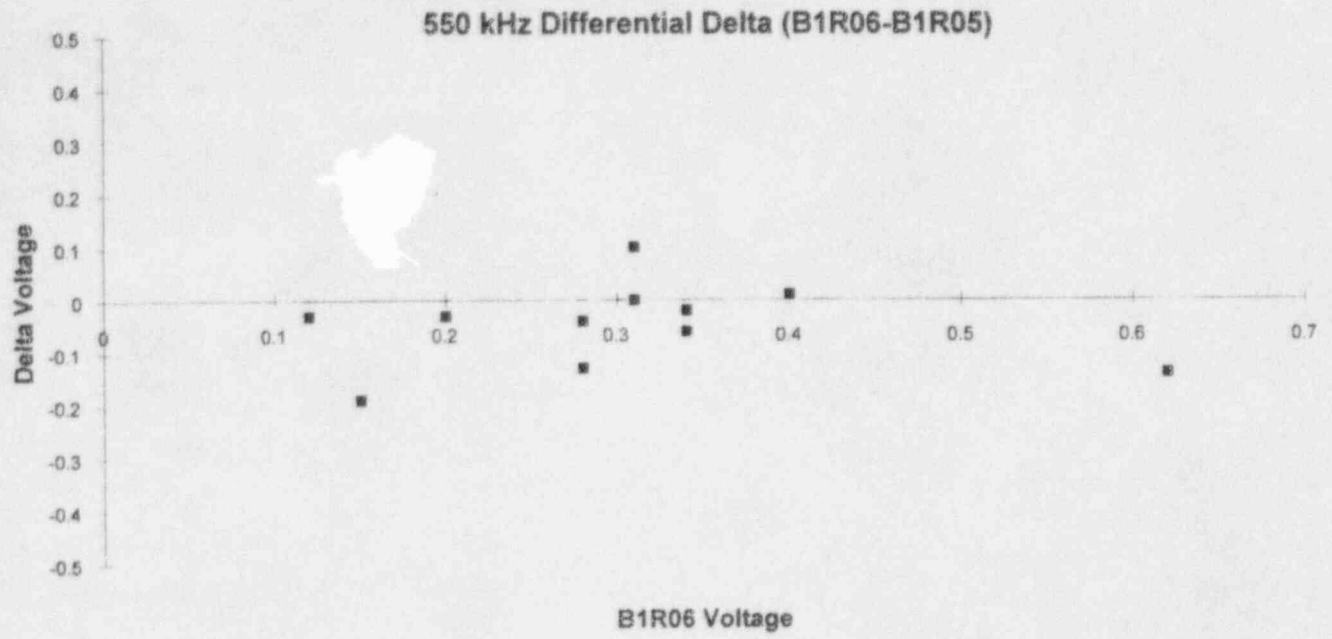
FIGURE 12

BYRON PRE/POST CHEMICAL CLEANING MBM COMPARISON
