DOCKET 50-266
SAFETY EVALUATION OF DAMAGED CRGT SUPPORT PINS
POINT BEACH NUCLEAR PLANT, UNIT 1

SAFETY EVALUATION OF DAMAGED CRGT SUPPORT
PINS AT POINT BEACH NUCLEAR PLANT, UNIT 1

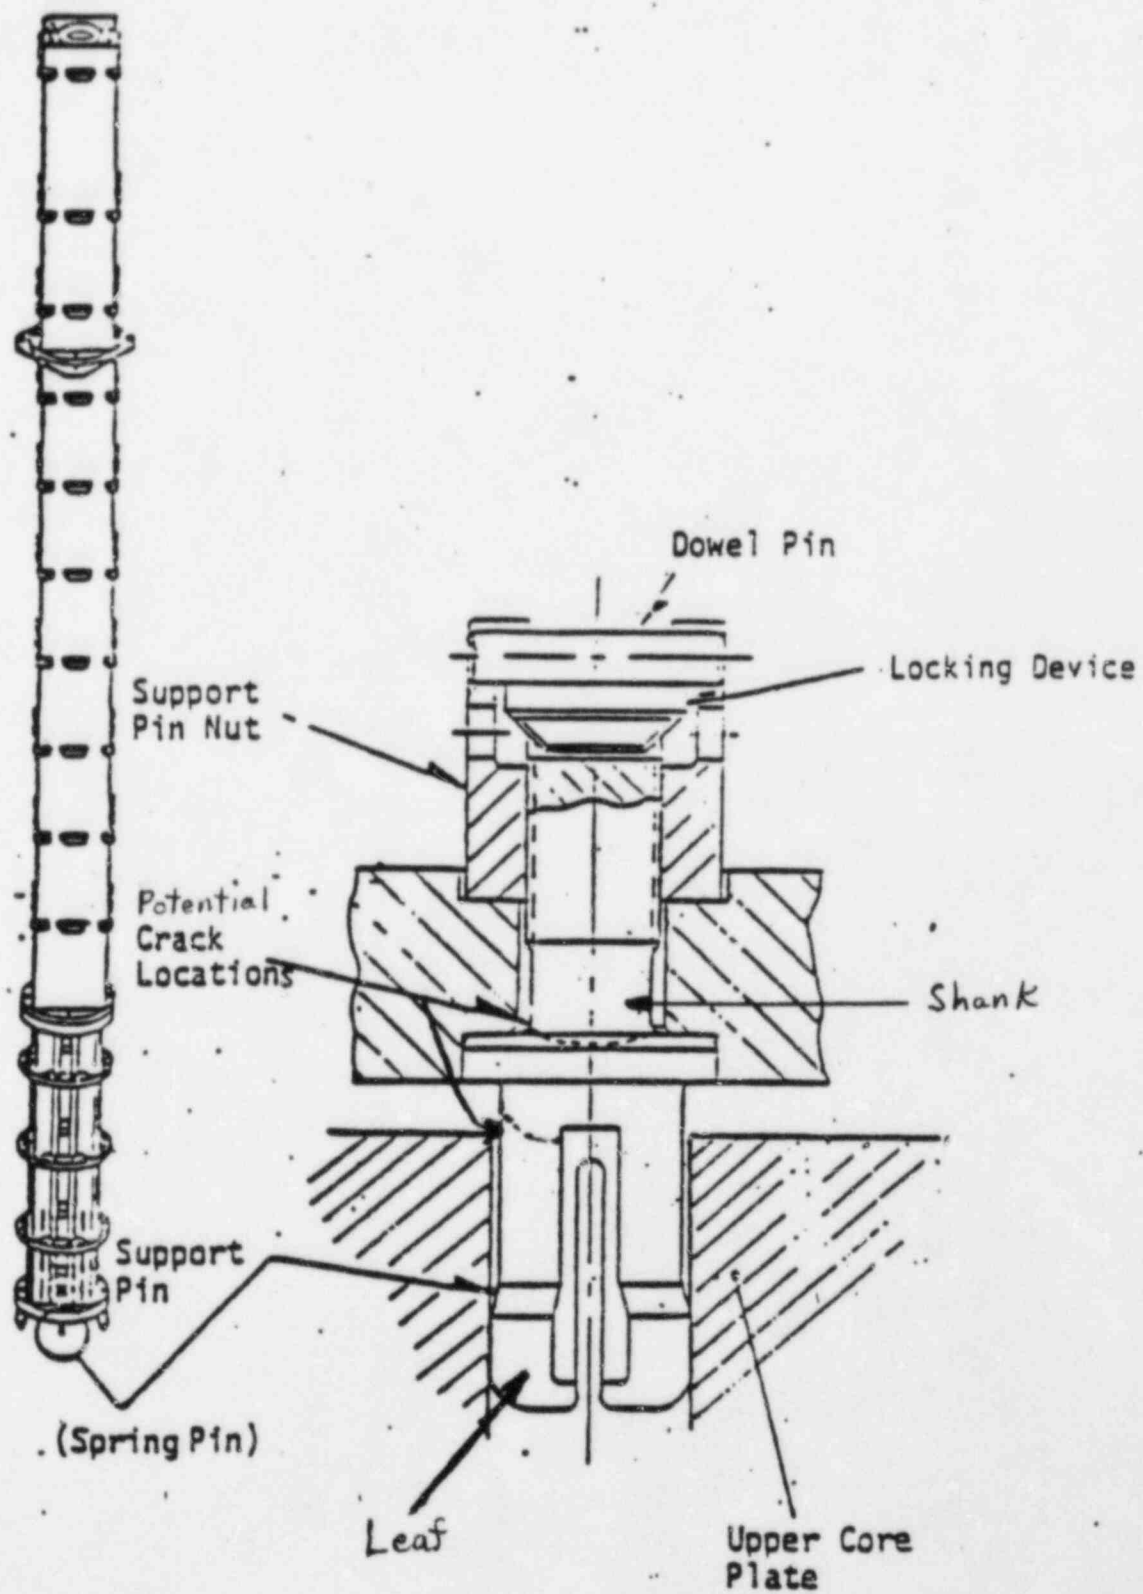
FIGURE 7

An ultrasonic inspection of the CRGT support pins at PBNP, Unit 1, was recently completed. The inspection revealed UT indications in the shank-to-collar region of 67 of 74 support pins (i.e., ~90%) (see Figure 7). No indications were found in the support pin leaves. A subsequent visual inspection of the sleeve nuts and threaded shank portion of the support pin assembly revealed three missing nuts and shanks (one each on the CRGTs above core positions G-3, I-5 and K-7) (see Figure 8). Visual inspection of the peripheral portion of the upper core support plate (the inner portions are essentially inaccessible), the core former plate just below the upper core support plate, the lower core plate, the lower portion of the reactor vessel, (see Figure 9) and all upper nozzles of fuel assemblies (see Figure 10) discharged during this outage (the full core) and the previous outage did not locate the missing portions of the pins. Visual inspections of the

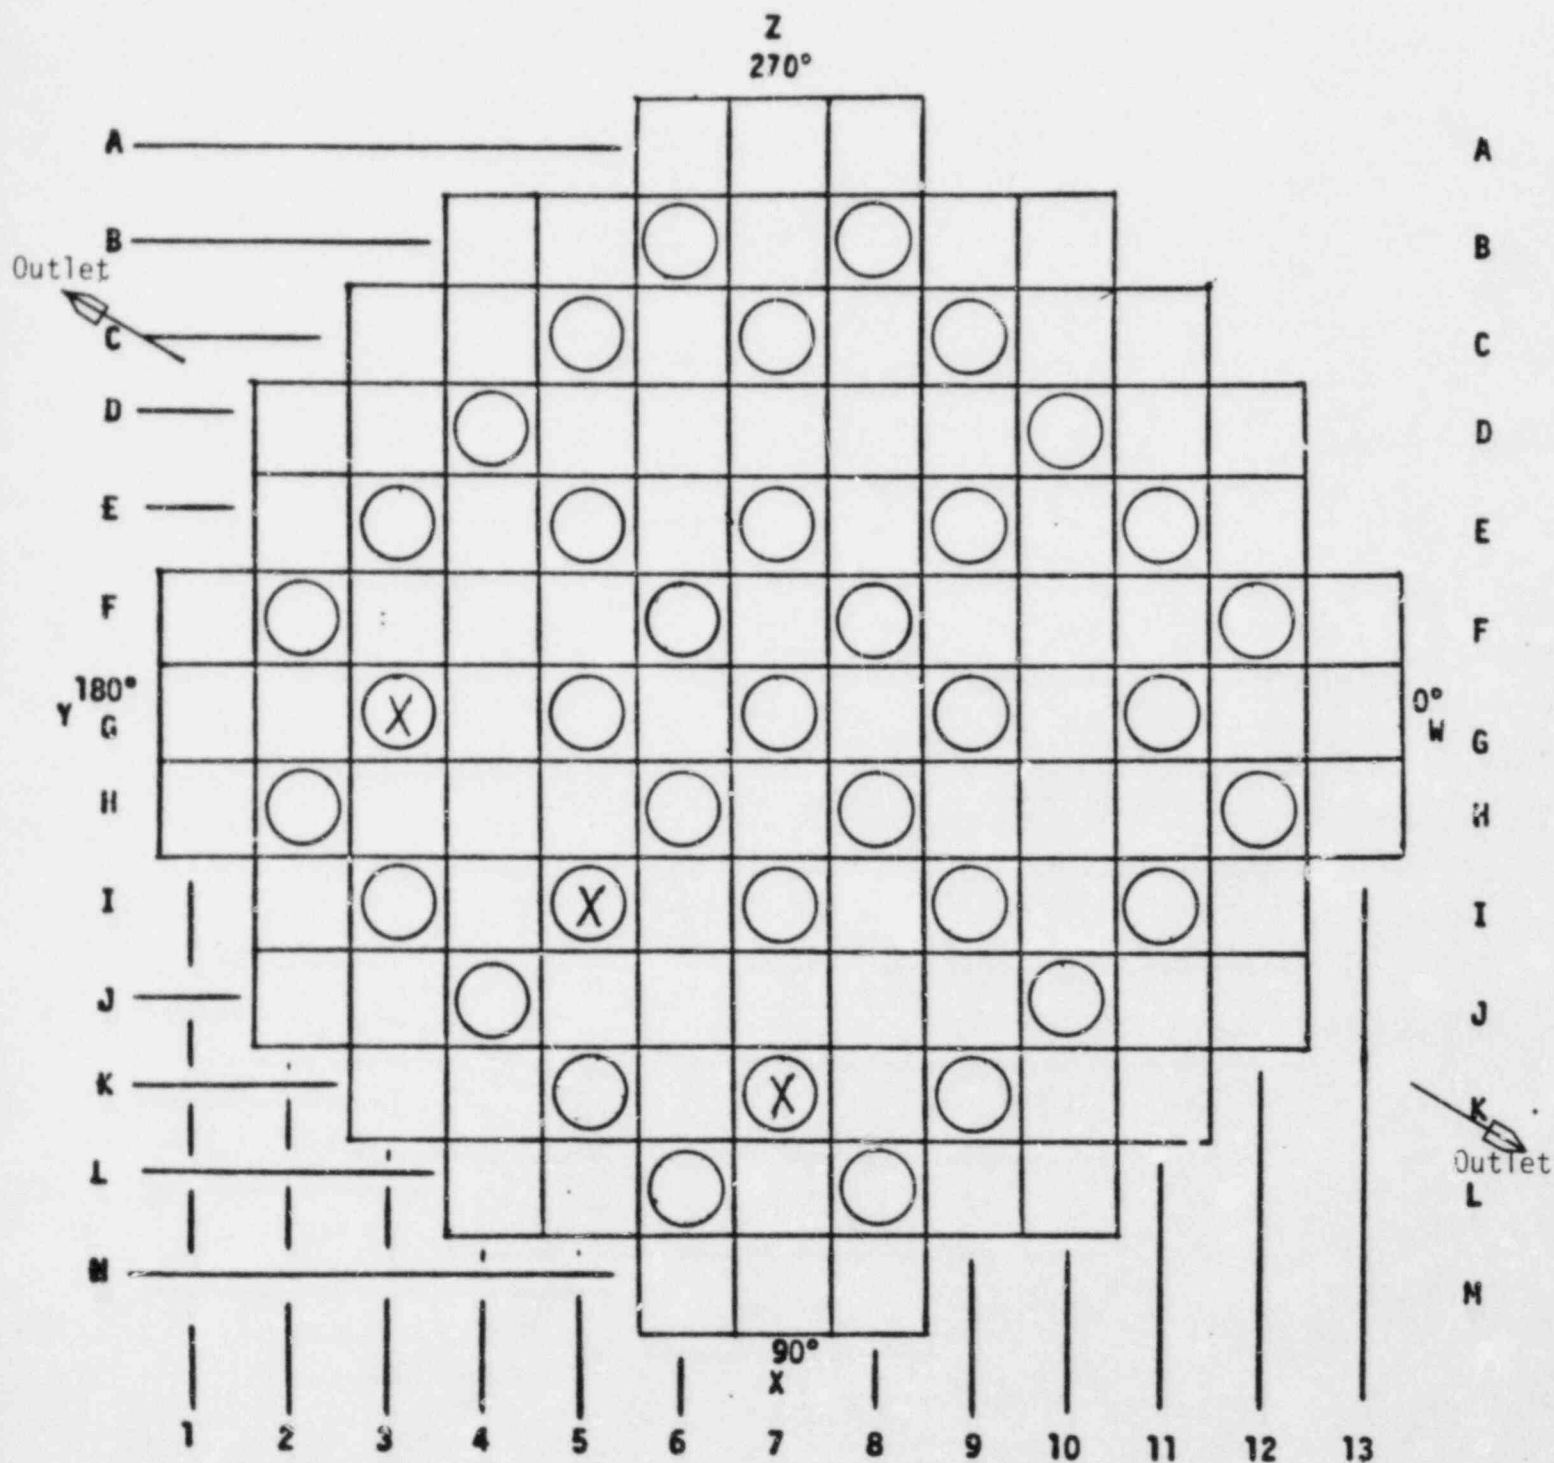
FIGURE 8

Control Rod Guide Tube Locations

CRGTs with a Missing Split Pin Nut
