Westinghouse Safety Evaluation

Cracked CRGT Support Pins

CRACKED SUPPORT PIN AND LOOSE PARTS
EVALUATION FOR POINT BEACH UNITS 1 AND 2

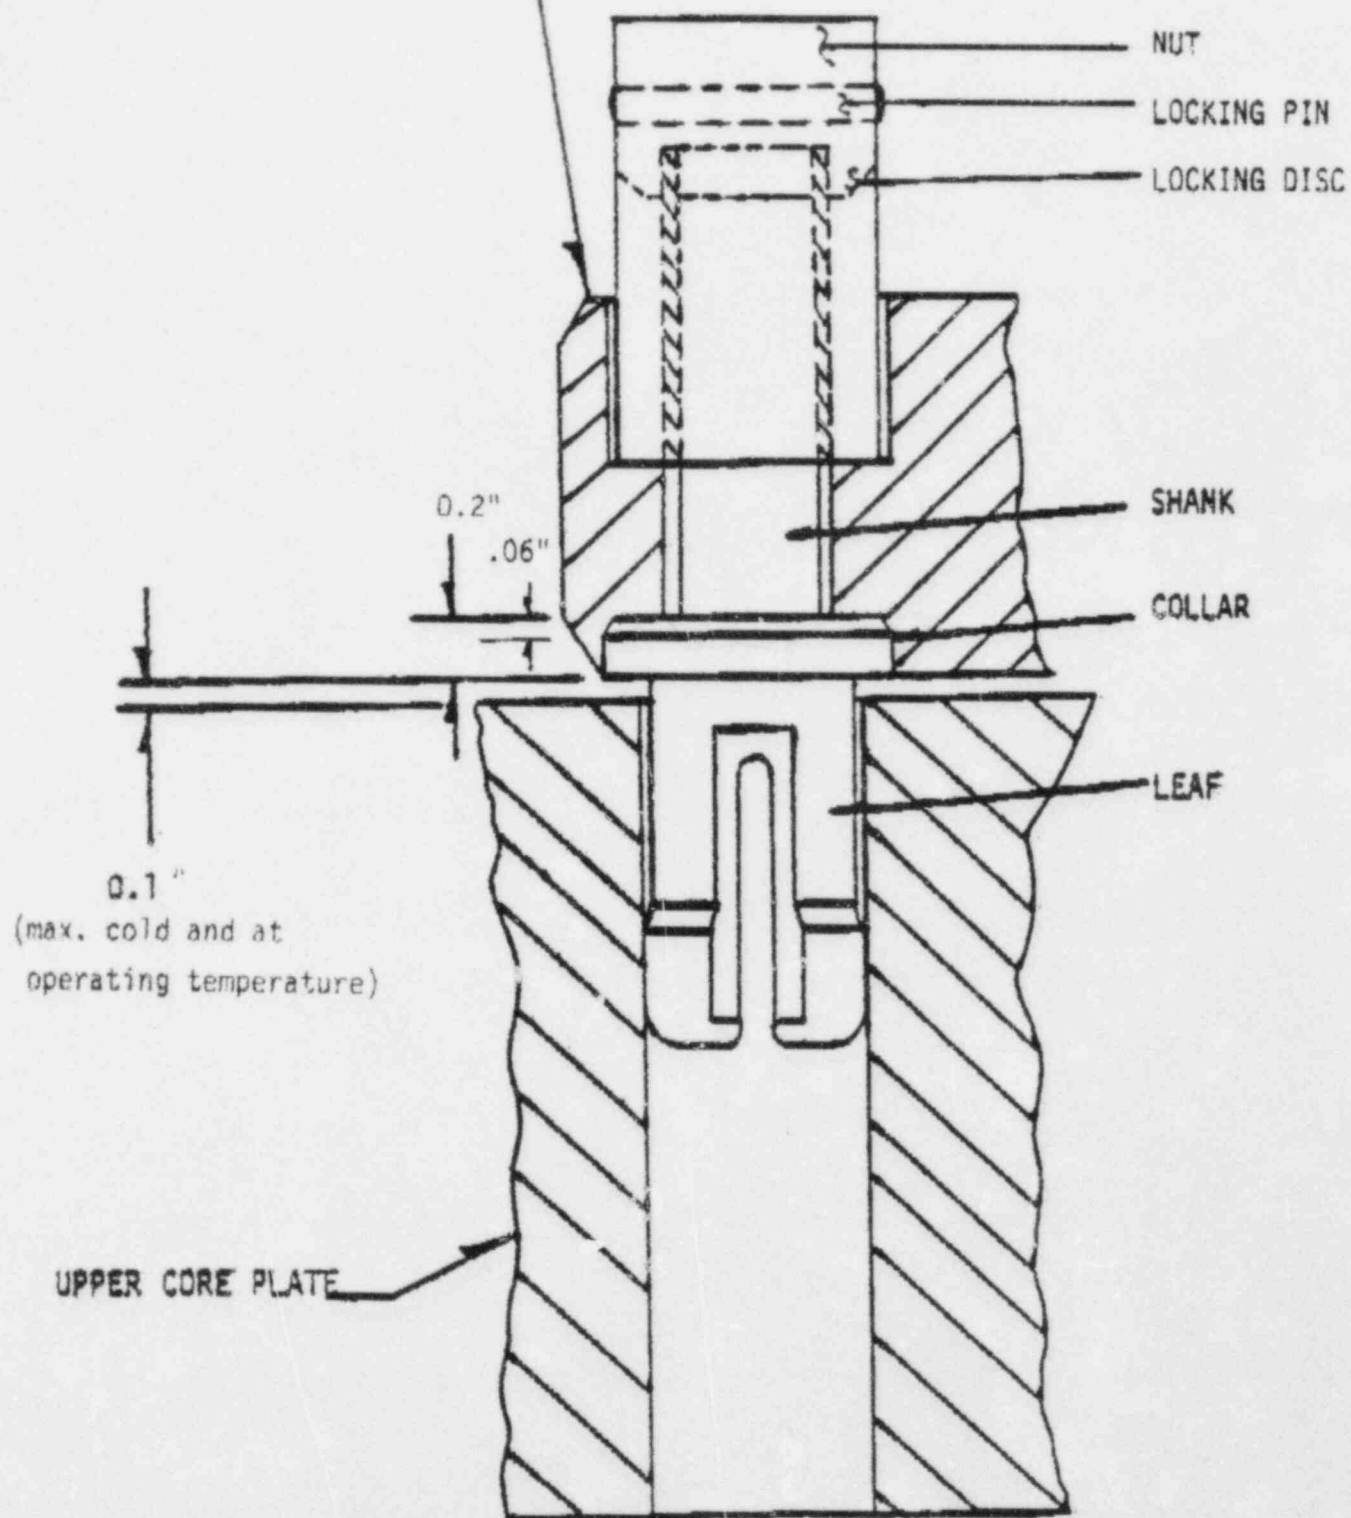
FIGURE 1

During a recent outage at Point Beach Unit 1, an ultrasonic inspection of the guide tube support pins was conducted. The inspection revealed indications in 67 out of 74 support pins. The indications were located in the shank-to-collar region of the support pin (Figure 1). No indications were found in the support pin leaves. A subsequent visual inspection revealed three missing support pin nuts and threaded shank portions of the support pin assembly. After performing a visual search on a portion of the upper core plate the missing objects were not located. The utility then consulted with Westinghouse and a conclusion to discontinue further search efforts in the upper internals area was reached.
