BELLEFONTE NUCLEAR PLANT UNITS 1 AND 2 - OVERPRESSURIZATION OF EMERGENCY  
RAW COOLING WATER PIPING BECAUSE OF TWO MECHANICAL FAILURES -  
BLRD-50-439/84-23, BLRD-50-439/84-22 - FIRST INTERIM REPORT

BELLEFONTE NUCLEAR PLANT UNITS 1 AND 2  
OVERPRESSURIZATION OF EMERGENCY RAW COOLING WATER PIPING  
BECAUSE OF TWO MECHANICAL MALFUNCTIONS  
BLRD-50-438/84-23, BLRD-50-439/84-22  
NCR 2879  
10 CFR 50.55(e)  
FIRST INTERIM REPORT

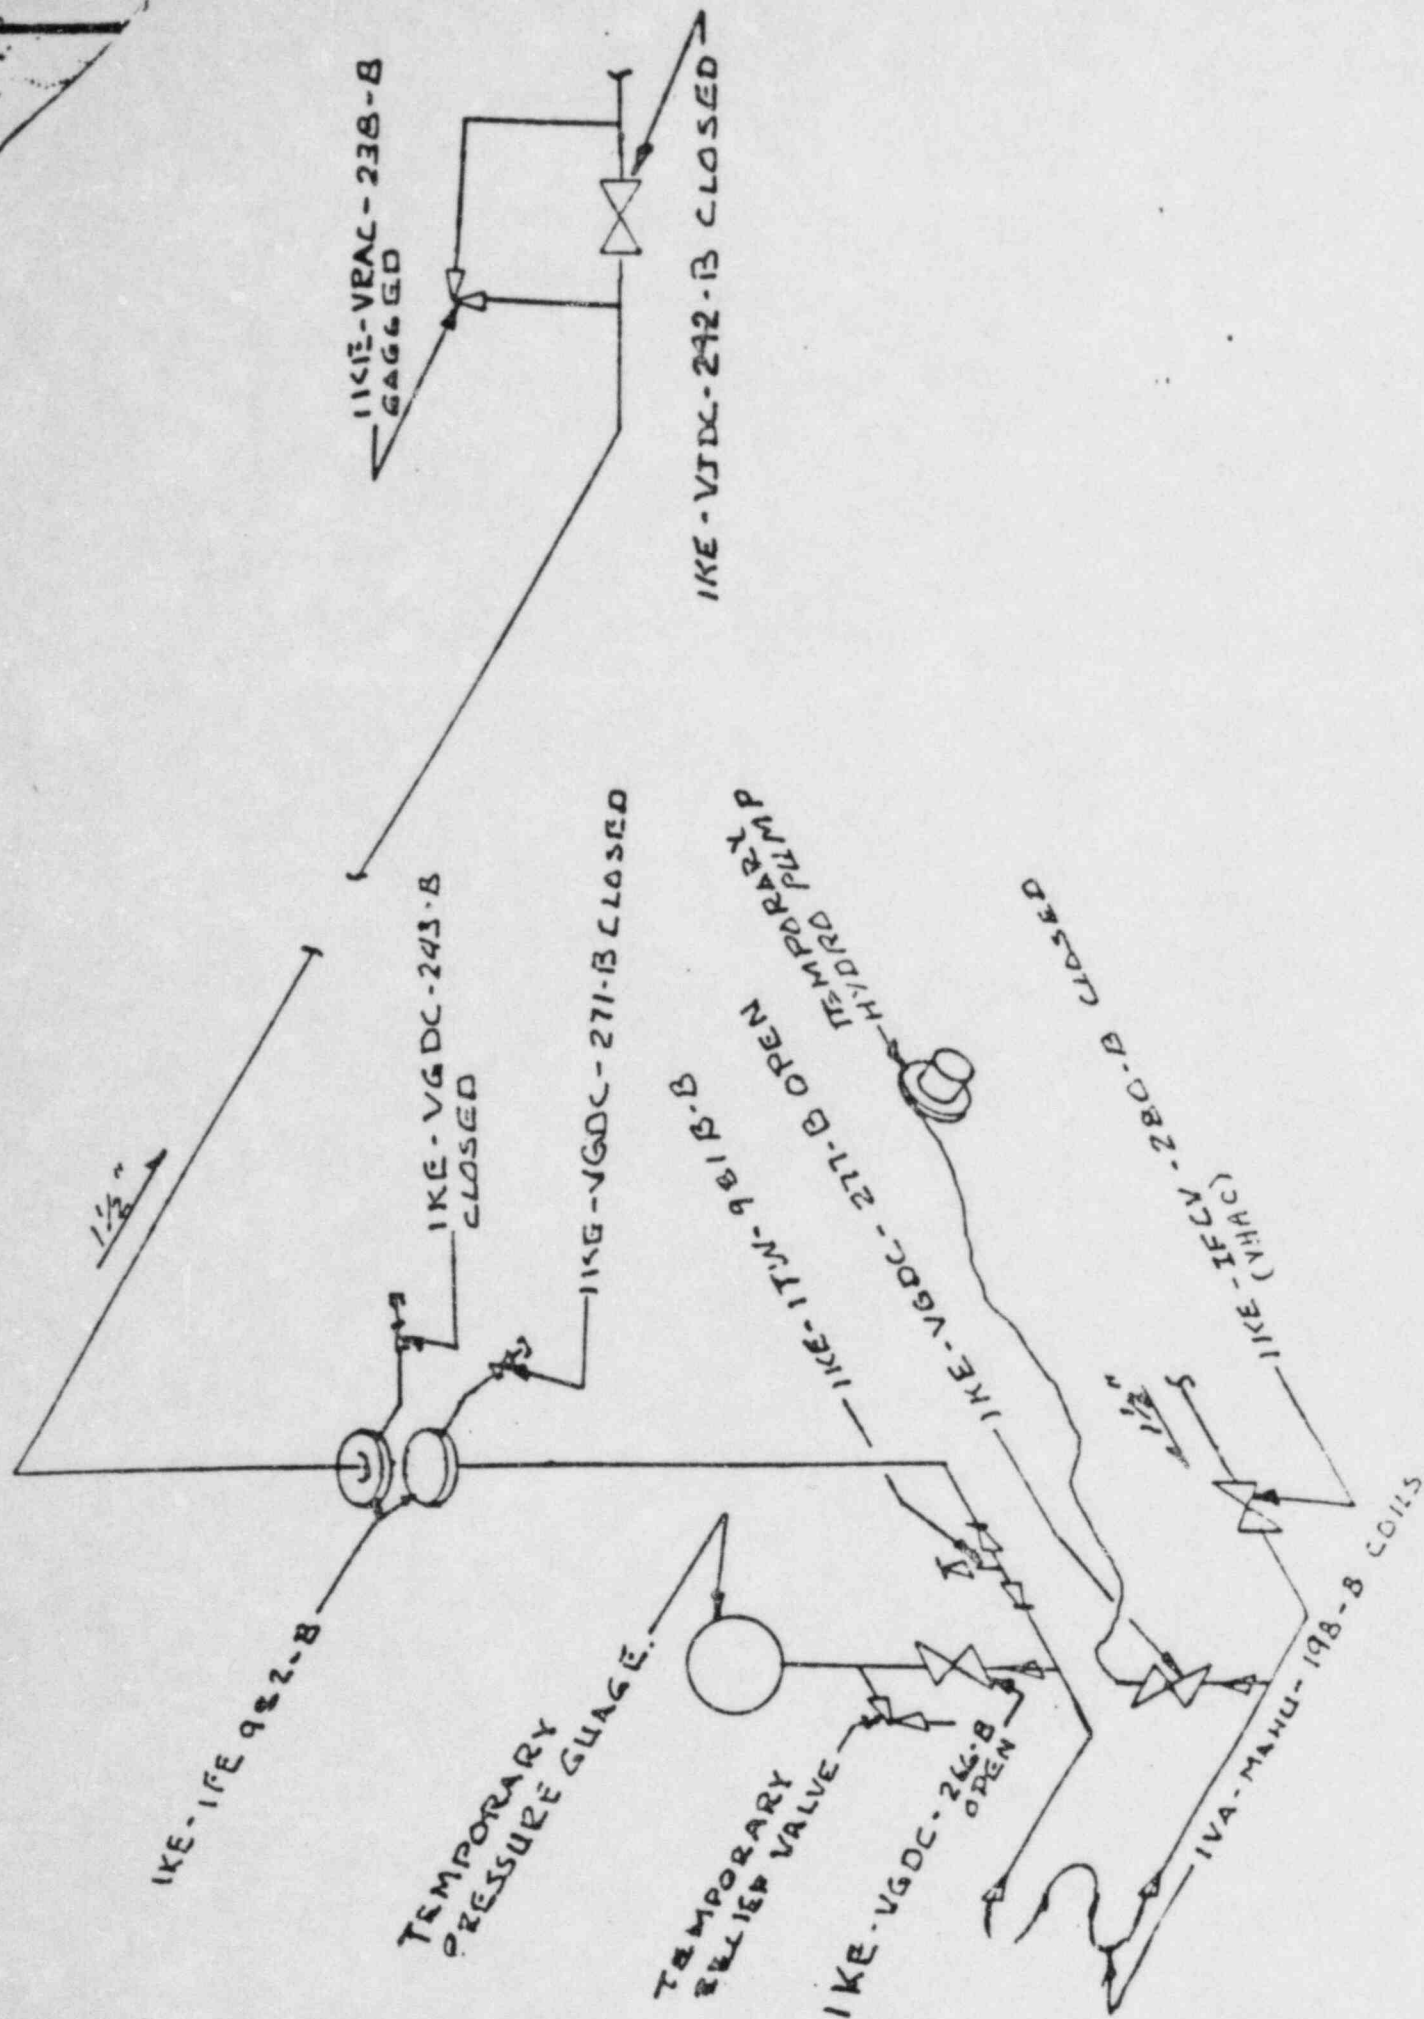
# ATTACHMENT

Due to a significant lag in the response of the pressure gauge the pressure indication continued to increase (above 235 lb/in<sup>2</sup>g) and efforts were initiated to relieve the pressure (since the relief valve had apparently failed). The coupling on the relief valve was loosened and valve 1KE-VJDC-242-B (see attached sketch) was opened in the discharge side of the air handling unit (AHU). By the time the pressure was relieved, the gauge had begun to level off at approximately 480 lb/in<sup>2</sup>g. Although the coils on AHU 1VA-MAHU-198-B and associated KE (ERCW) system piping between valves 1KE-VHAC-280 and 1KE-VJDC-242-B were subjected to a pressure estimated at 480 to 500 lb/in<sup>2</sup>g, they are only hydrostatically qualified to a pressure of 300 lb/in<sup>2</sup>g.

TVA is investigating the possibility of damage to the AHU coils due to the higher pressure. The defective pressure gauge will be reworked and the defective valve has been discarded.
