INVESTIGATION OF TURBINE DISC KEYWAY CRACKING

North Anna Unit 2

SwRI Project No. 06-7794-106
FINAL REPORT

March 26, 1984

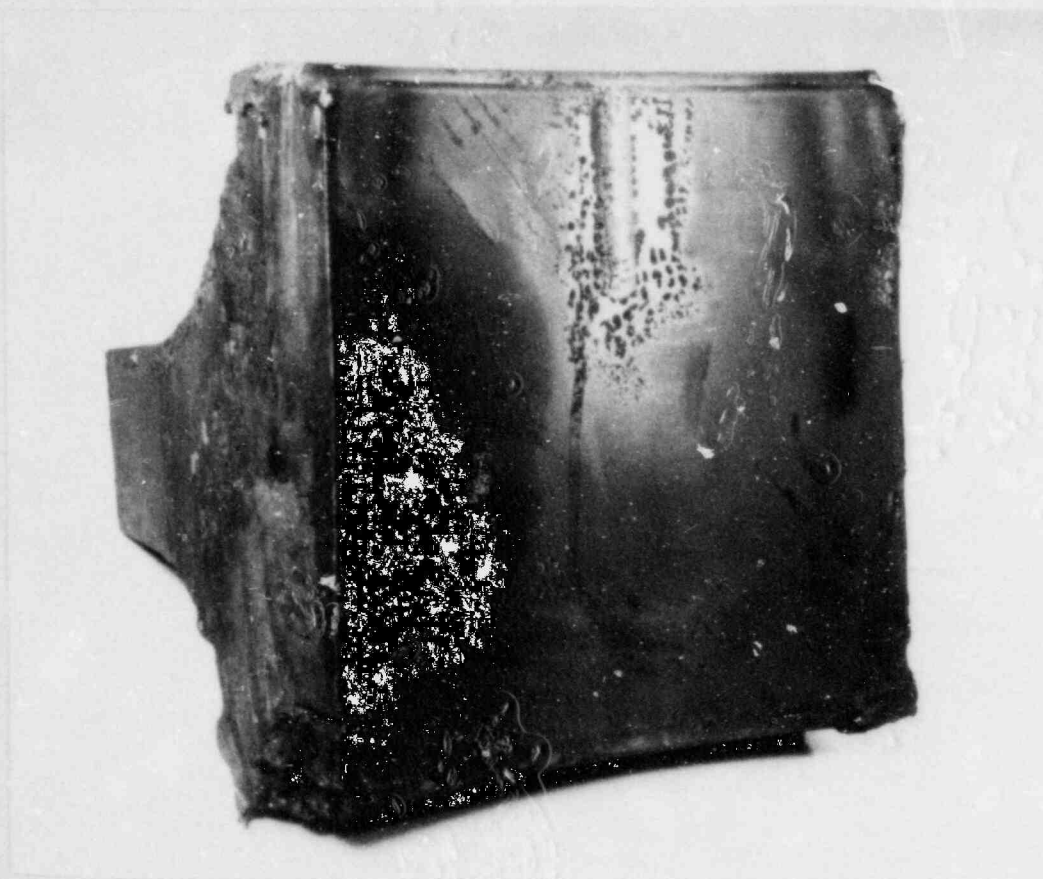
12164

FIGURE 1. DISC SAMPLE. Spotted effect is rust which was present when shipping crate was opened.

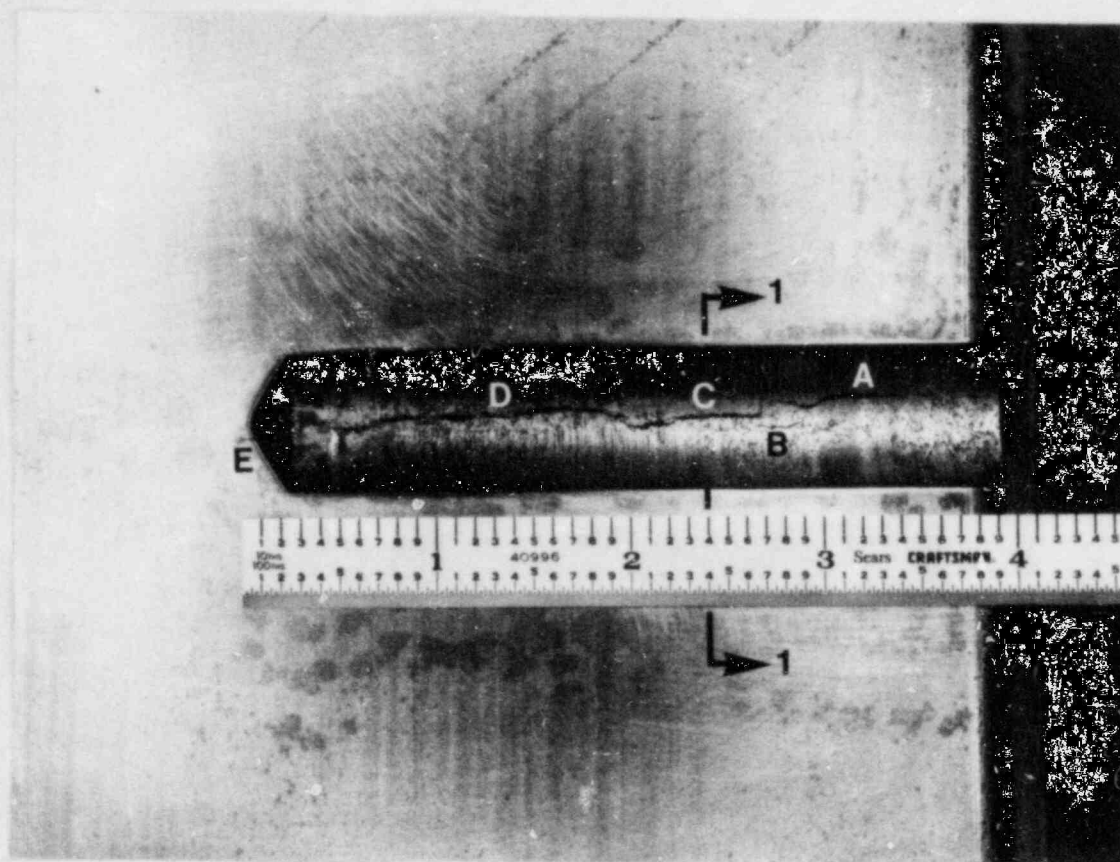
12161

The surface rust was removed from the keyway region by light abrasion with 400 grit paper and the keyway was subjected to a magnetic particle (MP) inspection. A d-c magnetic yoke and a dry powder indicator were employed. This inspection revealed several distinct crack indications within the keyway, see Figure 2. These indications were oriented parallel to the long axis of the keyway and were distributed along its length to within approximately 1/2 in. of the open end. In the inner one-half of the keyway, the crack indication appeared as several nearly-connected segments located end-to-end near the centerline (Segment D, Figure 2). One separate, small crack indication was noted at the conical end of the keyway extending a short distance along the disc bore surface, (Segment E, Figure 2). The largest indication near the open end (Segment A) was displaced from the centerline of the keyway.

FIGURE 2. MAGNETIC PARTICLE CRACK INDICATIONS IN KEYWAY.
Actual size.

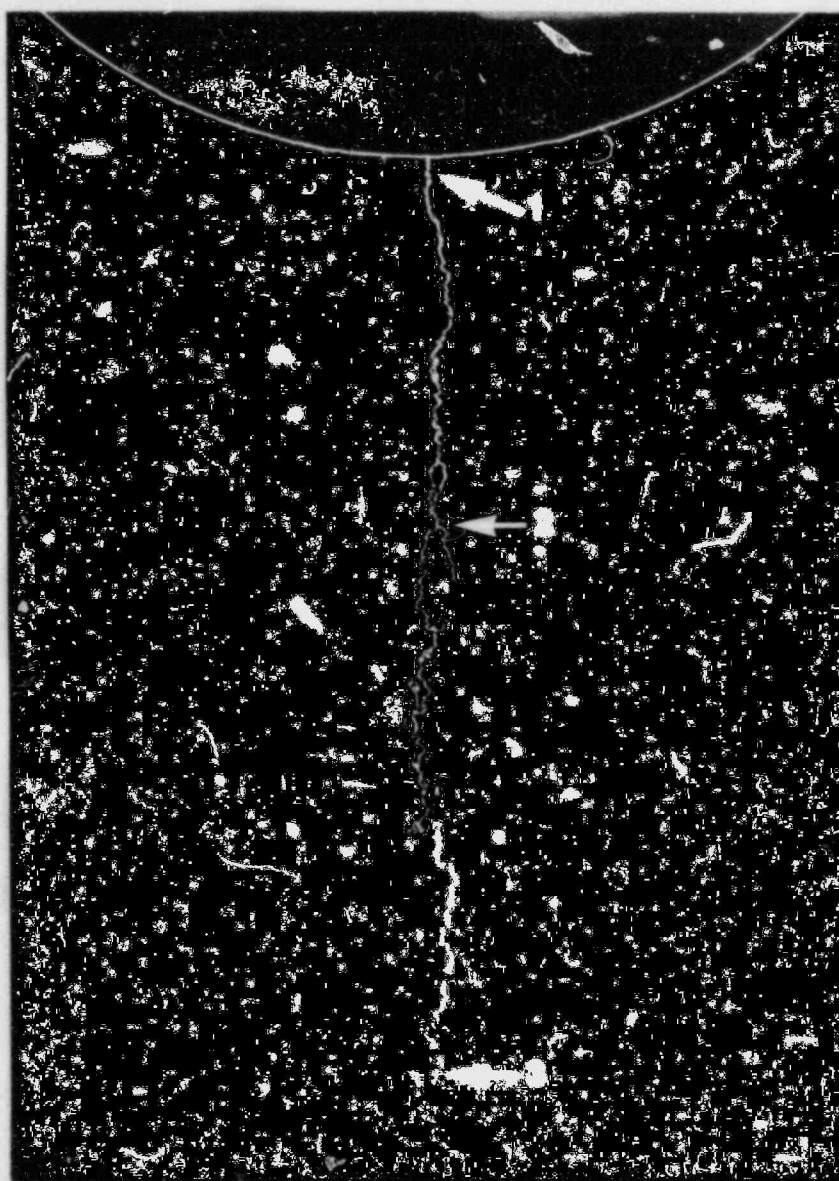
12230

A transverse metallographic section was taken through the keyway at a location approximately 1-1/2 inches from the open end. The location is marked as Section 1-1 in Figure 2. A photomacrograph of the crack as observed in that section is shown in Figure 3. At this point, the crack extended to a depth of 0.58 inch. Limited branching had occurred at two locations along the crack path.

FIGURE 3. TRANSVERSE SECTION THROUGH KEYWAY.
Dark field illumination.

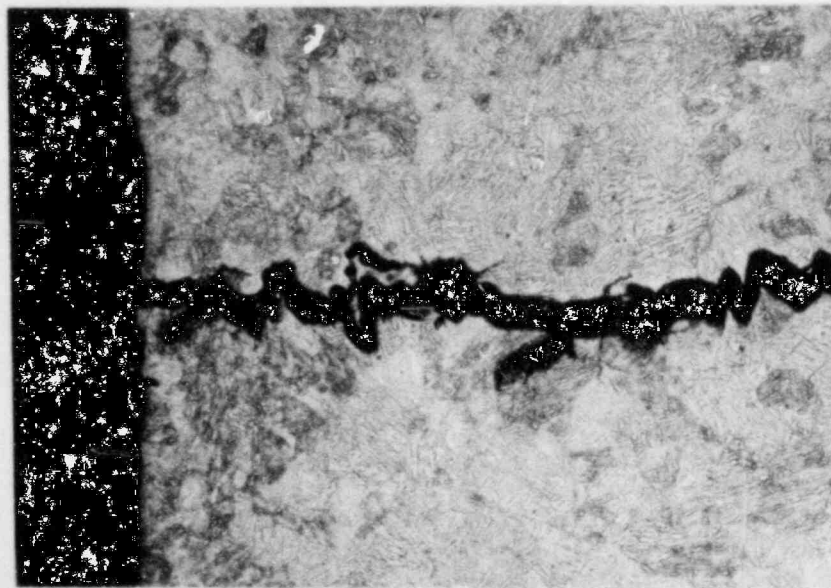
Photomicrographs illustrating the microstructural features of the cracking are shown in Figure 4. The crack path is predominantly intergranular over its entire length and localized branching, extending two or three grain diameters from the main crack, was present along the crack path. Most of these short branches were filled with an oxide and several were disconnected from the main crack in the plane of this section [Figure 4(b)]. In this section, the crack tip consisted of several disconnected intergranular segments [Figure 4(c)].

12270 (a) At keyway surface.
Location 1, Figure 3.

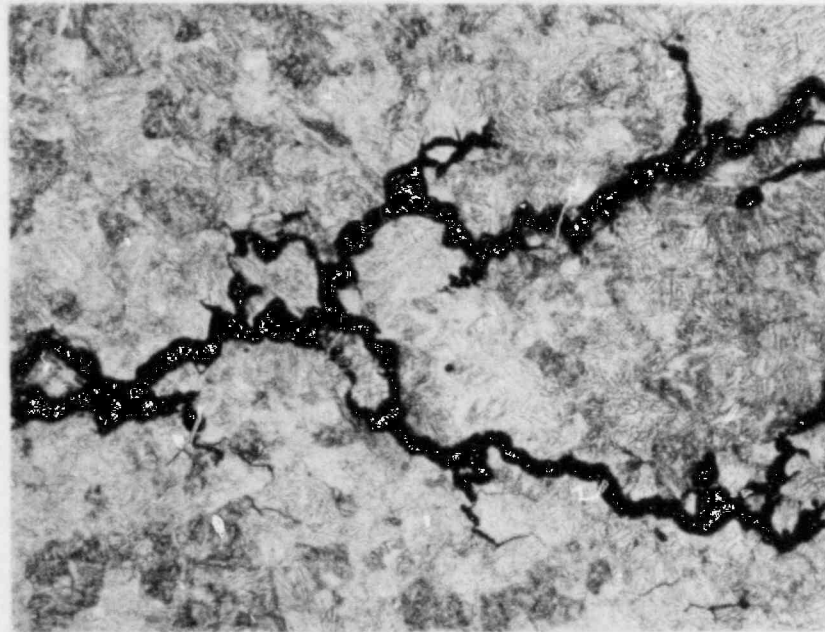
12272 (b) Central portion of crack.
Location 2, Figure 3.

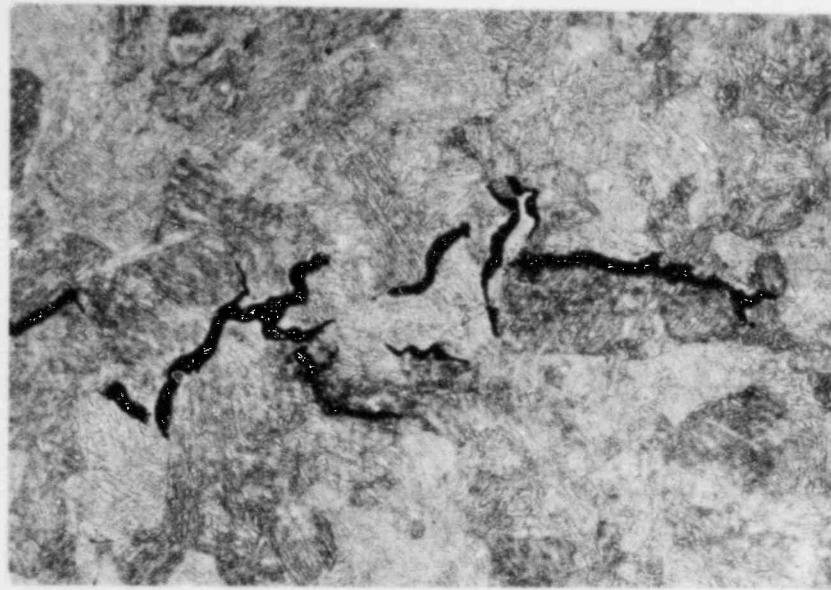
12274 (c) Crack tip. Location 3,
Figure 3.

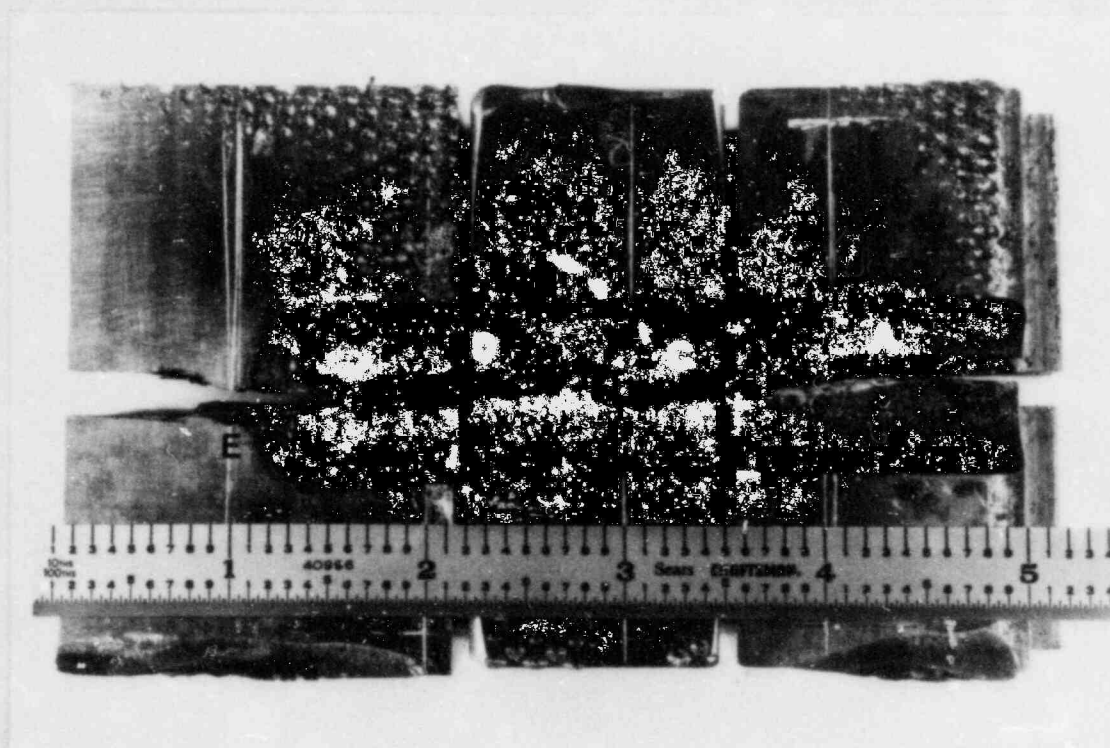
12325

The keyway specimen was cut into three approximately equal segments. Each segment was cooled in liquid nitrogen and then broken open to expose the crack surfaces. A photograph of the keyway after the segments were opened is shown in Figure 5. The segments broke open along the three major MP indications marked A, C and D in Figure 2. The short crack at indication B did not open.

FIGURE 5. KEYWAY SPECIMENS. Refitted after breaking open.

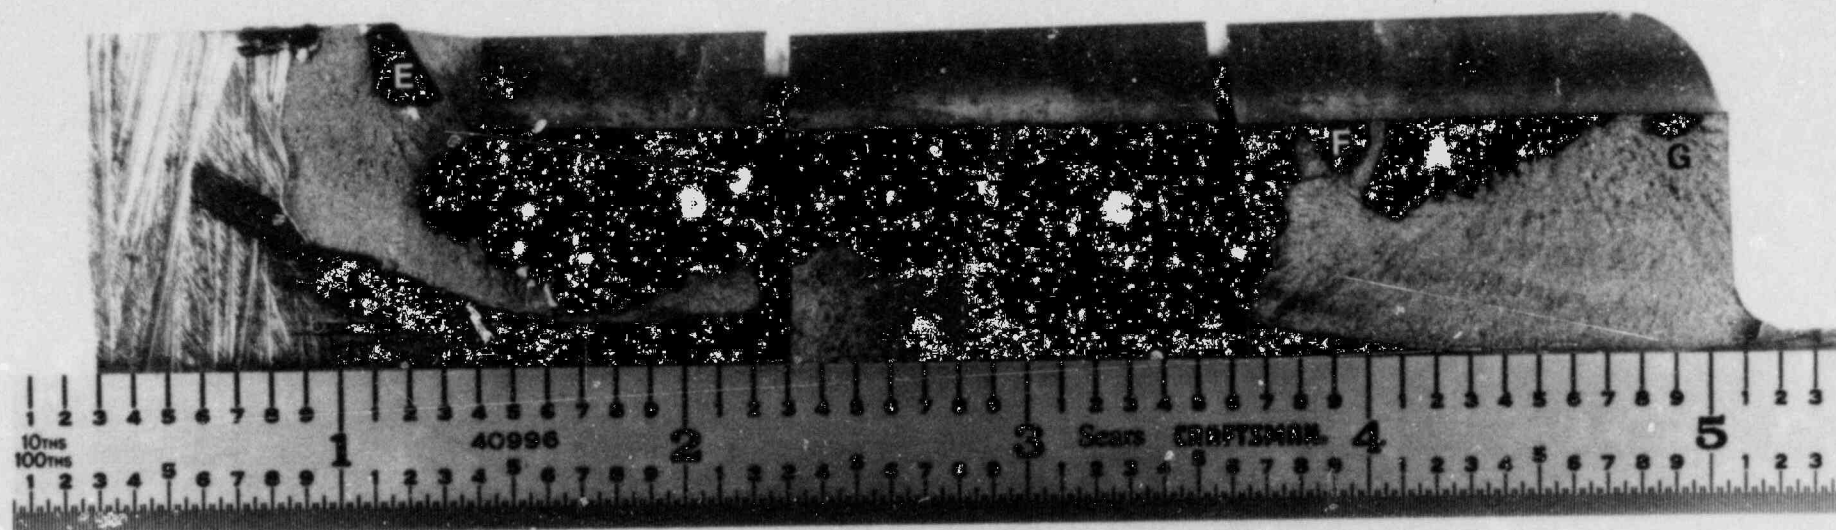
FIGURE 6. EXPOSED CRACK SURFACES.

The crack surfaces presented a dark, blue-black appearance so that the extent of cracking was clearly delineated. Photomacrographs of the exposed crack surfaces are shown in Figure 6 and a scale diagram of the crack profile is shown in Figure 7. The segments corresponding to the individual MP crack indications are marked in each figure. Segments A and C clearly represent separate independent cracks. Segment D was continuous but was marked with several distinct steps indicating that this segment represented at least three initially independent cracks which joined together in the later stages of growth. These features are consistent with the segmented appearance of the MP indication (Segment D in Figure 2). The crack Segment E at the blind end of the keyway also proved to be a separate, independent crack. Opening of the outer segment of the keyway revealed two small cracks which were not detected in the MP inspection. These are marked as Segments F and G in Figure 7.

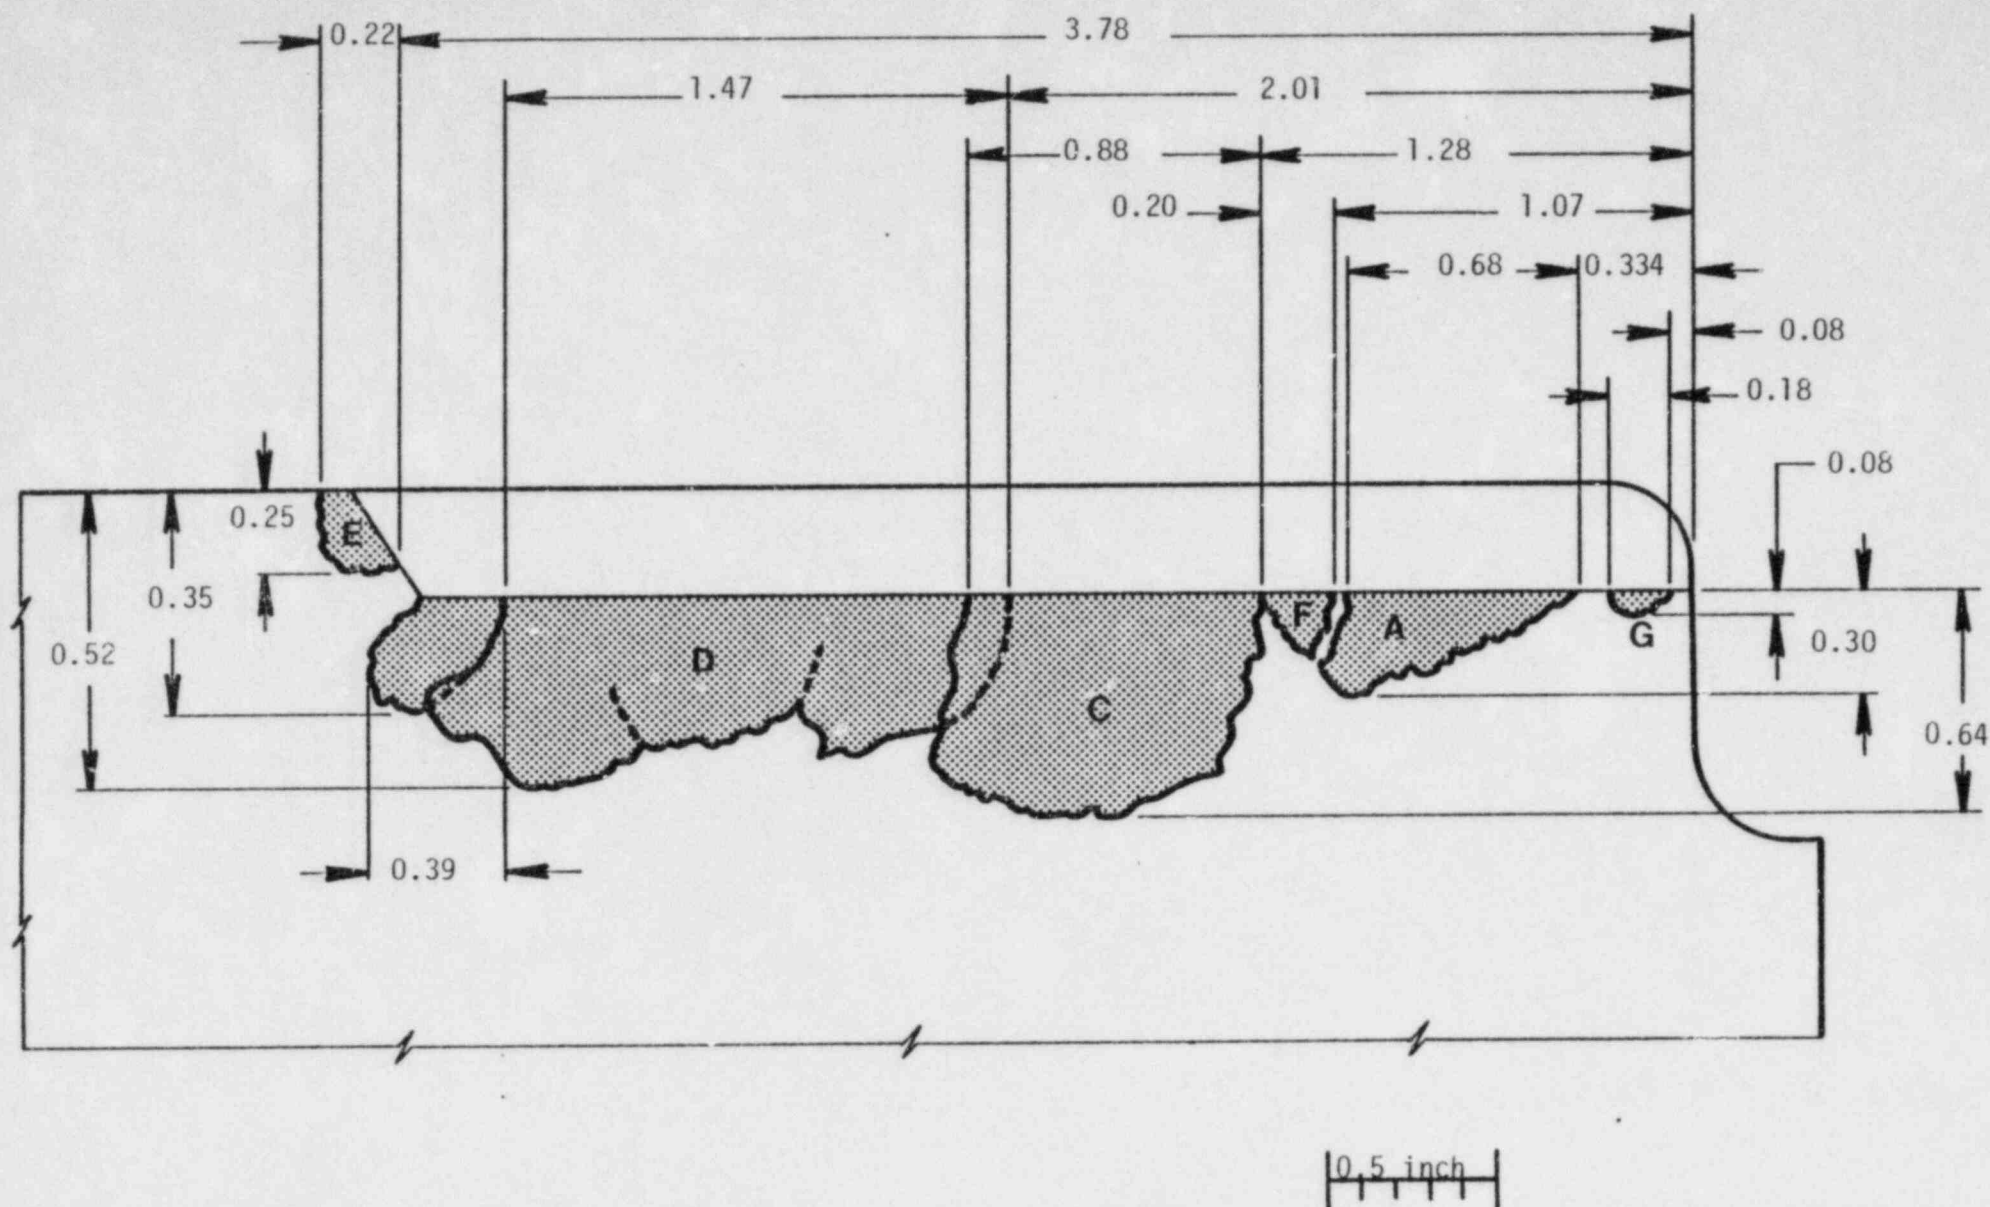
The three major segments of the keyway cracking (A, C and D in Figure 7) extended over nearly the full length of the keyway and measured 0.68 inch, 0.88 inch and 1.86 inches long, respectively. Segment C extended to a depth of 0.64 inch while Segments A and D were 0.30 inch and 0.52 inch deep, respectively.

FIGURE 7. DIAGRAM OF CRACK SURFACES.
Dimensions in inches.

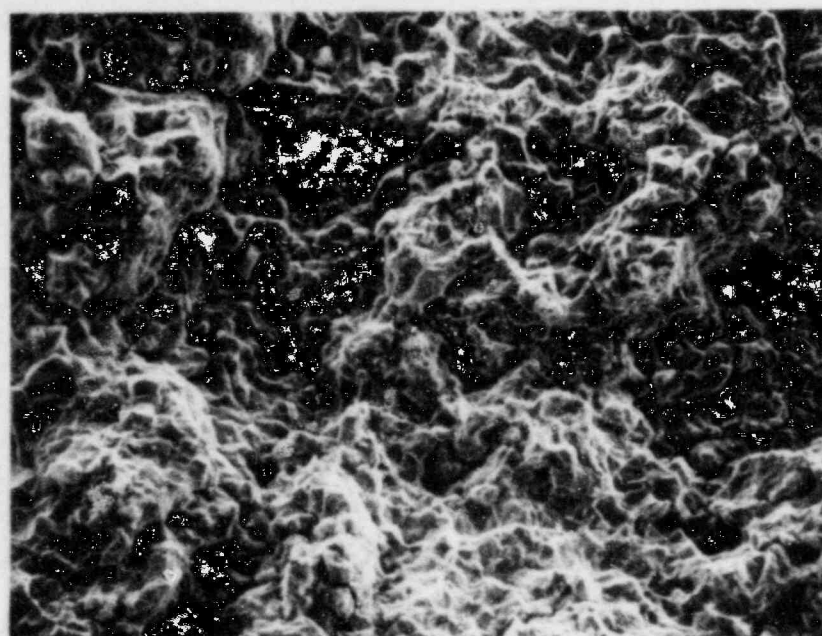
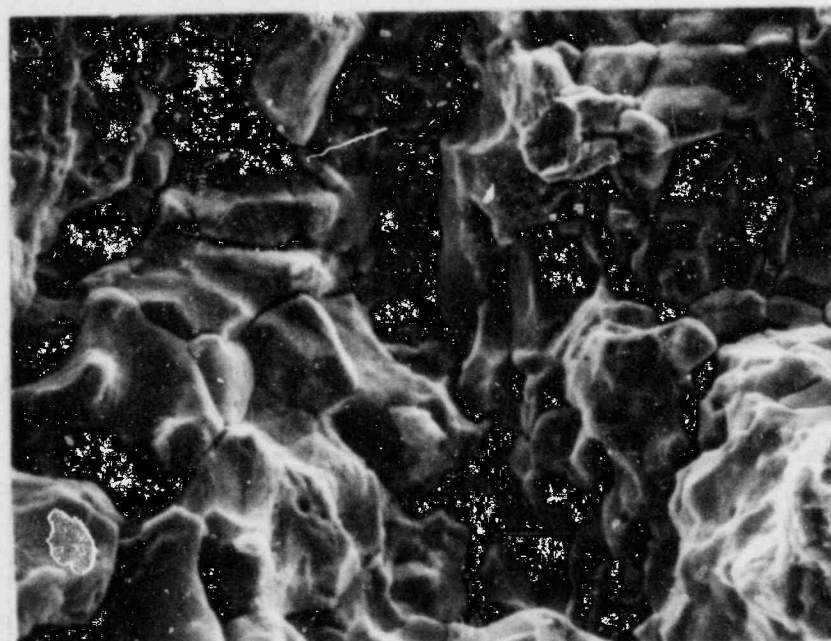
One segment of the exposed crack surfaces was electrolytically cleaned (specimen cathodic) and examined in the scanning electron microscope (SEM) to identify the fine-scale topographic features. Representative SEM fractographs are shown in Figures 8 and 9. The SEM examination established that the crack surface was predominantly intergranular. Only a very few, isolated, transgranular facets were observed. There was some evidence of limited

FIGURE 8. SEM FRACTOGRAPHS FROM EXPOSED CRACK SURFACE.
Segment D, Figure 7, near keyway surface.

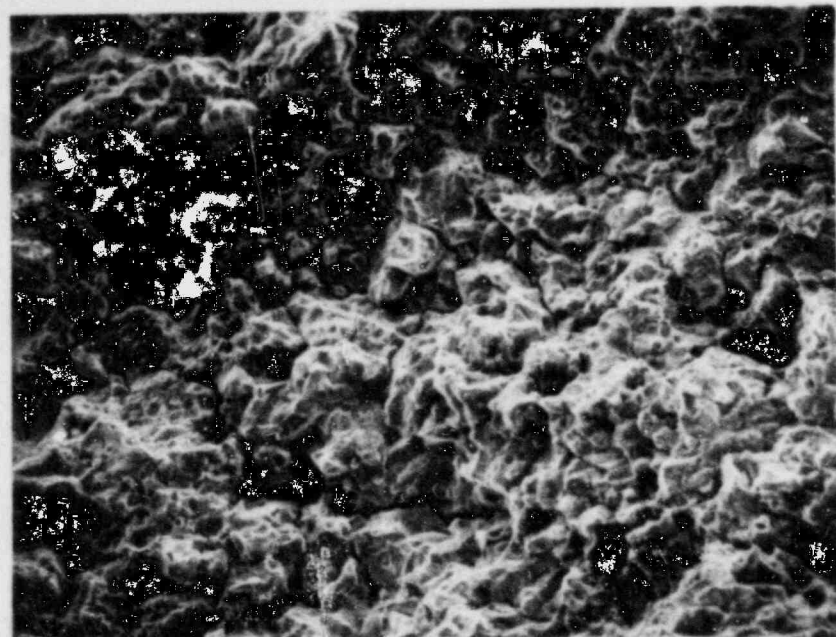
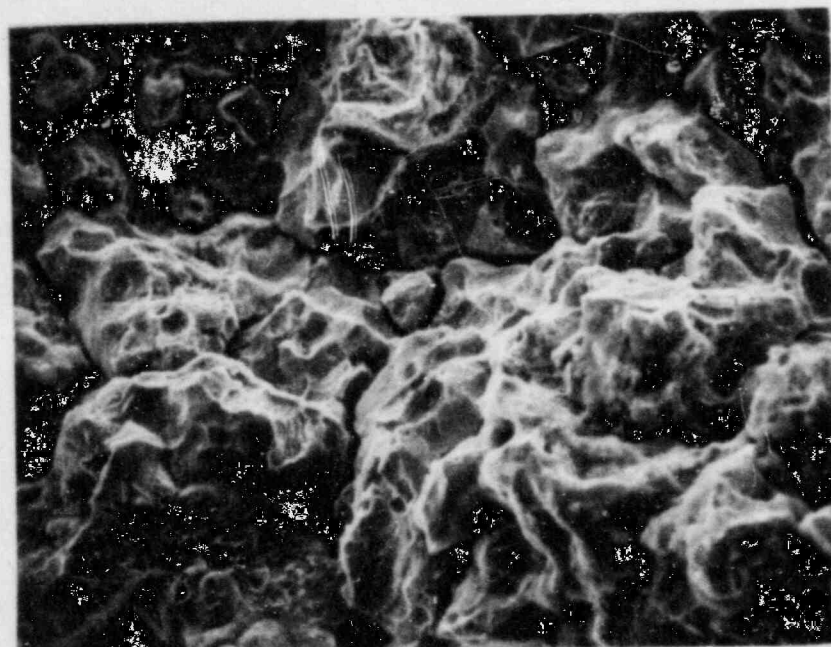
FIGURE 9. SEM FRACTOGRAPHS FROM EXPOSED CRACK SURFACE.
Segment D, Figure 7, near crack front.

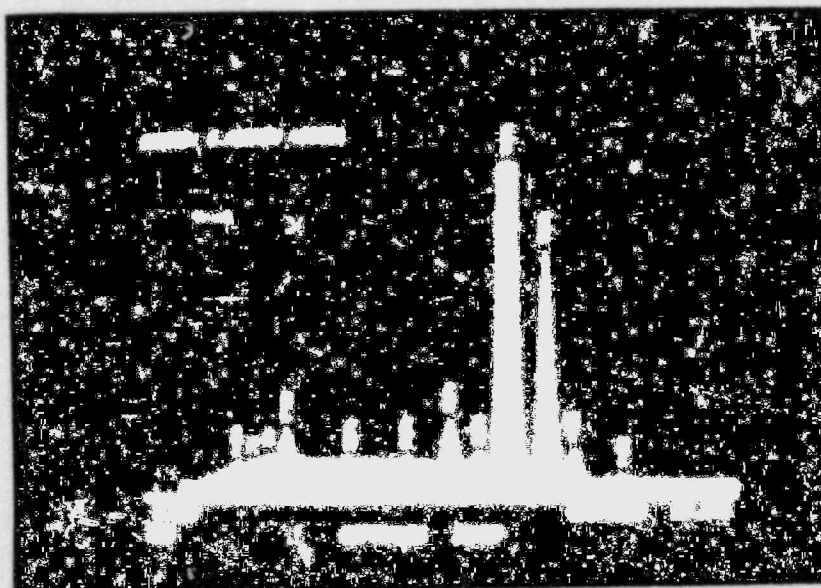
12326

Prior to cleaning, the deposit present on the crack surface was qualitatively analyzed by energy dispersive X-ray spectroscopy (EDS). An X-ray energy spectrum from the as-opened crack surface at a point near the keyway surface is shown in Figure 10. The principal elements detected were iron, chromium, and nickel; all constituents of the base metal. A small amount of chlorine was detected at this particular point. Except for extremely small peaks for chlorine and sulfur, no other extraneous surface elements were detected. These observations establish that the crack surface deposits are simply oxides of the base metal and that no unusual surface contaminants were present.

FIGURE 10. X-RAY ENERGY SPECTRA FROM
EXPOSED CRACK SURFACE.
