MIDLAND ENERGY CENTER PROJECT
DOCKET NOS 50-329 AND 50-330
EXCESSIVE WEAR - LINEAR CONVERTER SHAFT GUIDES
FILE: 0.4.9.89 SERIAL: 28057

Excessive Wear of Pacific Air Products Company Linear
Converter Shaft Guides

INTERIM REPORT 1

PROJECT: Consumers Power Company
Midland Plant Units 1 and 2
Bechtel Job 7220

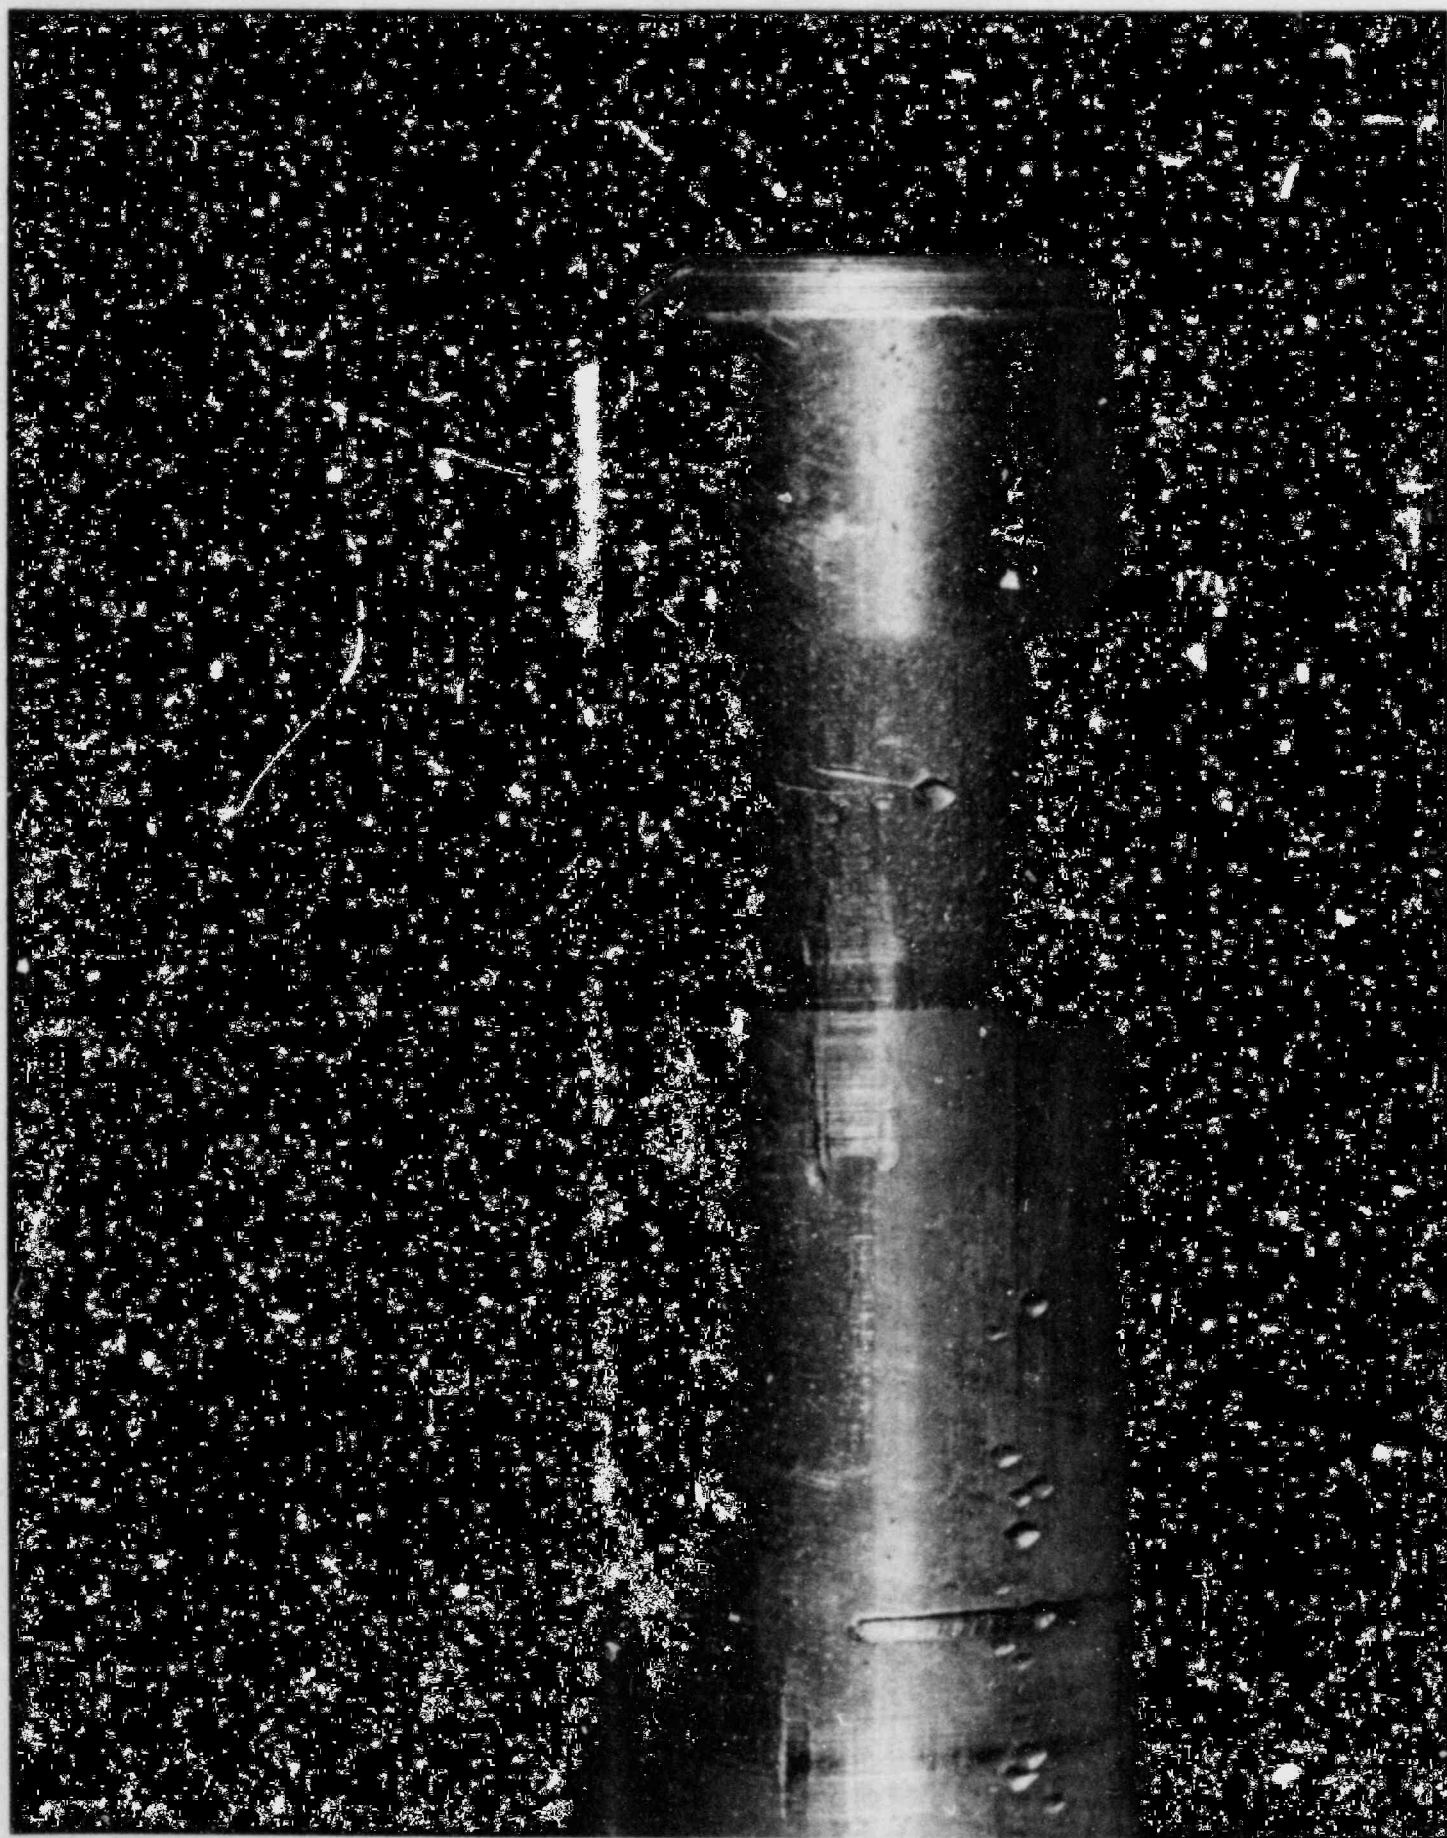
- A. Actual field conditions confirm that the excessive wear on the linear converters is caused by "hunting" of the control circuitry. For example, in one case a volume sensing device was installed downstream of the dampers. When the dampers opened, the air was aimed directly on the velocity sensing device. At that moment, the device sensed the increased velocity and caused the damper to change position thereby deflecting the airstream away from the sensing device. The sensing device once again called for the damper to open, etc., etc.. This field condition, "velocity stratification", caused the damper to "hunt". (We estimate that this condition could cause short cycle response at about 21,000 strokes per day or 651,000 strokes per month or 3,906,000 strokes in a six month period.)

I am enclosing a photograph of the input shaft of a linear converter that was returned to us from the field. The wear pattern is indicative of the hunting problem. I would suggest that your project be inspected to determine whether any of the tell-tale signs are present. Hunting caused by the control circuit not only affects the linear converter but it also affects the damper and the actuator. If this condition exists, it should be remedied as soon as possible. A determination of the number of cycles run by the equipment should also be made to assist in evaluating the replacement or servicing that may be required.
