## LICENSEE EVENT REPORT (LER)

FACILITY NAME (1) Point Beach, Unit 1										DOCKET NUMBER (2) 0 5 0 0 0 2 6 6										PAGE (3) 1 OF 1																							
TITLE (4) Reactor Vessel Outlet Nozzle-to-Shell Weld Indications																																											
EVENT DATE (5)						LER NUMBER (6)						REPORT DATE (7)						OTHER FACILITIES INVOLVED (8)																									
MONTH		DAY		YEAR		YEAR		SEQUENTIAL NUMBER		REVISION NUMBER		MONTH		DAY		YEAR		FACILITY NAMES				DOCKET NUMBER(S)																					
0 2		2 8		8 4		8 4		0 0 2		0 0 0		0 3		2 8		8 4						0 5 0 0 0																					
0 2		2 8		8 4		8 4		0 0 2		0 0 0		0 3		2 8		8 4						0 5 0 0 0																					
OPERATING MODE (9)		THIS REPORT IS SUBMITTED PURSUANT TO THE REQUIREMENTS OF 10 CFR § (Check one or more of the following) (11)																																									
N		20.402(b)										20.406(c)										80.73(a)(2)(iv)										73.71(b)

DOCKET NO. 50-266  
LICENSEE EVENT REPORT NO. 84-002-00  
REACTOR VESSEL NOZZLE WELD INDICATIONS  
POINT BEACH NUCLEAR PLANT, UNIT 1

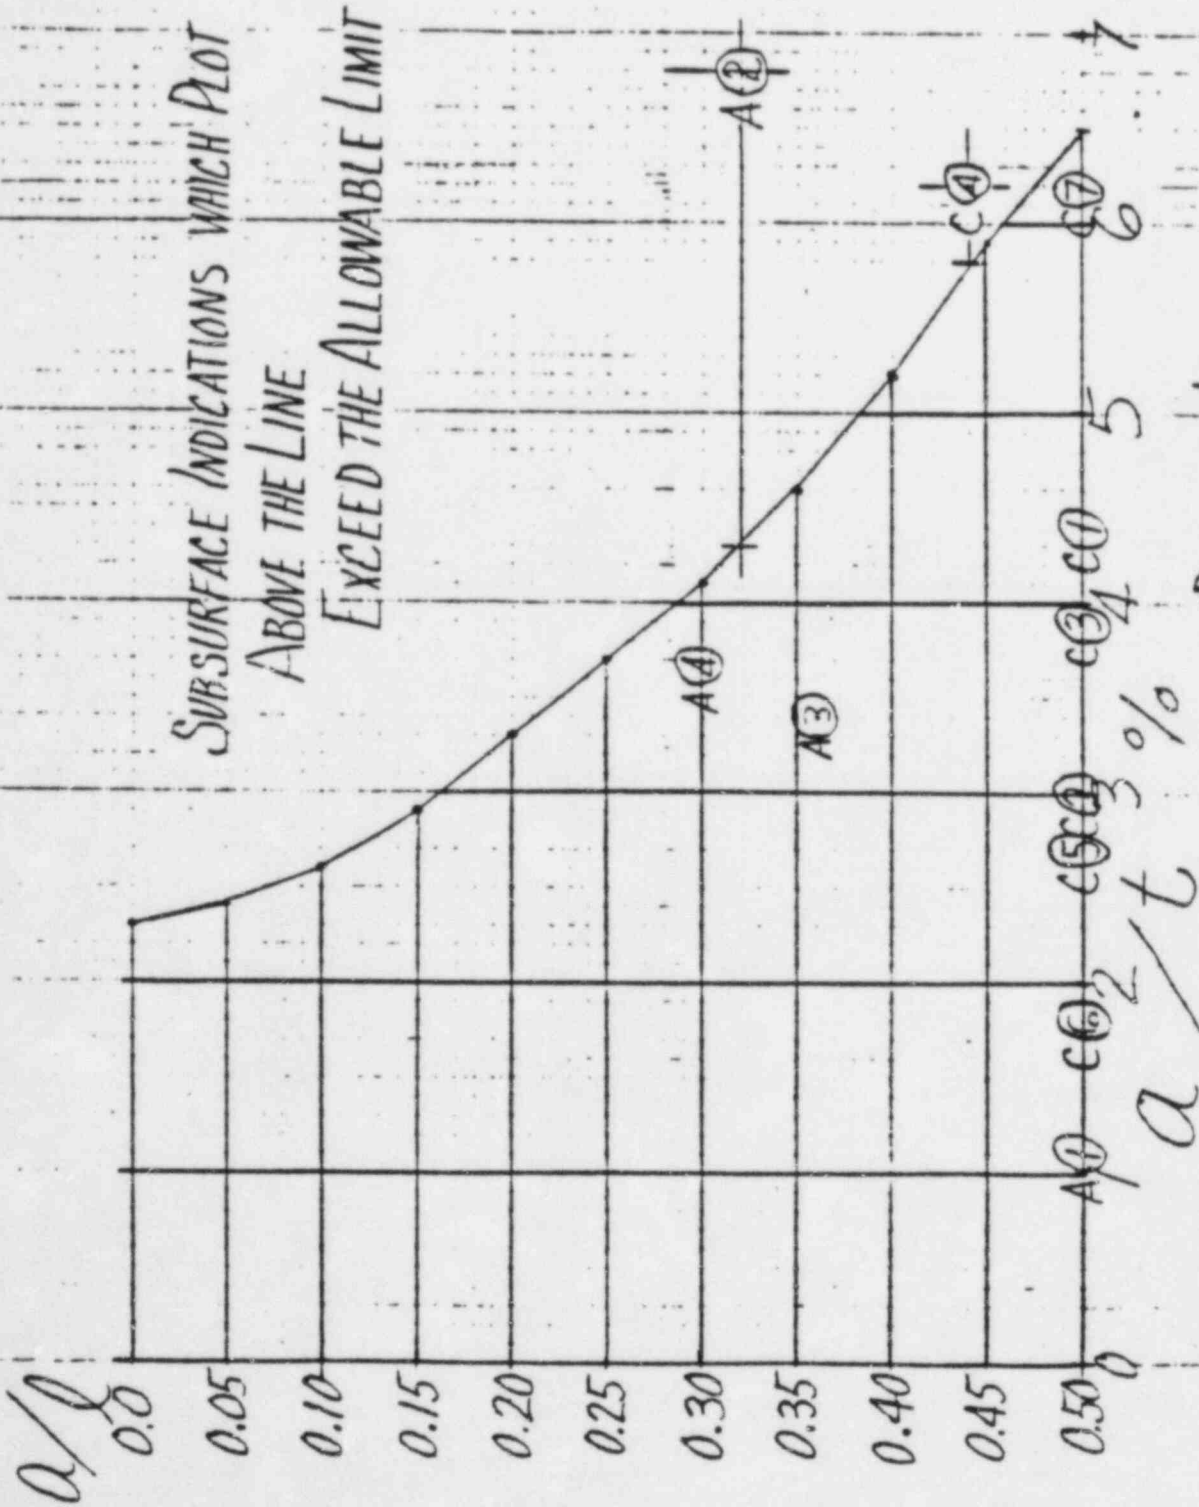
Figure 1

TABLE 1WB-3512-1 PLOT OF INDICATIONS

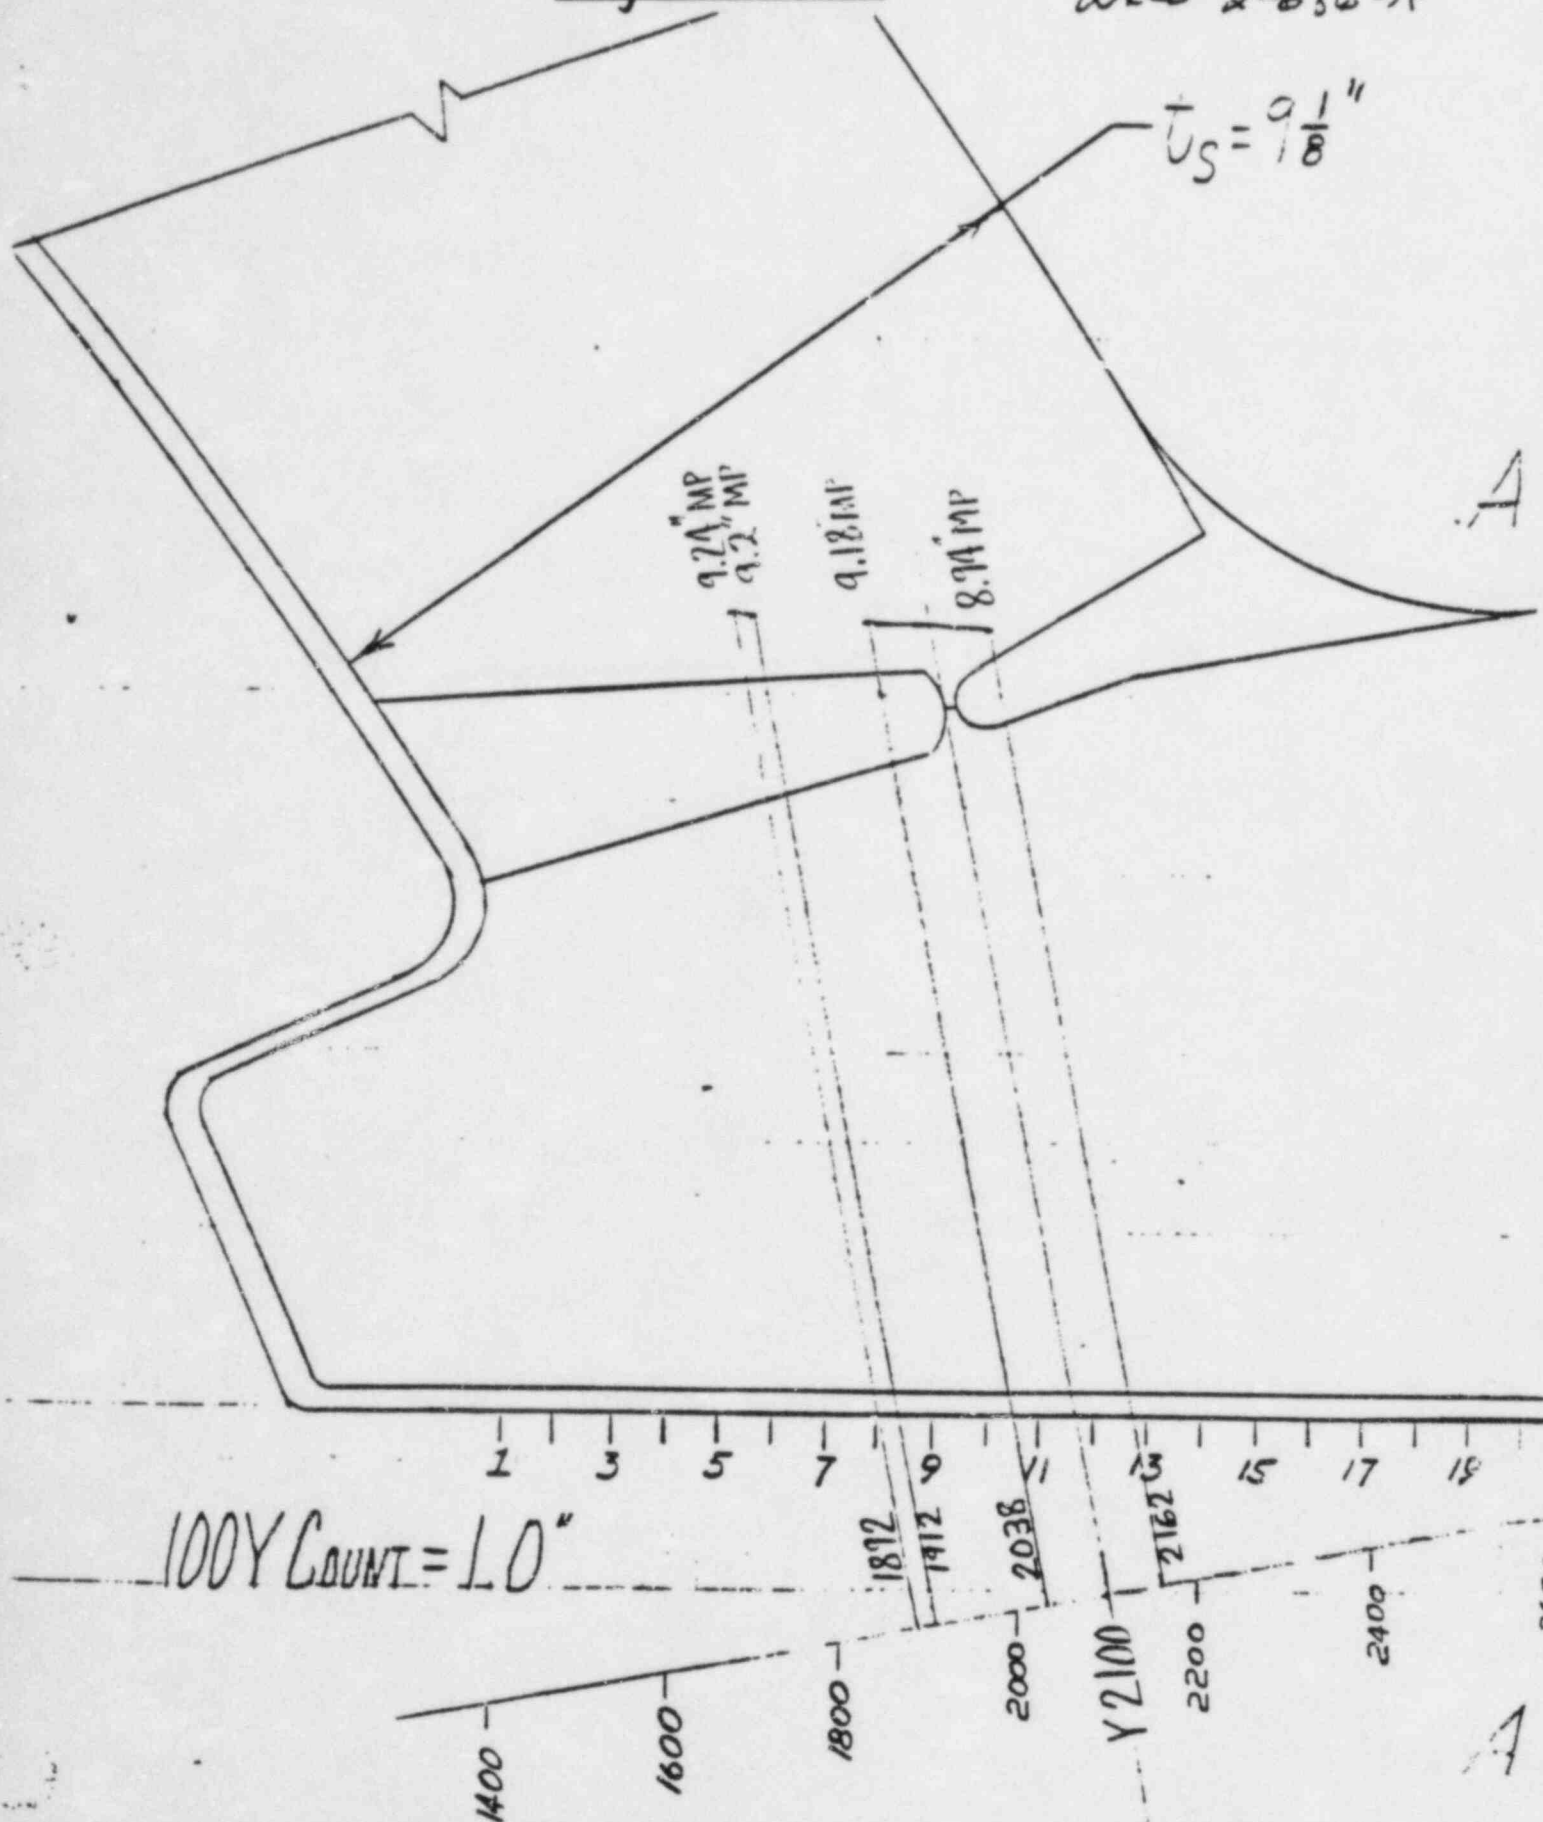
Figure 2

WELD 2-686-A

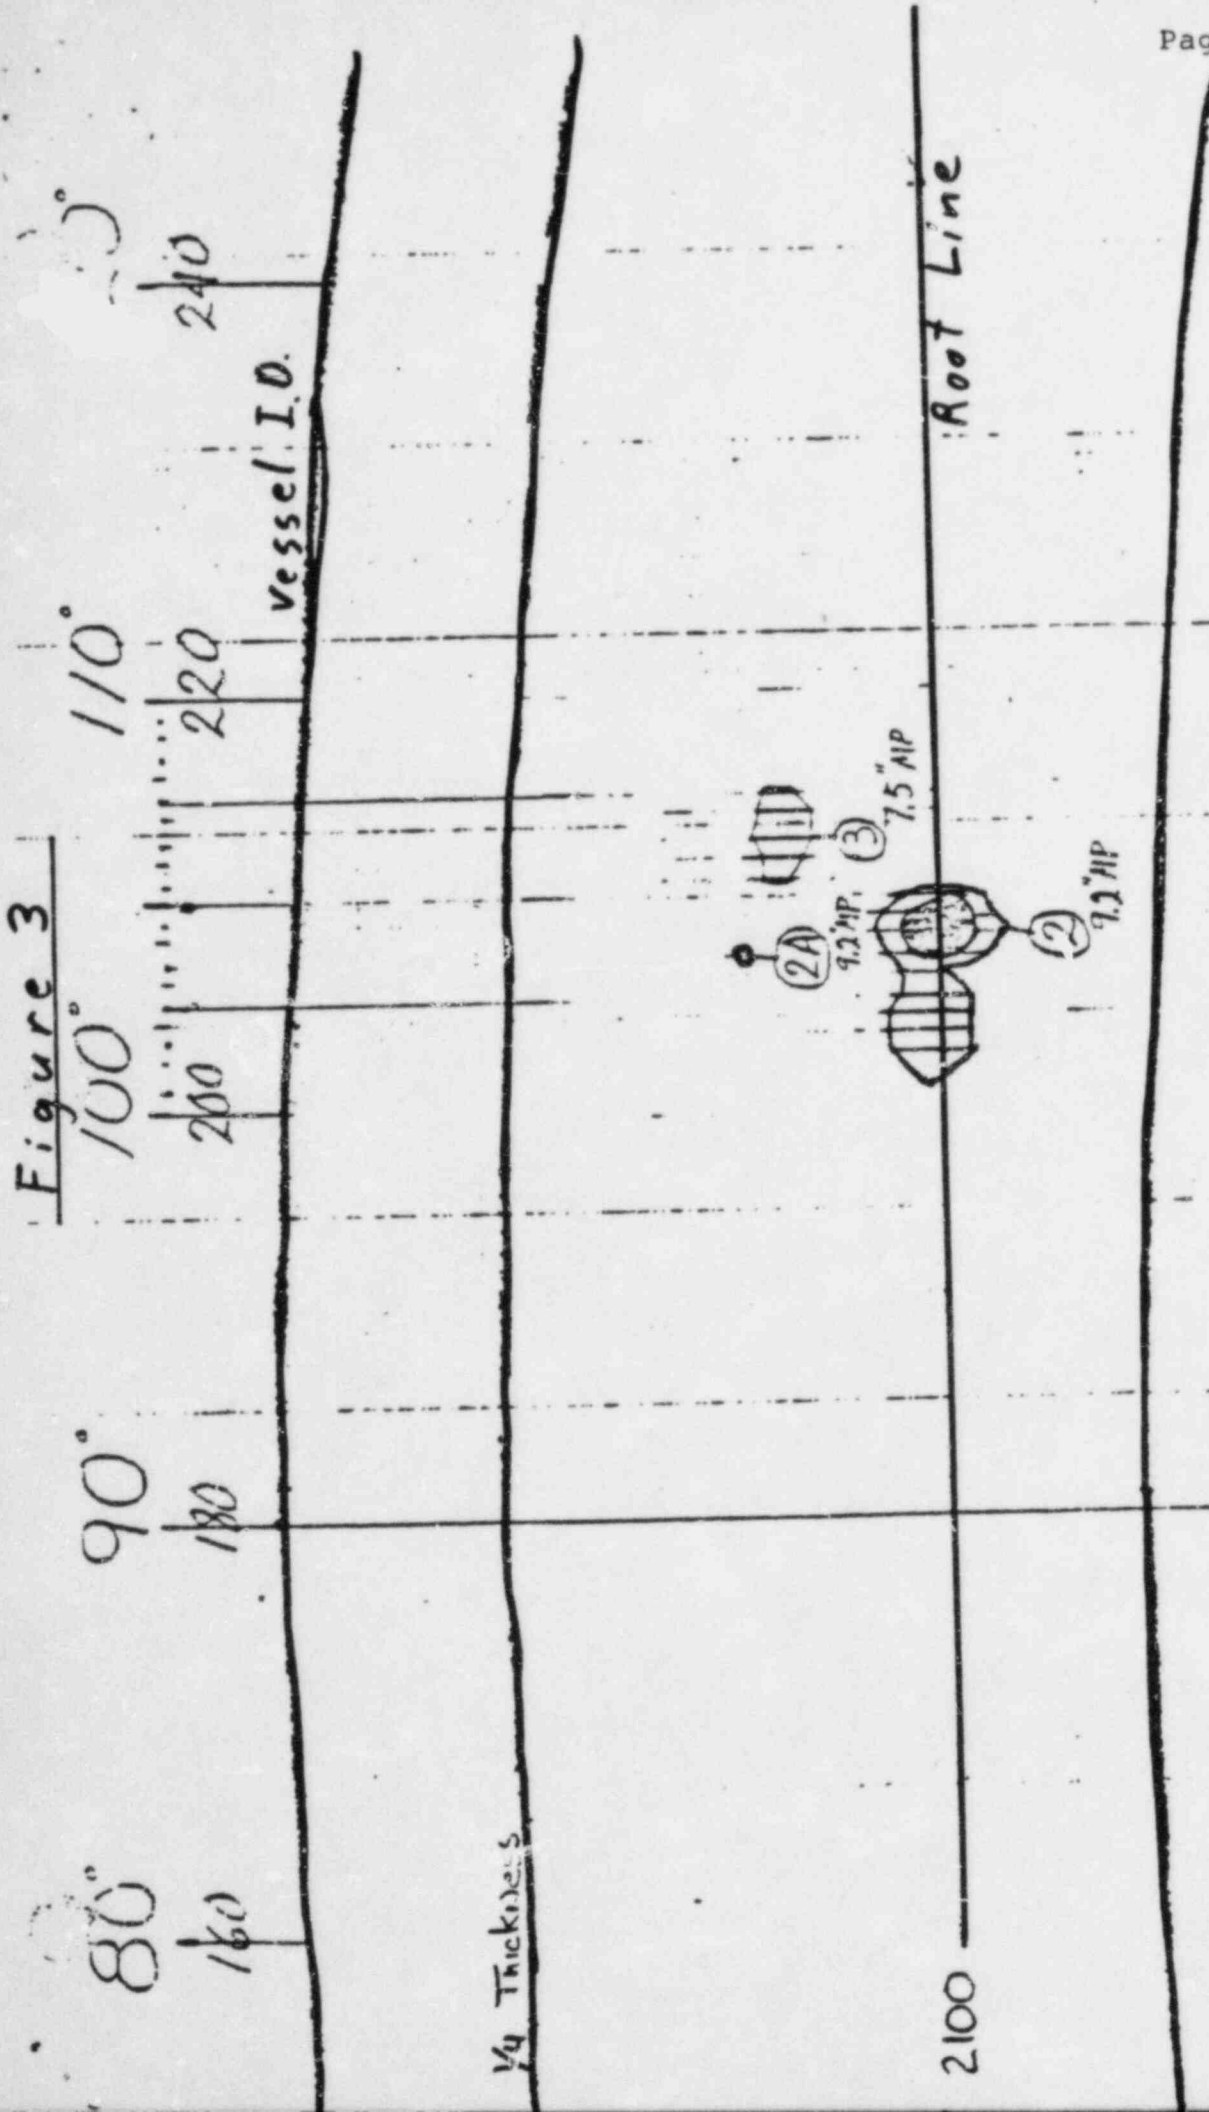
Figure 3

As can be seen in Figure 3, the flaw indication in the "A" outlet nozzle-to-shell weld which exceeds the acceptable size limits of Table IWB-3512 is in the proximity to another individually acceptable indication, A(2A), such that  $(a_1 + a_2) \leq (a_e + a_{e'})/2$  may not be satisfied. In the fracture analysis, interaction of these two indications was considered. Using ASME, Section XI, Appendix A, fatigue growth calculations were performed on these two indications. Predicted growth was small, so interaction was not expected to occur. Additionally, stress amplification of one flaw on the other was considered in computing the maximum applied stress intensities. The effect on stress intensity at the larger crack by the small crack was determined to be insignificant.

Outlet Nozzle AT  
VESSEL AZIMUTH 28.5°  
WELD 2+6861-A

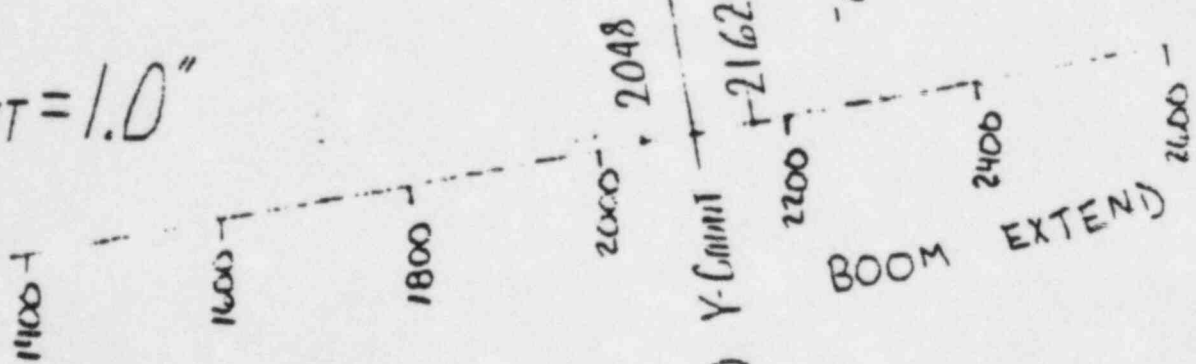
Figure 4

WELD 2-686-C

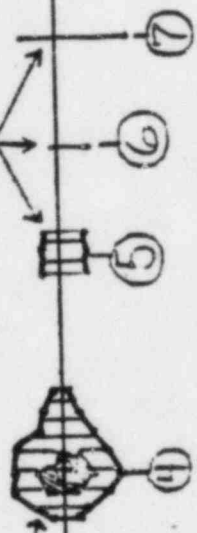
Figure 5

OUTLET NOZZLE AT  
VESSEL AZIMUTH 208.5°  
WELD 2-686-C
